Our Ref: PSM4636-006L REV5

**RE: AUGUSTA STREET, HUNTINGWOOD EAST,  
RESULTS OF GEOTECHNICAL INVESTIGATION**

## **1. Introduction**

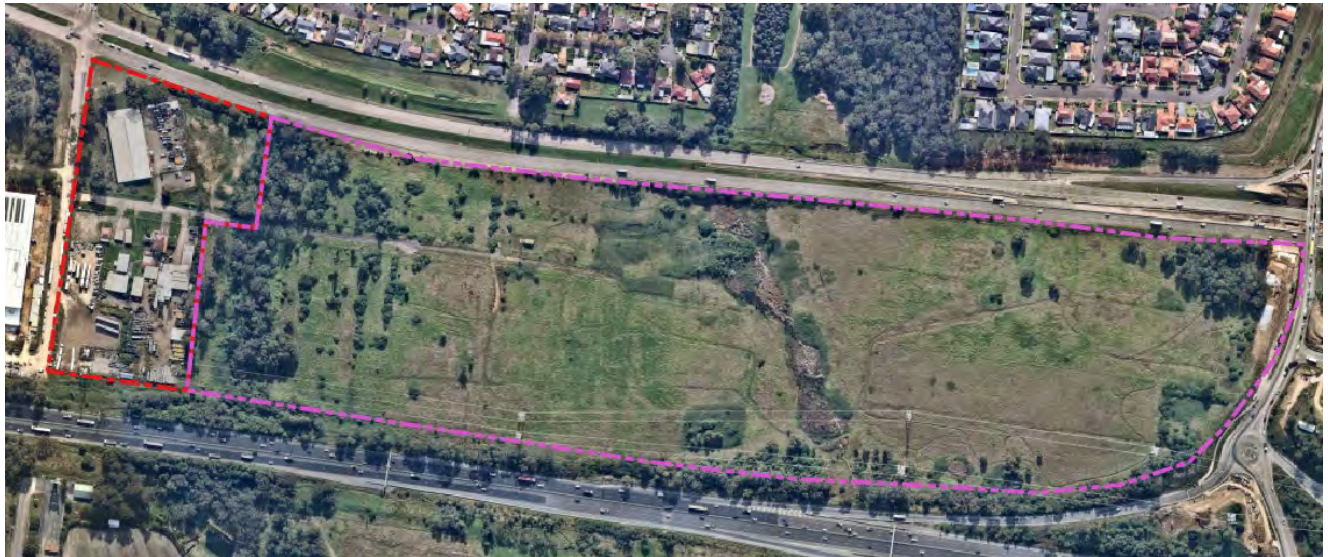
**Inset 3: Nearmap Aerial photograph of the site conditions on 19 May 2022**

- Blacktown Creek passes across the middle portion of the Site from north to south
- Two sets of high voltage transmission tower are located adjacent to the southern boundary of the site
- The western region of the transmission tower to the left of the Blacktown Creek is dipping in the western direction towards Flushcombe Road
- The remainder of the site had an undulating surface but is generally dipping towards Blacktown Creek
- A telecommunication tower and a single-storey demountable building mounted on brick piers were observed near the eastern end of Augusta Street
- The site is bounded by post and wire fences
- Existing fill comprising CLAY material mixed with debris from demolition e.g., tiles, bricks and glass bottles were observed at localised areas.

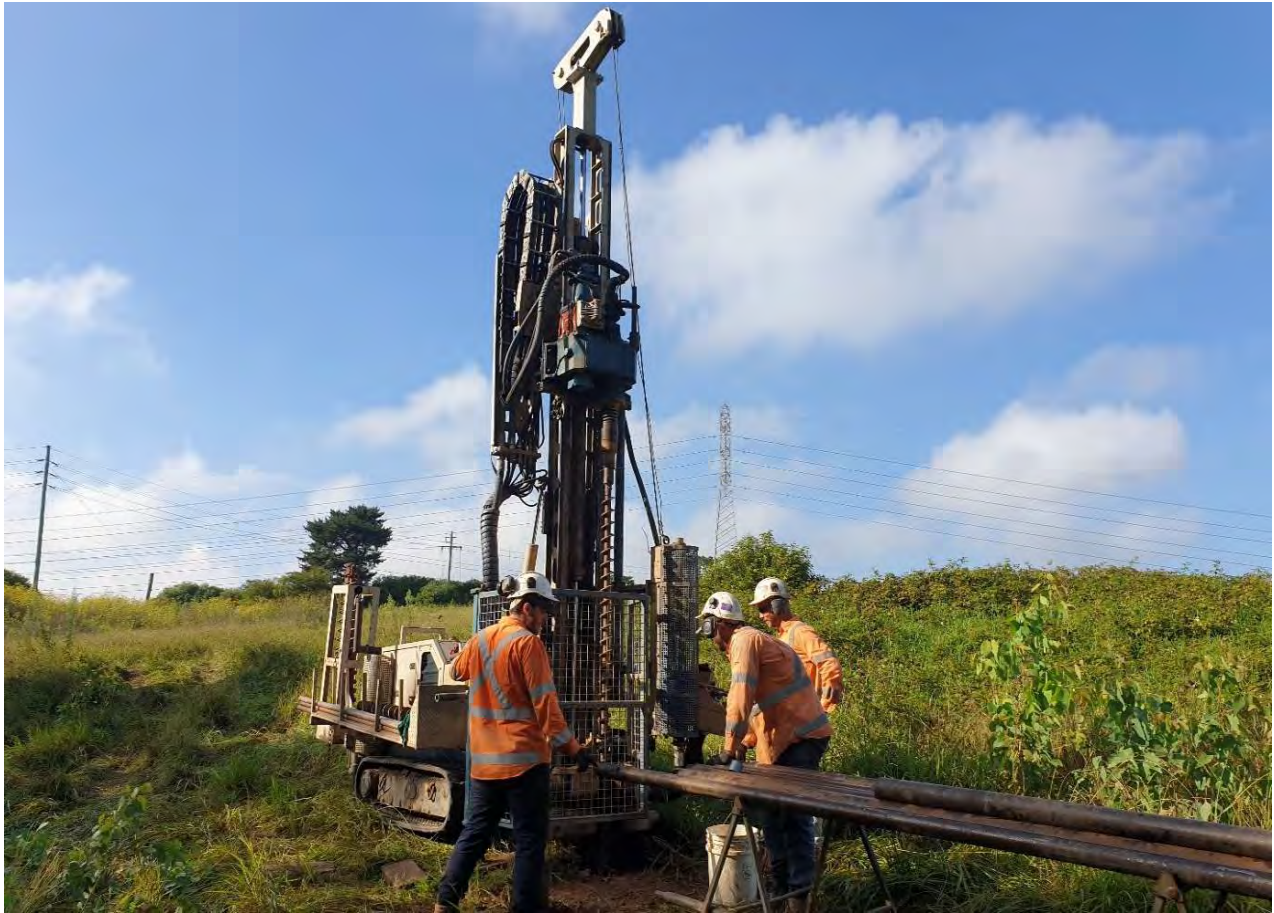
Photo 3 - Drill rig setup on BH12 (18/02/2022)

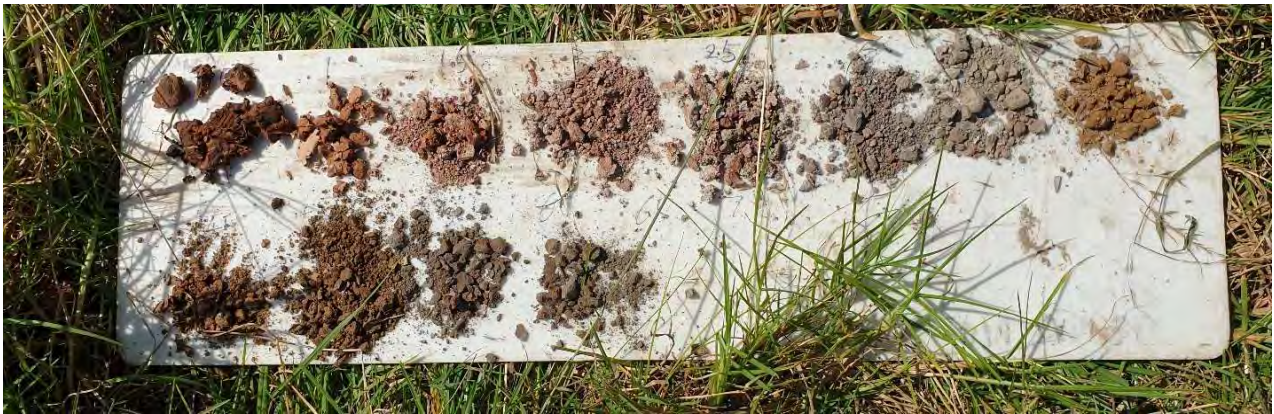
Photo 4 - Cuttings from BH02 (21/02/2022)

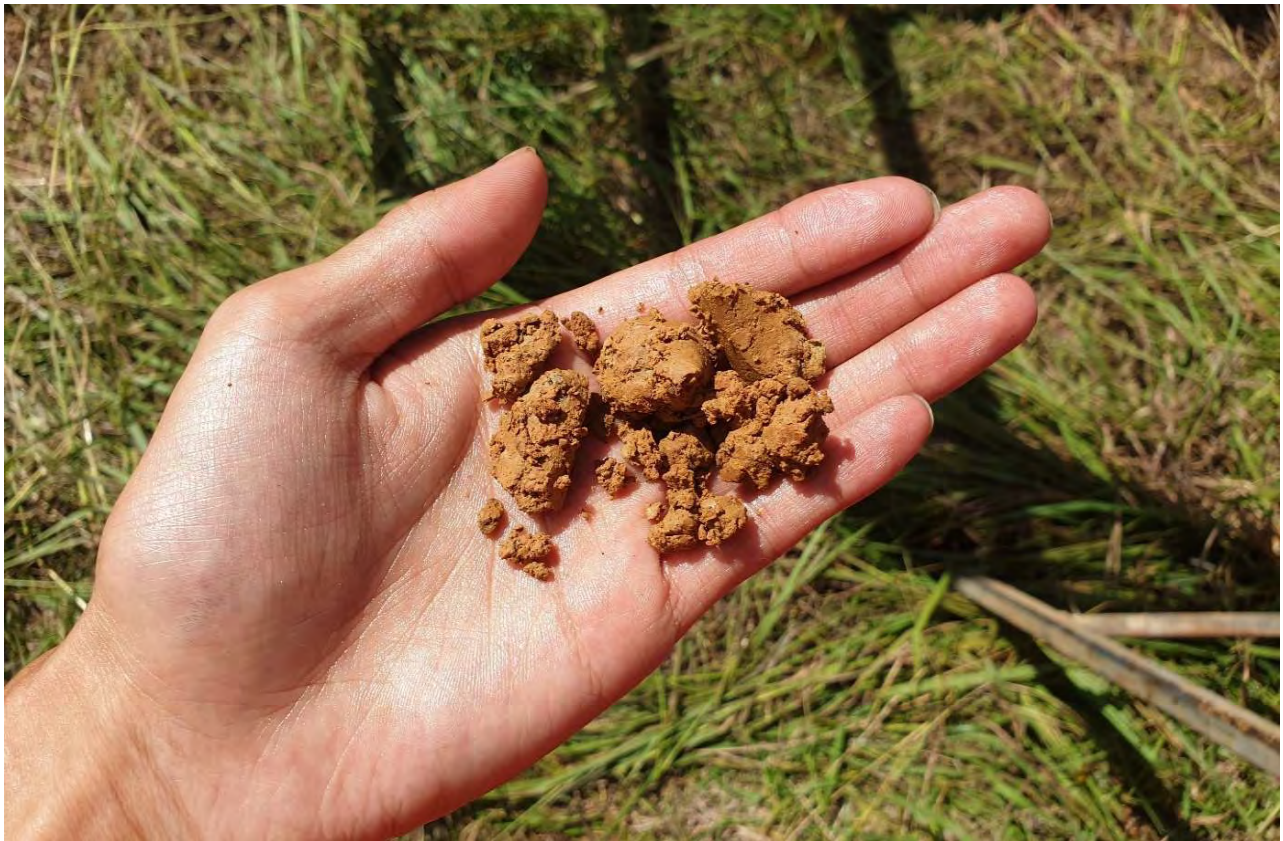
Photo 5 - Typical NATURAL unit encountered in BH11 (17/02/2022)

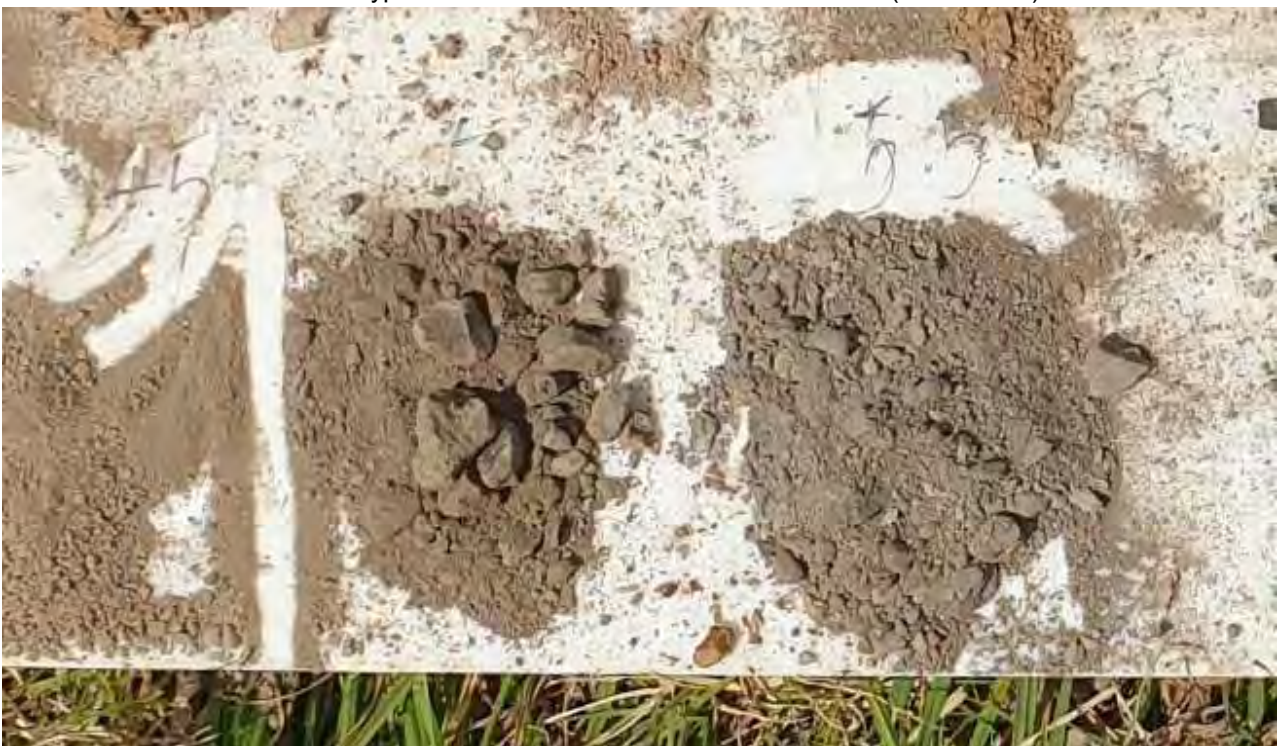
Photo 6 - Typical BEDROCK unit encountered in BH08 (21/02/2022)

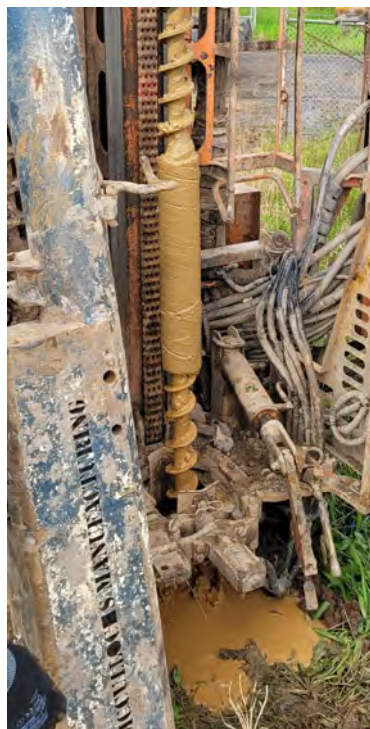
Photo 8 - Water encountered at BH14 (23/05/2022)

Groundwater was encountered during the fieldwork at BH14 at a depth of 4.0 m below the surface. There was no groundwater observed during drilling in the other boreholes. After the installation of piezometer at BH11, it was observed that the piezometer was filled with water used during the drilling process and was kept undrained. PSM returned the Site on 18 March 2022 to measure the groundwater level at the piezometers installed. Table 5 presents the depth of groundwater encountered below the ground surface level following significant rainfall in the first week of March 2022.
