## STATE HIGHWAY 4, MILFORD DIAMOND FEATURE ROCK REMOVAL

MILFORD, NEW ZEALAND

### PROJECT OVERVIEW:

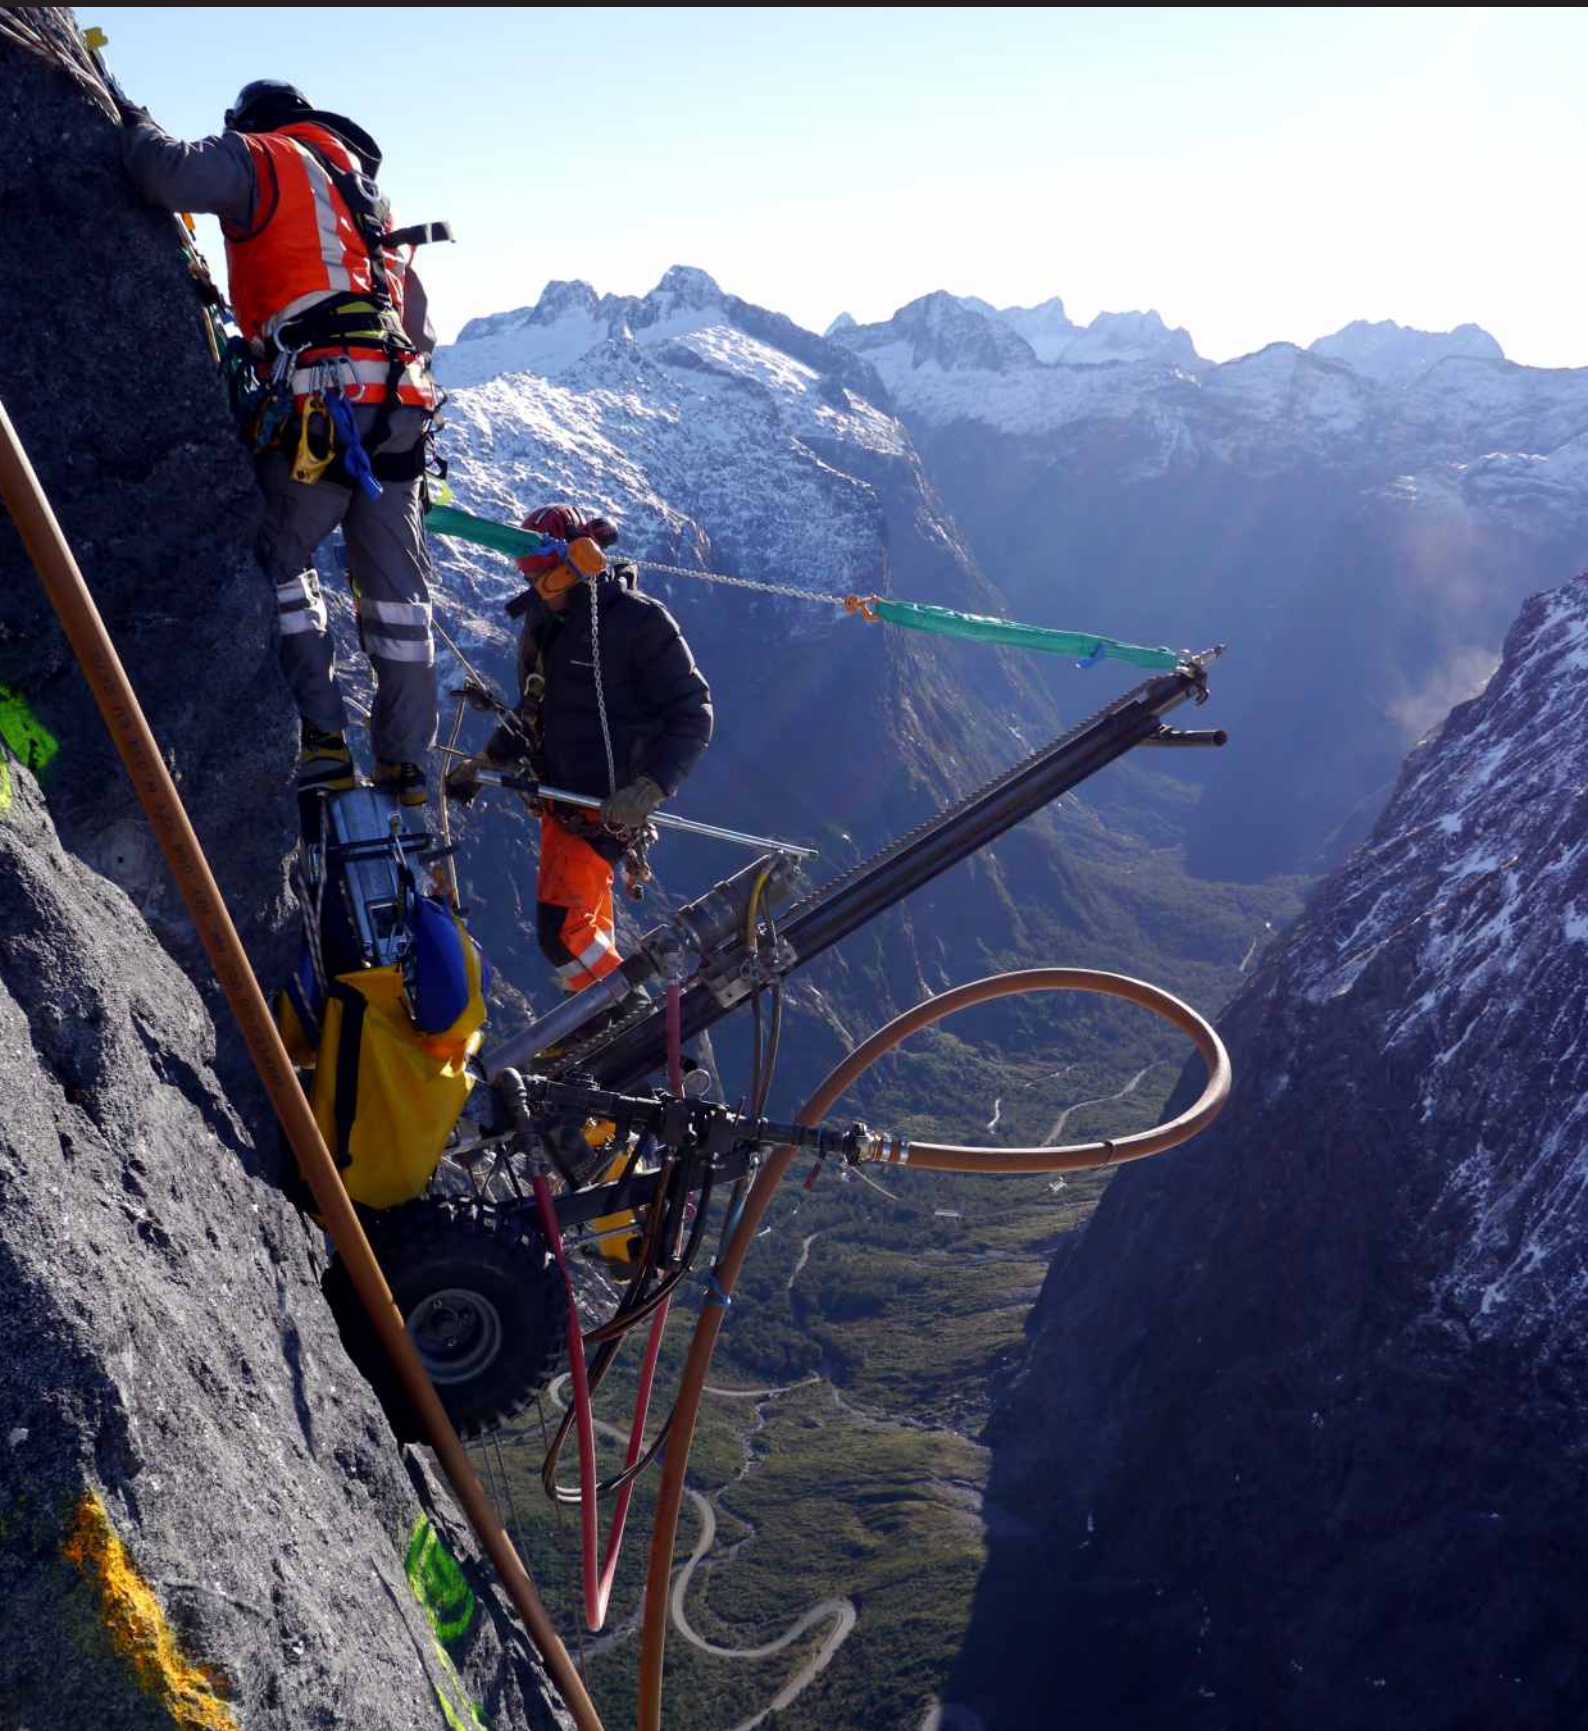
Geovert assessed the feature with NZTA engineer's Opus, and determined the rock mass was failing in a combination sliding rotational toppling mechanism with less than 10% of the toe area providing the only point of attachment. As a result of this inspection the road was closed to all traffic until the drill and blast removal of a 25m high 2000 tonne unstable rock mass was removed. This was located 900m vertical above the western portal of the Homer Tunnel at 1800mASL and the contract period began in May which meant dealing with severe alpine weather conditions.

The rockmass was deemed highly unstable and a drill and blast programme was implemented under urgency to remove it. A series of extensometer points were installed to monitor for any movement during drilling and for post blast inspection. The blast design was engineered to maximise fragmentation and reduce damage to existing highway furniture including the newly completed temporary portal extension structure. Drilling was completed for 23 holes, with 300kg of high velocity explosives used. Post blast scaling and inspection was completed to allow the road to reopen.
