CREMORNE STREET LANDSLIP REMEDIATION

HERNE BAY, AUCKLAND, NEW ZEALAND

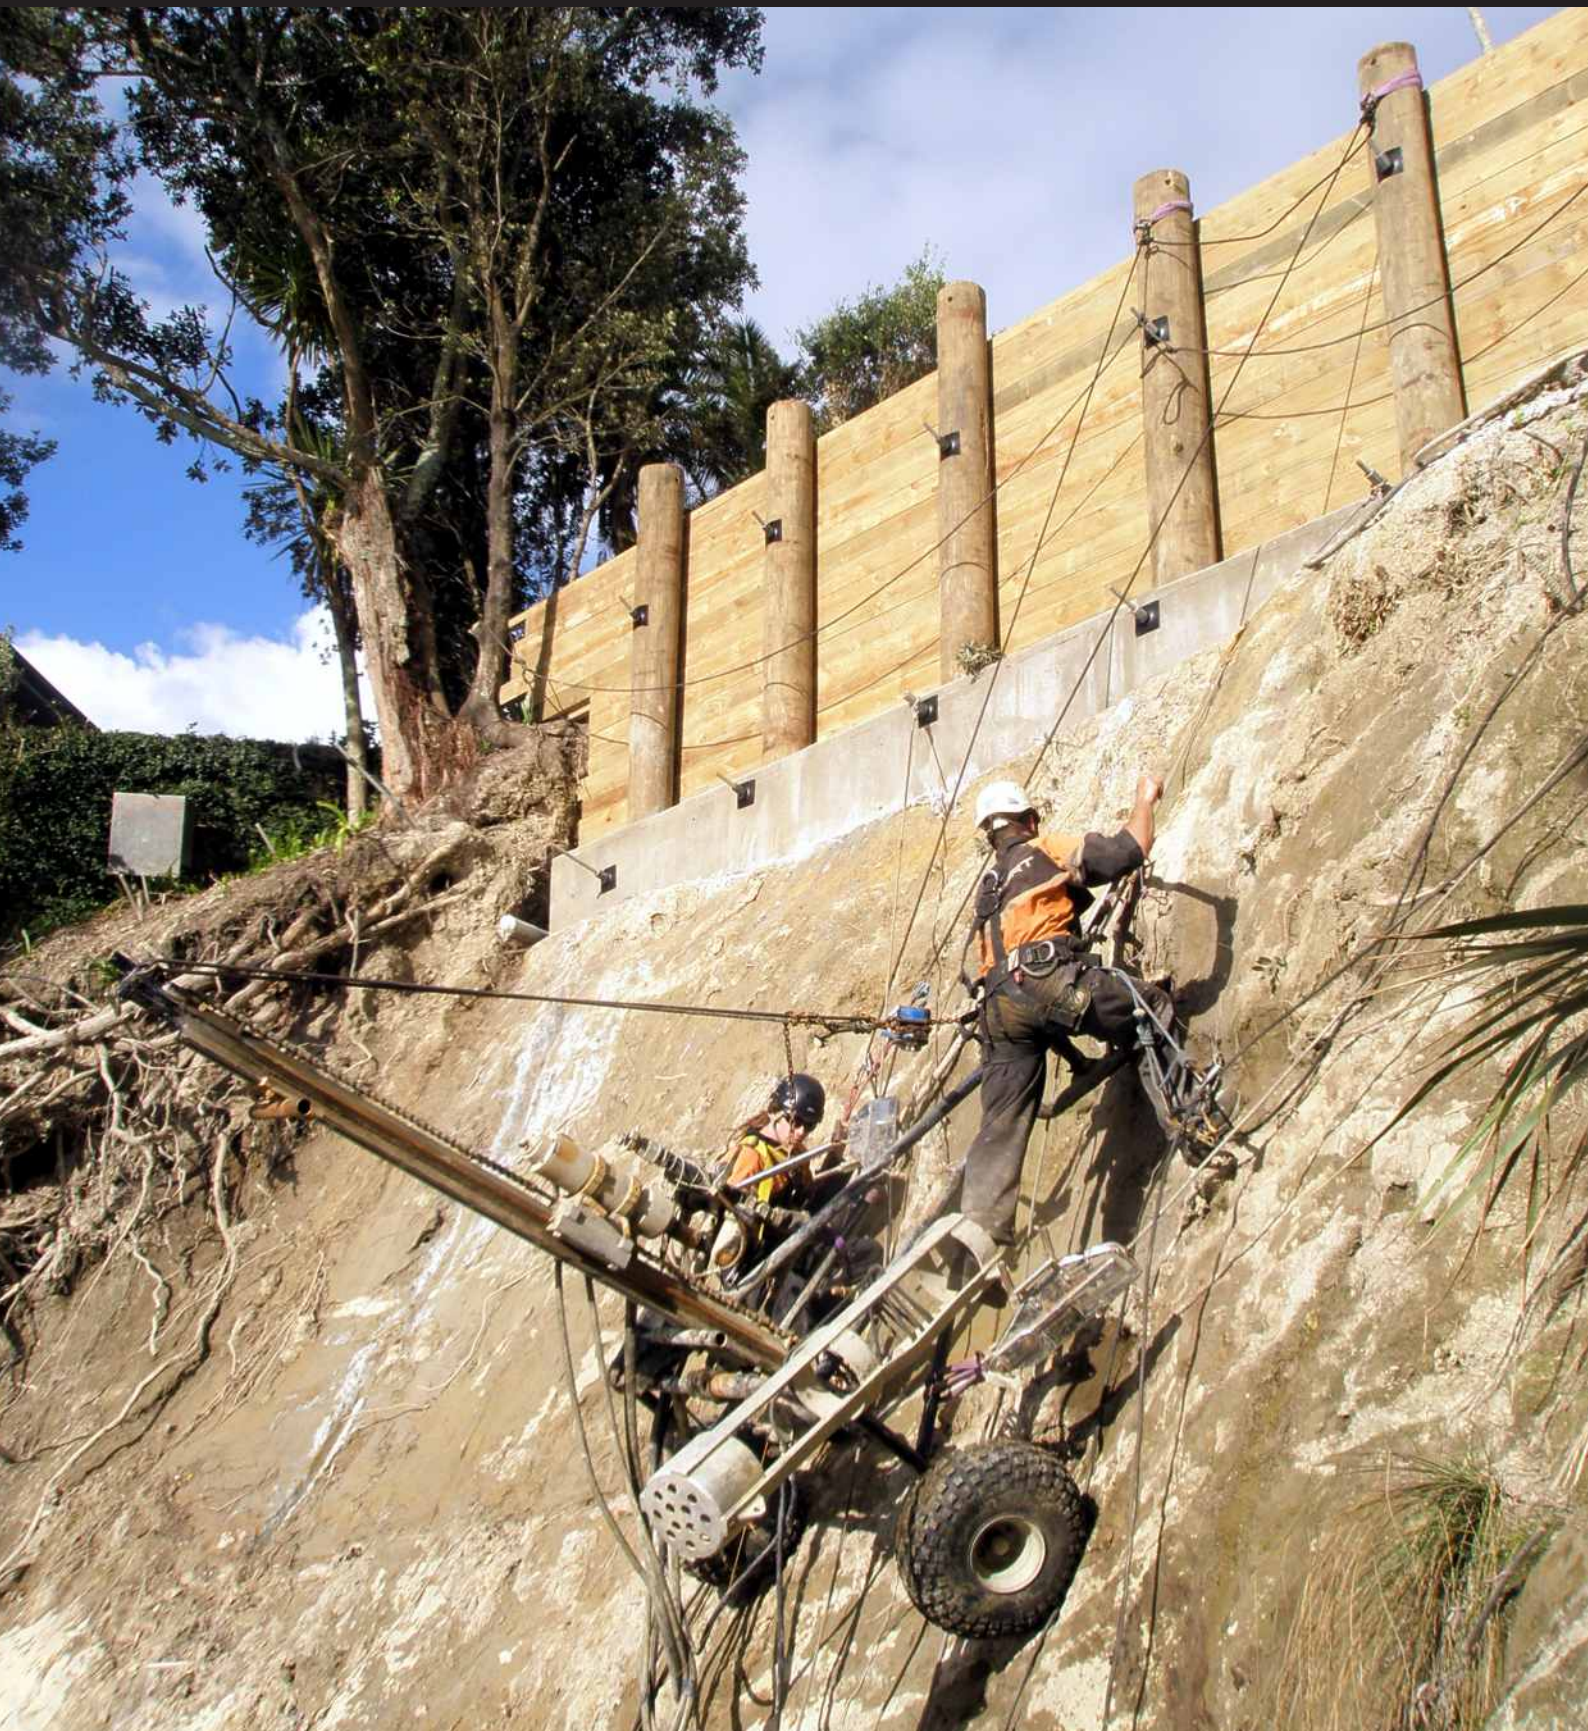
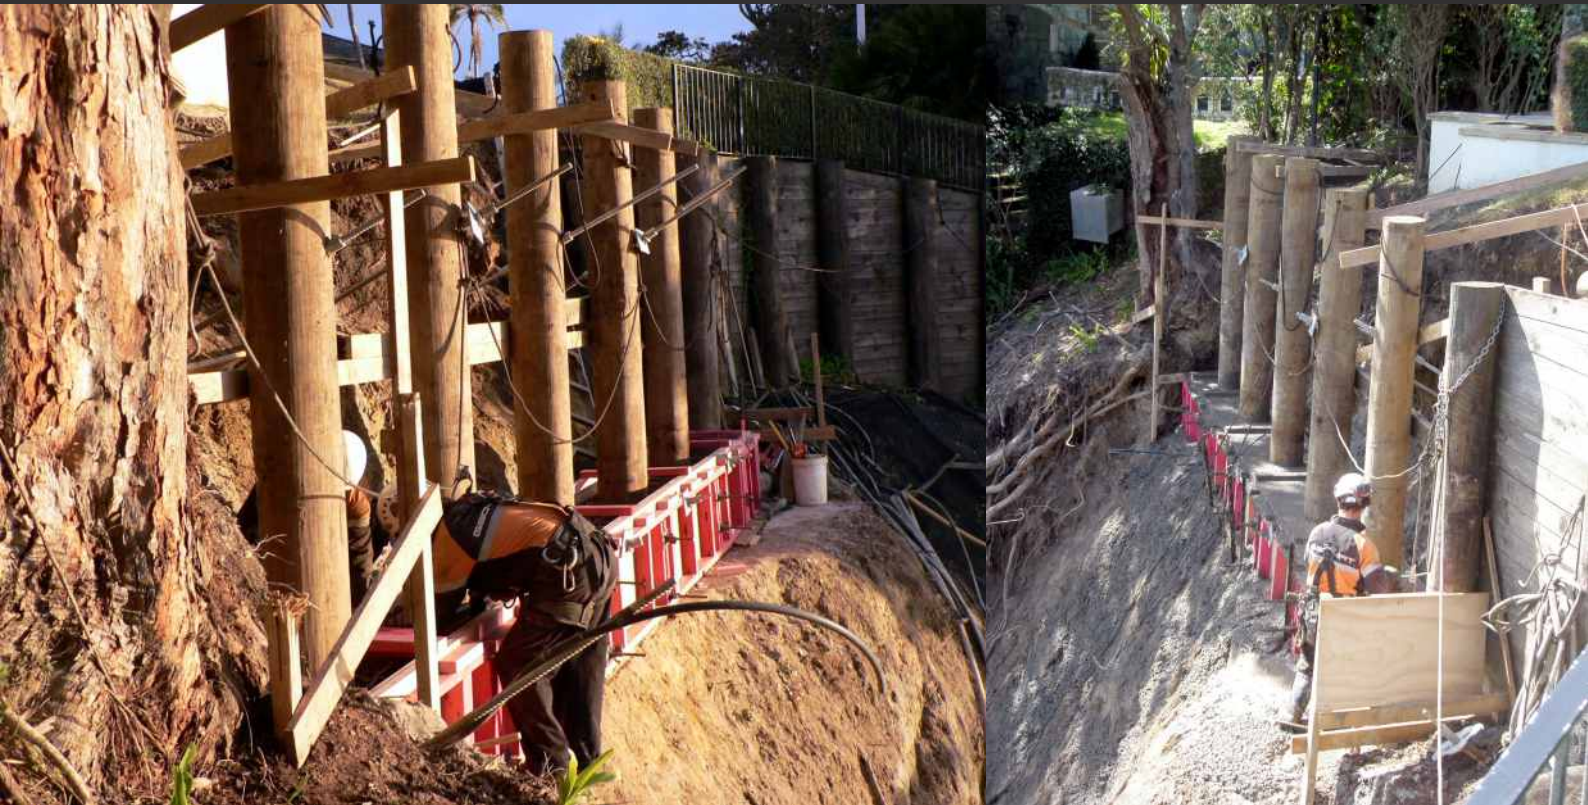
After prolonged periods of heavy rain in the Auckland region significant slips occurred and put a variety of private & public infrastructure at risk of loss or damage. Geovert were contracted to complete emergency slip repairs to prevent continued slope failures by using technical access to soil nail and TECCO mesh the affected slope.

Once stabilised a mini-piled & anchored retaining wall were constructed to reclaim lost land and prevent further failures. Geovert worked closely with the consultants on a bespoke design & build solution to satisfy the engineers and client as no cranes, concrete trucks or vehicles could access the site, all materials were placed by helicopter.
