BELLEVUE GARDENS CONTROLLED SCALING & BLOCK REMOVAL

NSW, AUSTRALIA

CONTROLLED REMOVAL OF SANDSTONE BLOCKS ABOVE RESIDENTIAL DWELLINGS

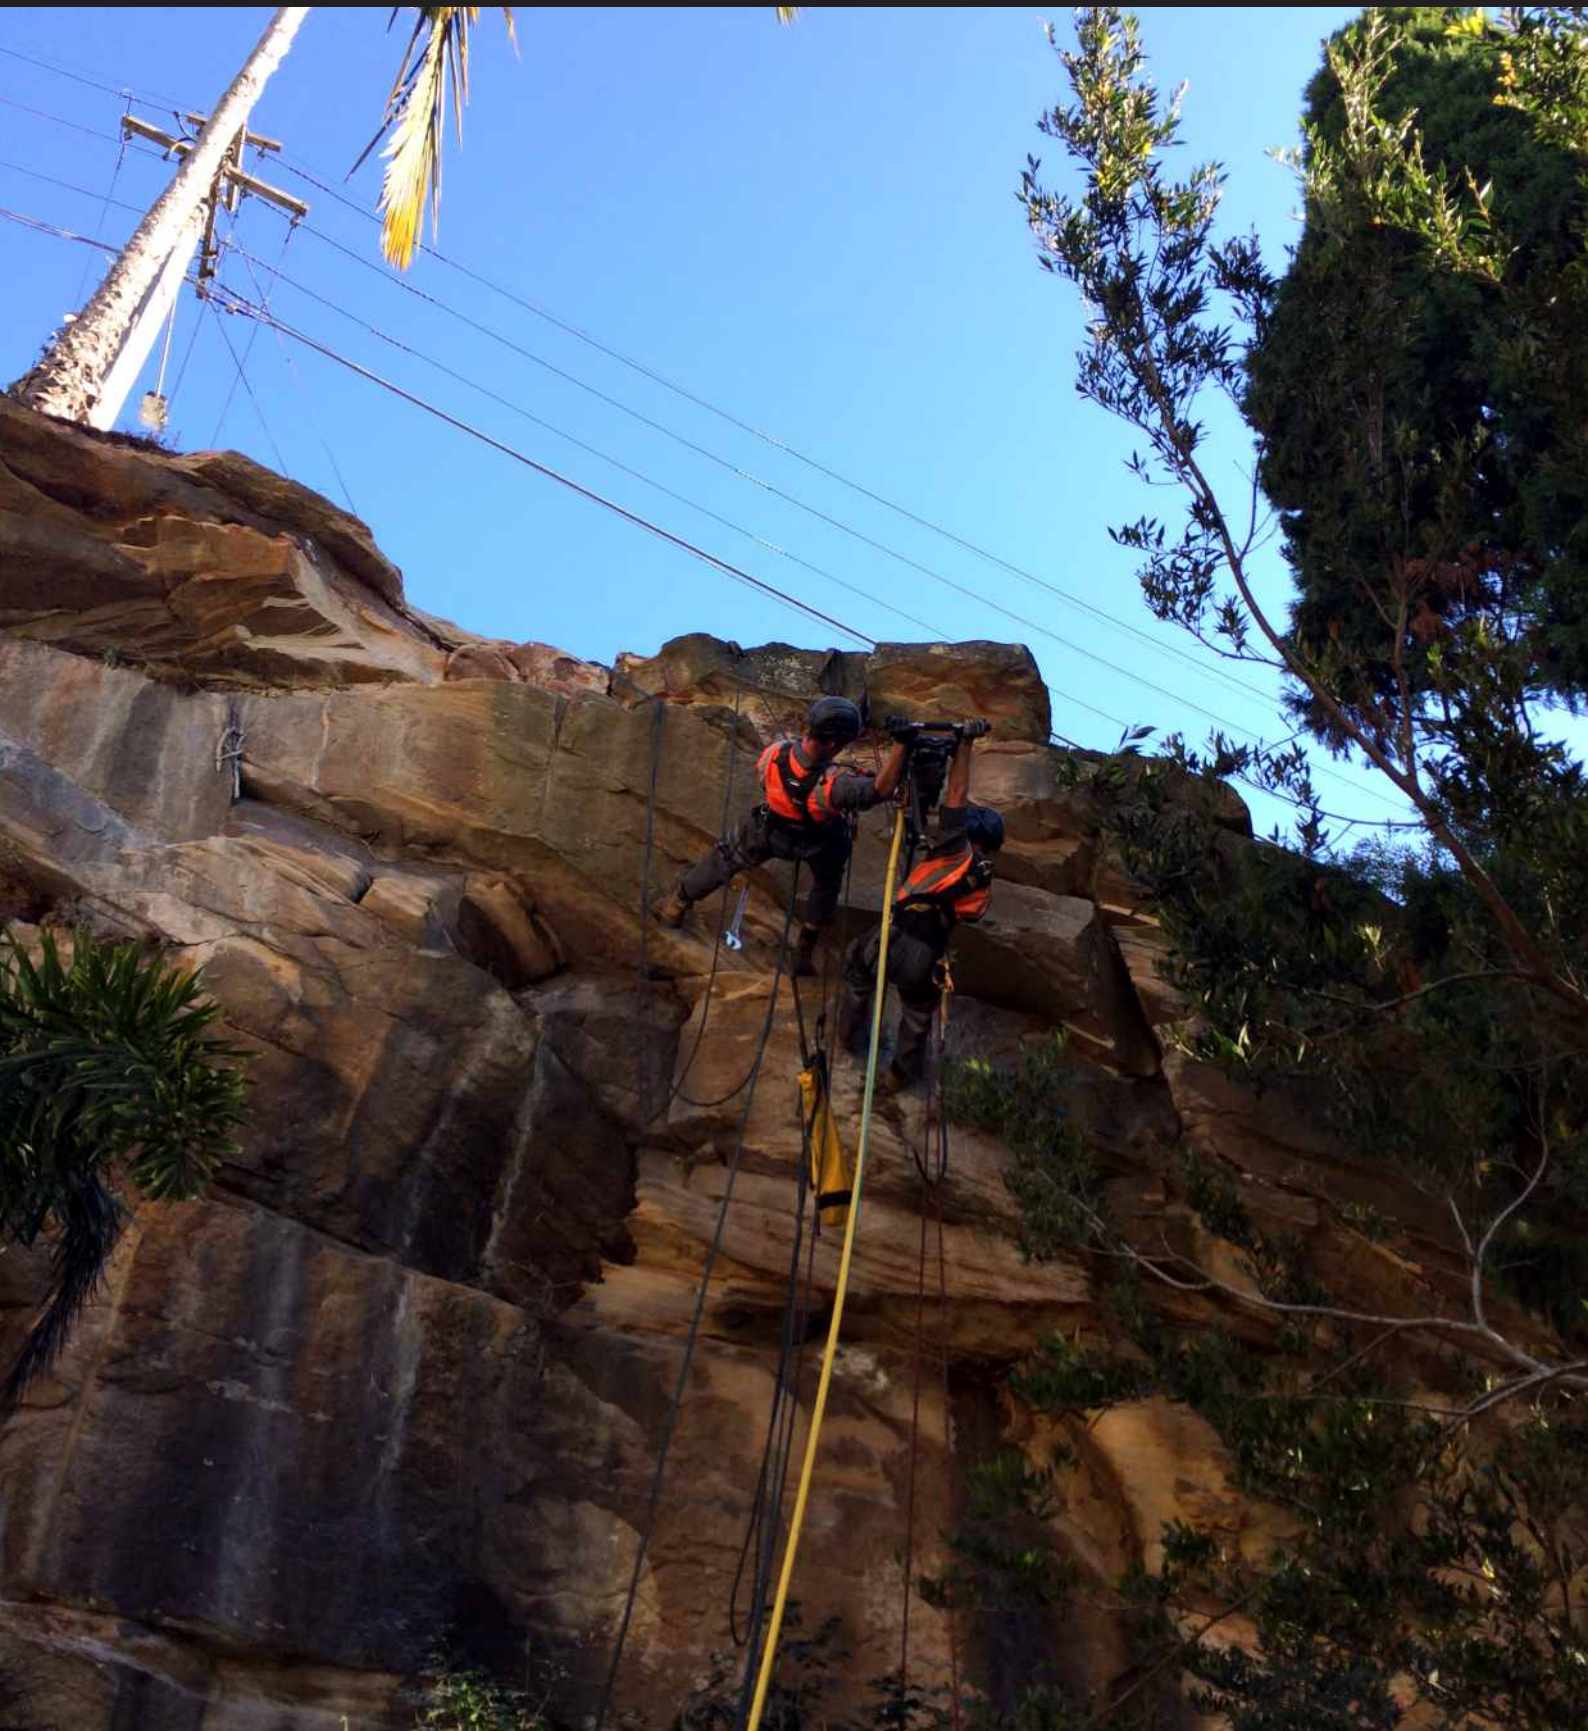
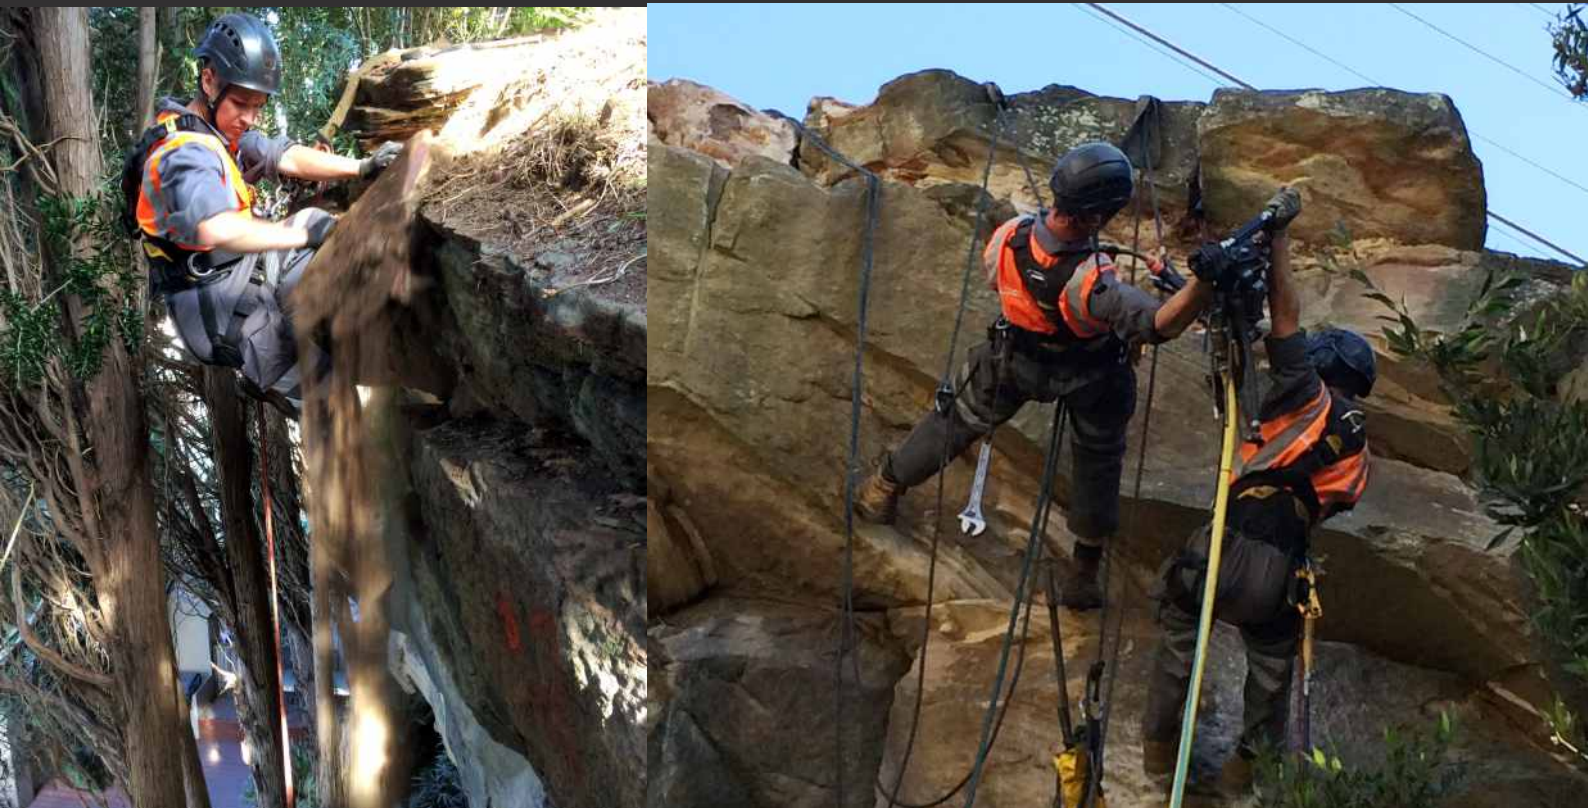
A large sandstone block was identified as needing temporary stabilisation measures prior to removal. Geovert developed a temporary

wire cable strapping system to enable technicians to execute a controlled removal and breakup of the 16 tonne sandstone block, located immediately above a timber deck. Utilising a system of recycled car tyres and plywood panelling, the deck was successfully protected during the breakup and removal of the block.
