MANAWATU GORGE SLIP REMEDIATION REMEDICATION OF MAMMOTH SLIP CLOSING HIGHWAY FOR OVER A YEAR

MANAWATU, NEW ZEALAND

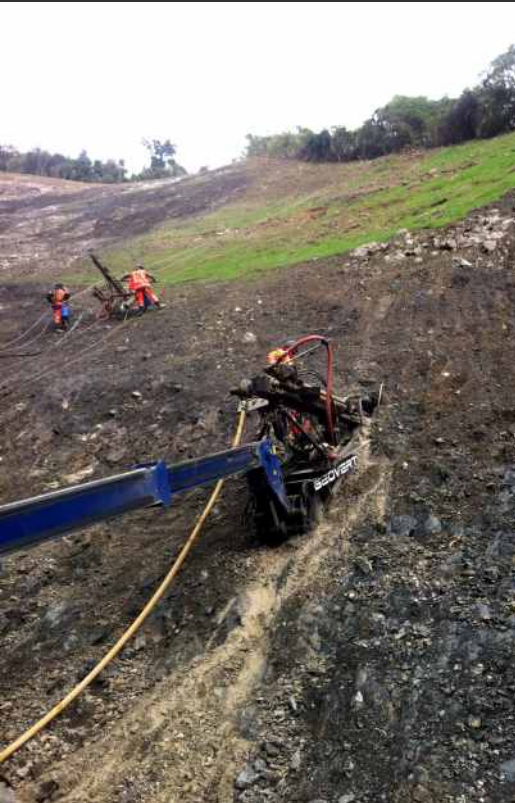
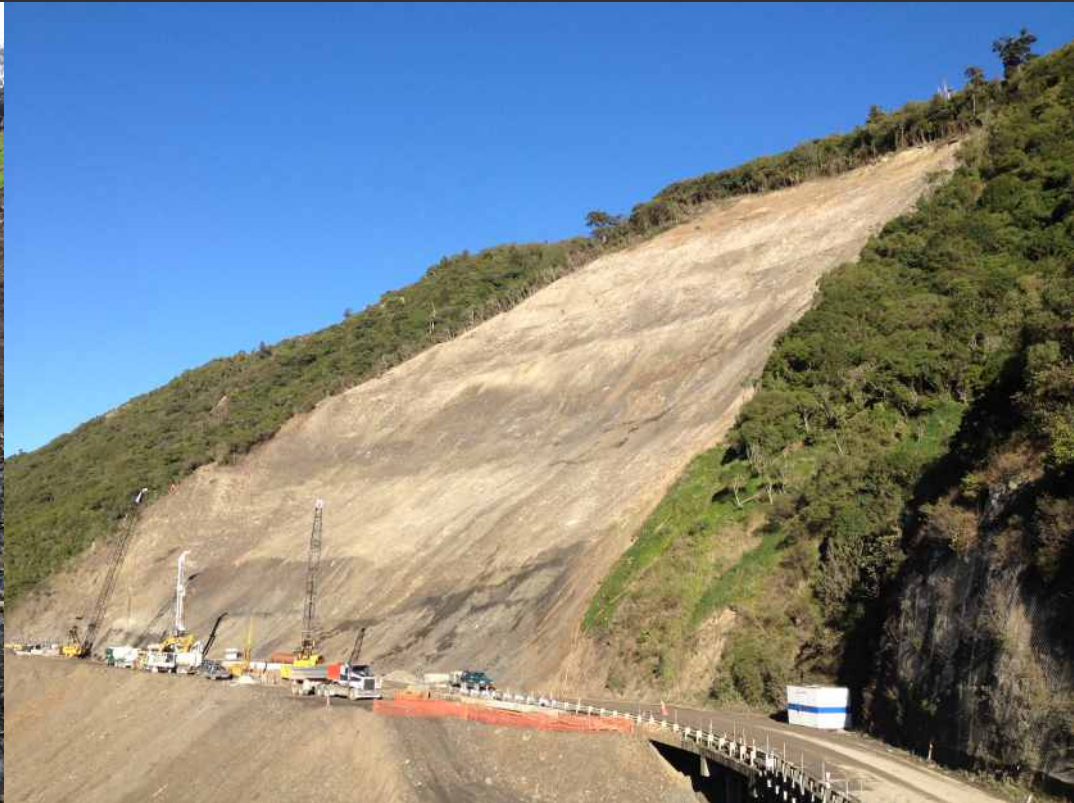
A VERY DIVERSE AMOUNT OF GROUND ENGINEERING TECHNIQUES WERE APPLIED

Geovert were commissioned directly by NZTA under the management of MWH for all slope stabilisation and drilling work completed on site. The work included installation of a Geobrugg Deltax mesh drape, installation of horizontal inclined drainage holes, stabilisation of the western colluvium slope and installation of a 500 kJ Geobrugg attenuator, 140m long, 4m high, 30m above road level which is that largest in the southern hemisphere.

Slope stabilisation works included over 2200 lm of drilling. Geovert's contribution to the reconstruction of the highway included over 1200 lm of drilling including installation of anchors on the abutment of Bridge 8 (complete new build), stabilisation of the Bridge 8

Abutment D potential/slow moving wedge failure, and installation of seismic strengthening anchors for Half Bridge 7 and Half Bridge 9.
