ENLARGED COTTER DAM (ECD) GROUT CURTAIN / PERCUSSION DRILLING & AUTOMATED GIN FOUNDATION GROUTING

300M LONG GROUT CURTAIN FORMED UNDER ECD FOUNDATIONS TO 60M IN 200MPA RHYOLITE

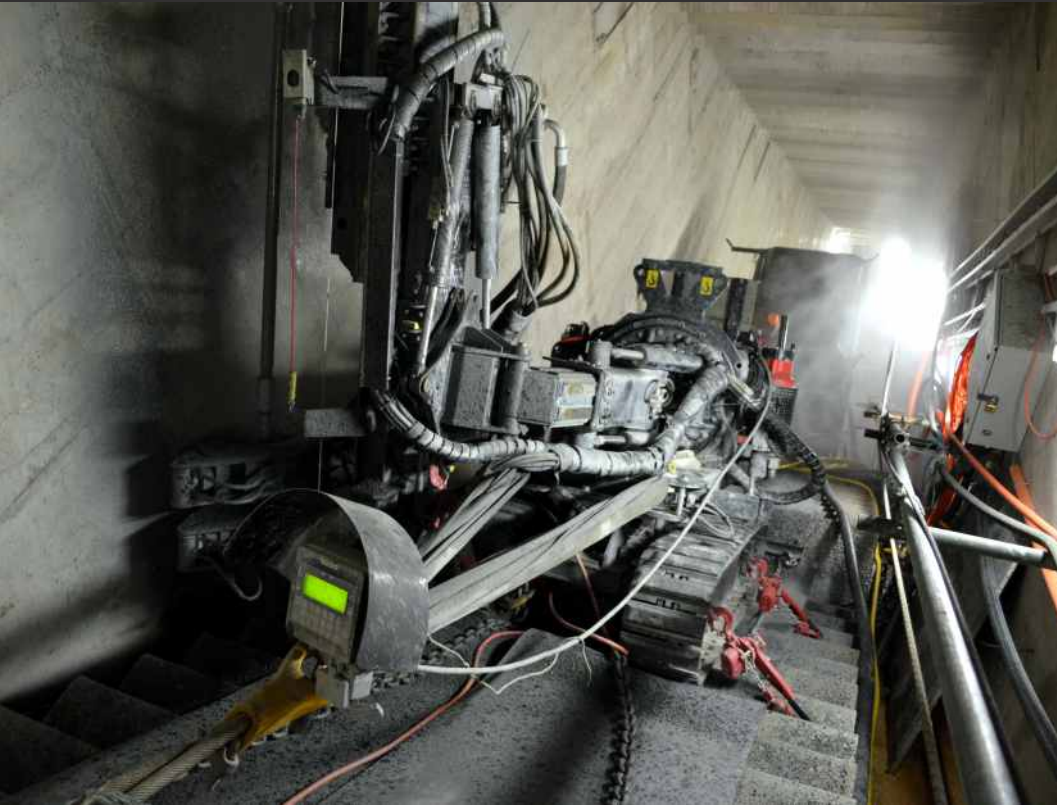
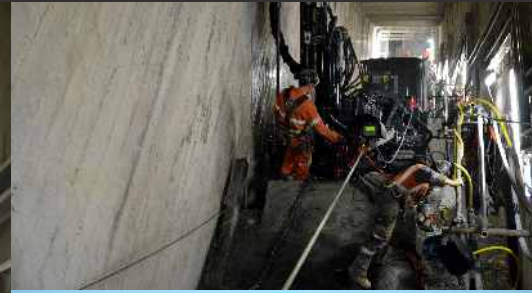
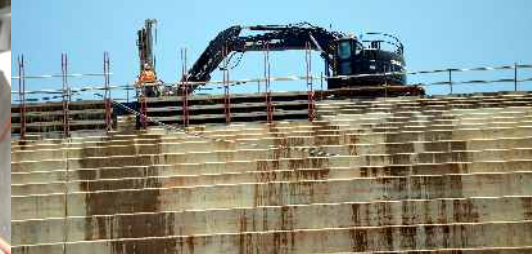
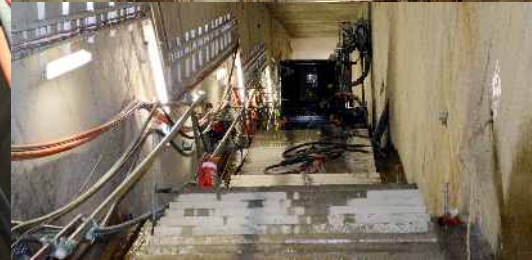
Works involved construction of a grout curtain some 300m long and up to 60m deep beneath the Enlarged Cotter Dam and the drilling of foundation drainage holes throughout the dam monolith and dam foundations. Large spool hydraulic winches were installed at the top of each gallery incline to allow a 5t tracked drill rig and a skid mounted diamond coring rig to be hauled up the 42° stairs, gaining 80m elevation over the length of the incline. A fully automated grout injection control system was installed in the gallery, ensuring the GIN stop criteria were met accurately.

were drilled beneath the dam monolith using DTH and top hammer techniques to optimise production and accelerate the program. Pressure relief drains were drilled from the crest of the dam using down the hole hammers, requiring extremely low deviation drilling to intersect the break through target area, 1.5m wide, on the gallery roof, up to 65m below (2% deviation).
