2021 Foreshore Monitoring and
Sampling Program

Memo

Subject: 2021 Foreshore Passive Treatment System Maintenance and Inspection Memo

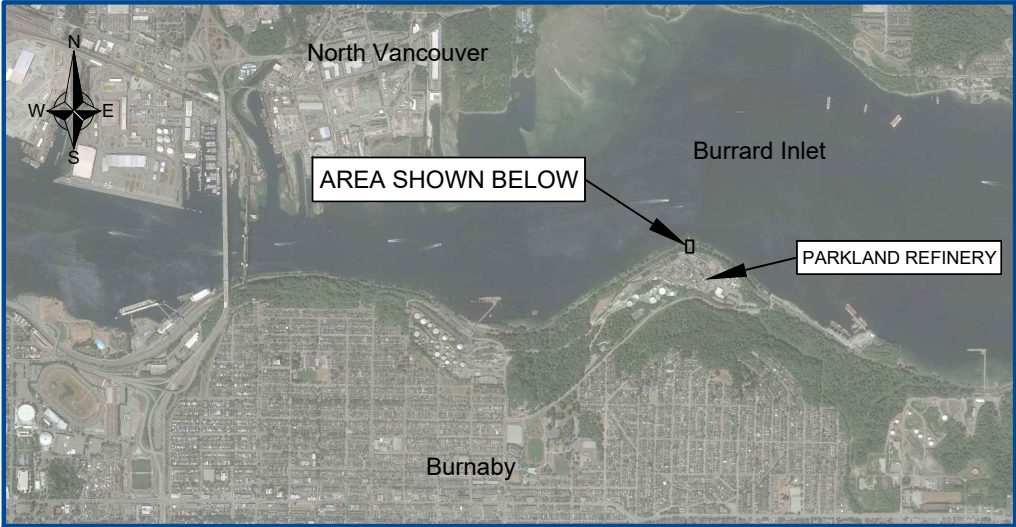
DATE:	PROJECT NO.:	DRAWN BY:	REVISION NO.:	DRAWING NO.:
November 2021	60653584	SGC	0	FIGURE 2

Property Line	Impermeable Sheet	POREWATER SAMPLES
Fence Line	Cobble Mat	Compliance Well
Foreshore Sampling Transect	Rip Rap Embankment	Sentry Well
CPR Extraction Trench	French Drain	Performance Well
Filter Rock Placement (2021)	NAPL Seep Observed in 2010	Up Gradient Well
Rip Rap Placement (2021)	Contingency Biodegradational Piping	ENV Requires Notifications?

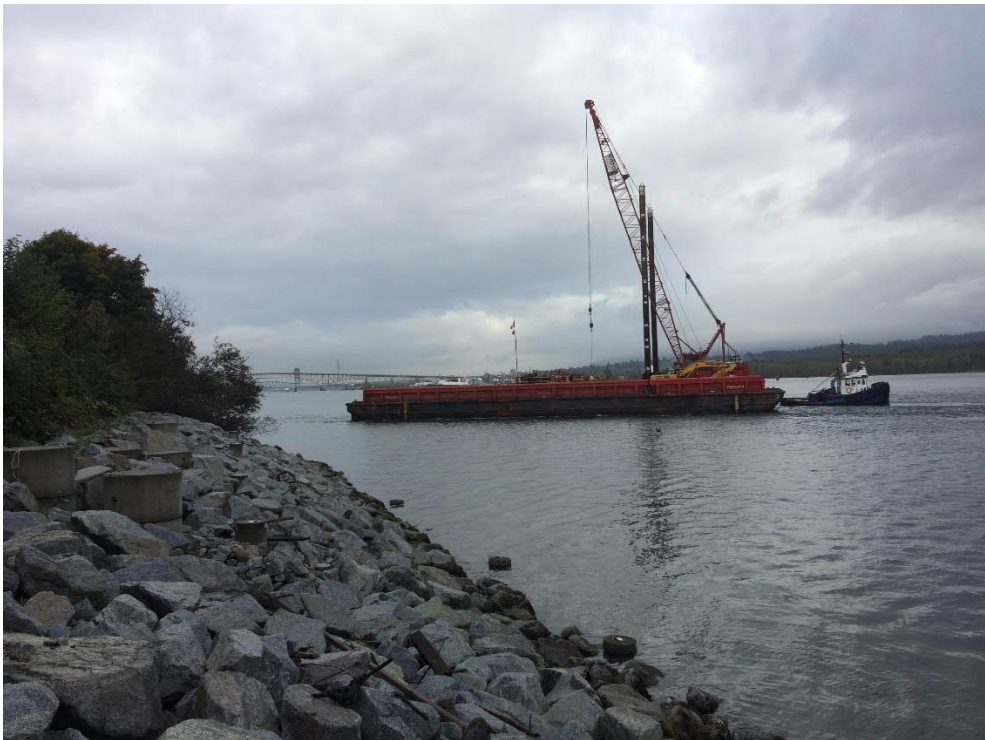
Client Name: Parkland Refining (B.C.) Ltd.		Site Location: Foreshore – Downgradient Area 2, Parkland Refinery, Burnaby, BC	Project Number: 60653584
Photo No. 1	Date: Sep. 27 2021

Direction Photo Taken: From the top of the Eastern FPTs facing west.			
Description: The derrick and barge mobilizing to Site.			
Photo No. 2	Date: Sep. 27, 2021

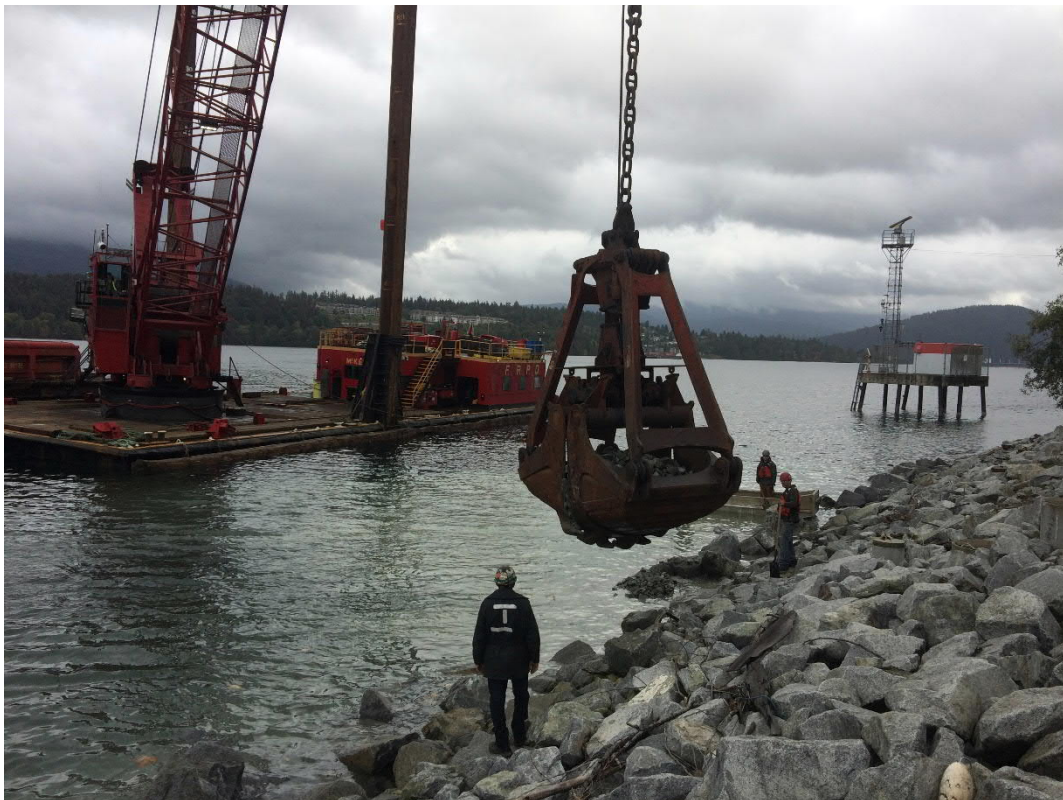
Direction Photo Taken: Top of Eastern FPTs looking east.			
Description: Use of the derrick and clamshell bucket to place rip rap on the FPTs.

- Beginning with the Eastern FPTs, rip rap was placed on the Eastern and Western FPTs using a 150-ton crawler crane spud derrick and a clamshell bucket (refer to **Photos 2 and 3** in **Appendix B**). Spuds on the derrick were deployed prior to moving rock material from the barge to the FPTs. Approximately 70 MT and 40 MT of rip rap were placed at the contact point of the rip rap and cobble interface of the Eastern and Western FPTs, respectively, where areas of exposed geogrid and geotextile layers had been observed.

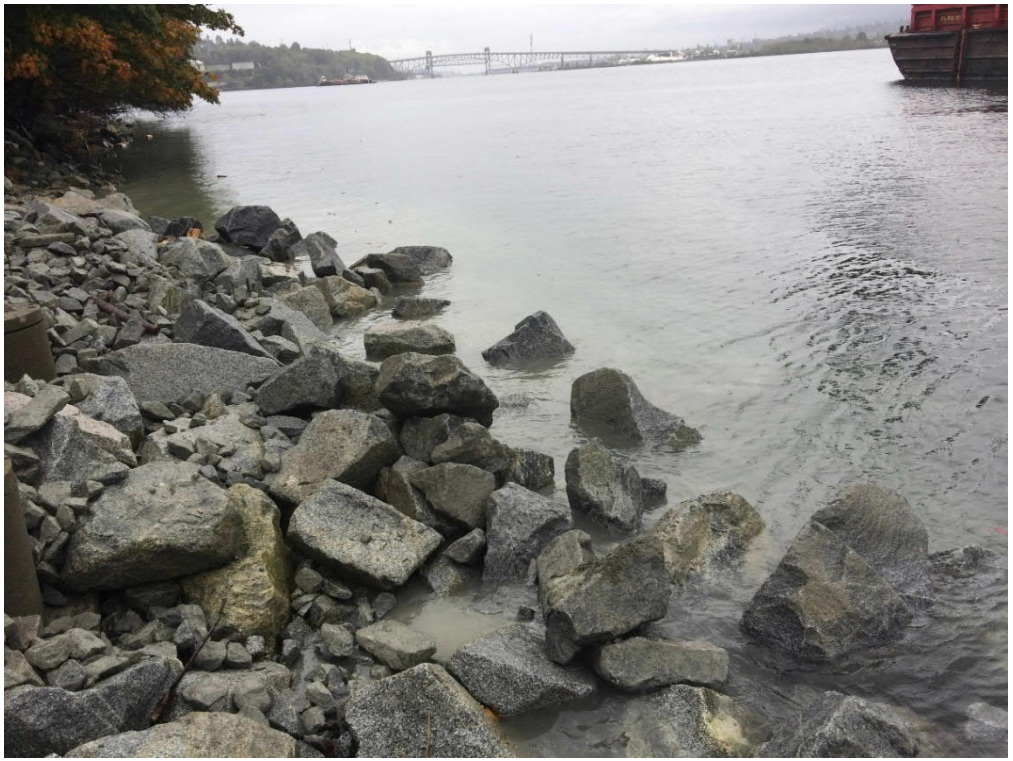
Client Name: Parkland Refining (B.C.) Ltd.		Site Location: Foreshore – Downgradient Area 2, Parkland Refinery, Burnaby, BC	Project Number: 60653584
Photo No. 3	Date: Sep. 27, 2021

Direction Photo Taken: Taken from top of Western FPTs looking west.			
Description: New rip rap at the contact point between the rip rap and cobble interface of the Western FPTs.			
Photo No. 4	Date: Sep. 27, 2021

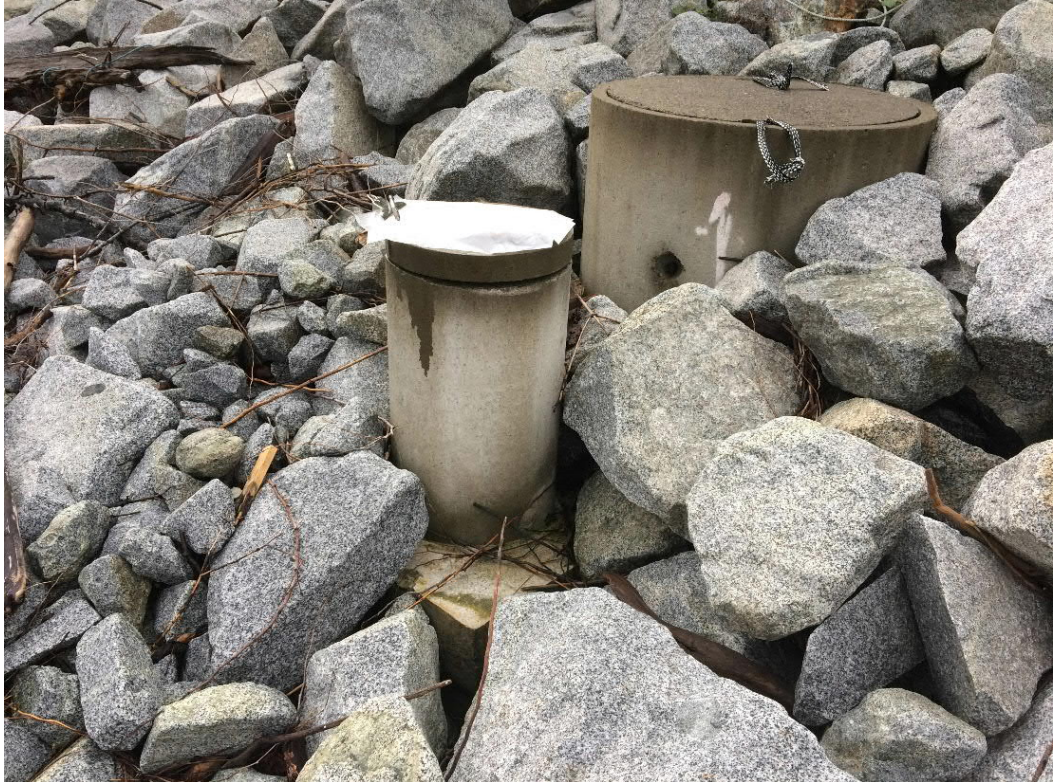
Direction Photo Taken: Top of Eastern FPTs; Photo of CBP-8			
Description: Example of concrete well protector with an exposed base prior to placement of filter rock. Taken of CBP-8 located on the Eastern barrier.

- Filter rock was placed around four additional concrete well protectors that were identified to have exposed bases by AECOM on September 27, 2021:
 - CBP-8

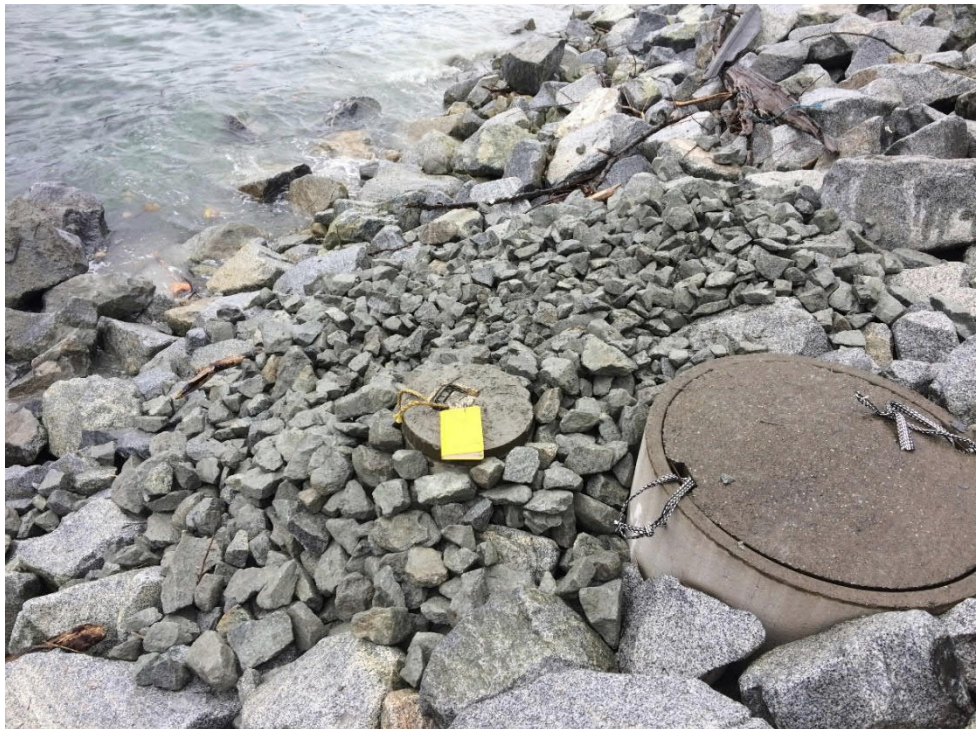
Client Name: Parkland Refining (B.C.) Ltd.		Site Location: Foreshore – Downgradient Area 2, Parkland Refinery, Burnaby, BC	Project Number: 60653584
Photo No. 5	Date: Sep. 27, 2021

Direction Photo Taken: Top of Eastern FPTs; Photo of CBP-8			
Description: Filter rock placed around CBP-8 to cover the exposed concrete well protector base.			
Photo No. 6	Date: Sep. 27, 2021

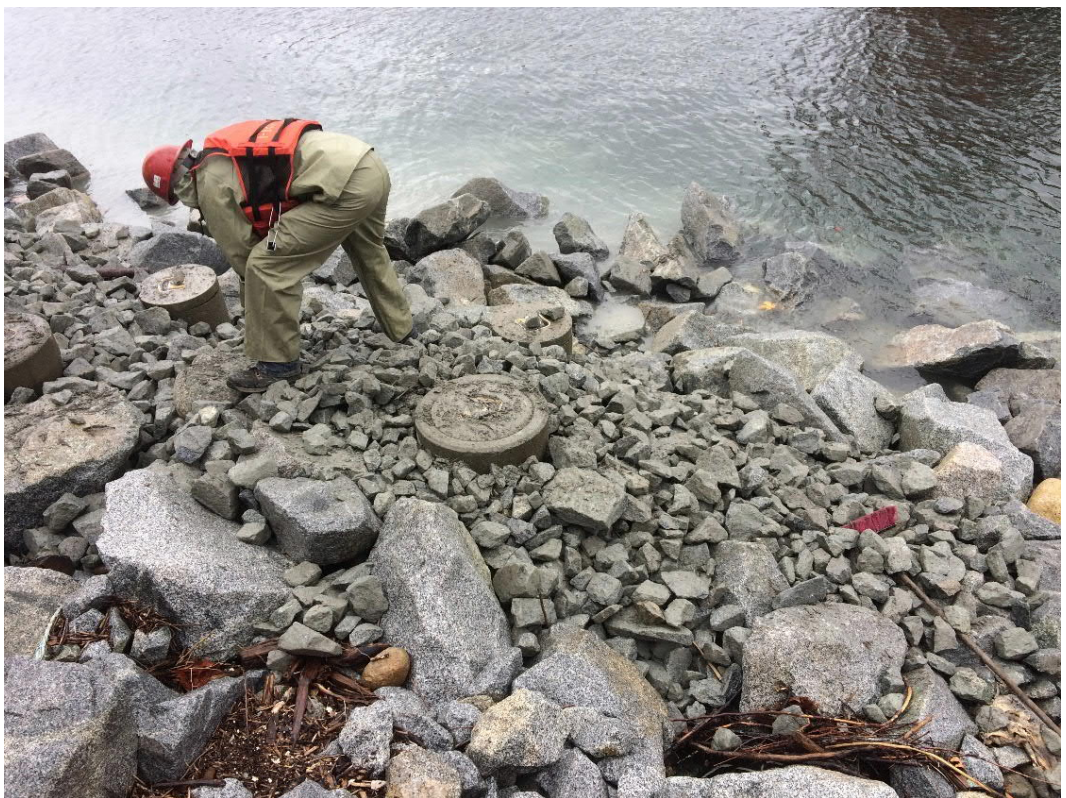
Direction Photo Taken: Top of Western FPTs (right to left is CBP-6 and PW17-6)			
Description: Example of filter rock placed by hand around concrete well protectors with exposed bases.

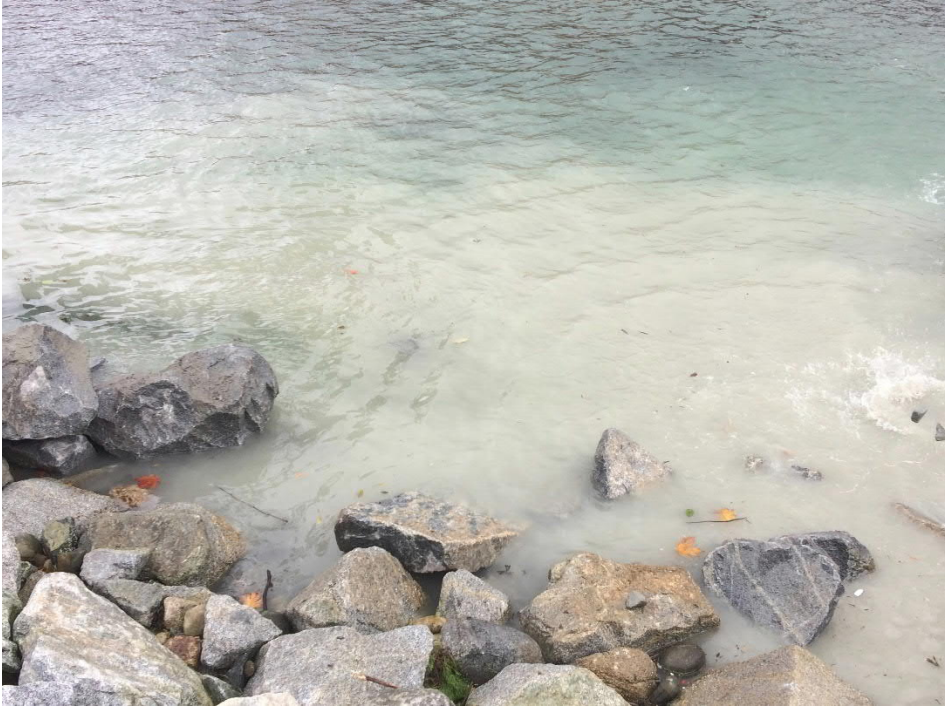
Client Name: Parkland Refining (B.C.) Ltd.		Site Location: Foreshore – Downgradient Area 2, Parkland Refinery, Burnaby, BC	Project Number: 60653584
Photo No. 7	Date: Sep. 27, 2021

Direction Photo Taken: From Eastern FPTs looking northwest.			
Description: Photo of surface water collected during turbidity monitoring inside the construction zone. Photo collected at 10:42am.
