LANGKAWI FEDERAL ROUTE, MALAYSIA

Slope failure repair using MIRAFL Polyfelt PEC

Industry:	Transportation
Application:	Roadways
Location:	Langkawi, Kedah, Malaysia
Product:	MIRAFL ® Polyfelt® PEC

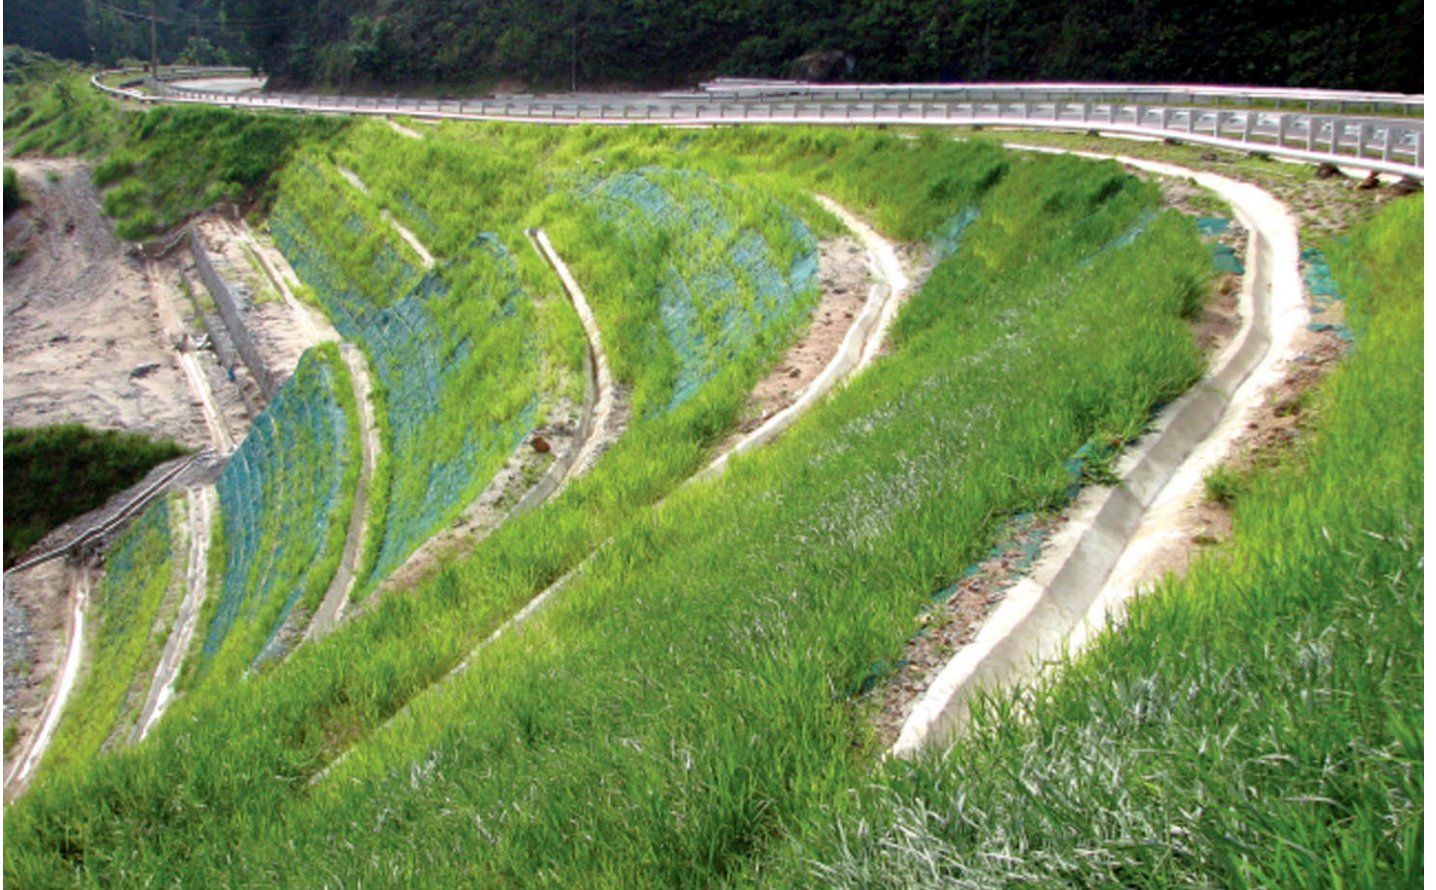
Continuous rainfall caused a major landslide on the Federal Route leading to Langkawi's highest mountain (881 m/2,890 ft). This area houses a museum, a park, and a satellite control centre. The landslide severely disrupted traffic and posed risks to road users.

The high, steep, and unstable failed slope made it difficult to trim it into a gentler gradient using conventional methods. After considering various solutions, PWD engineers decided to

realign the road, moving it 30 m (98 ft) away from the failed slope. This required constructing a geosynthetics reinforced slope starting from the toe of the failed area below the road.

Since there was no granular material available at the site, the design focused on using the fine sandy soil already present as backfill. **MIRAFL Polyfelt PEC** reinforcement geotextile was chosen due to its high tensile strength, optimal reinforcement/soil friction interface, and effective in-plane drainage in such soils.

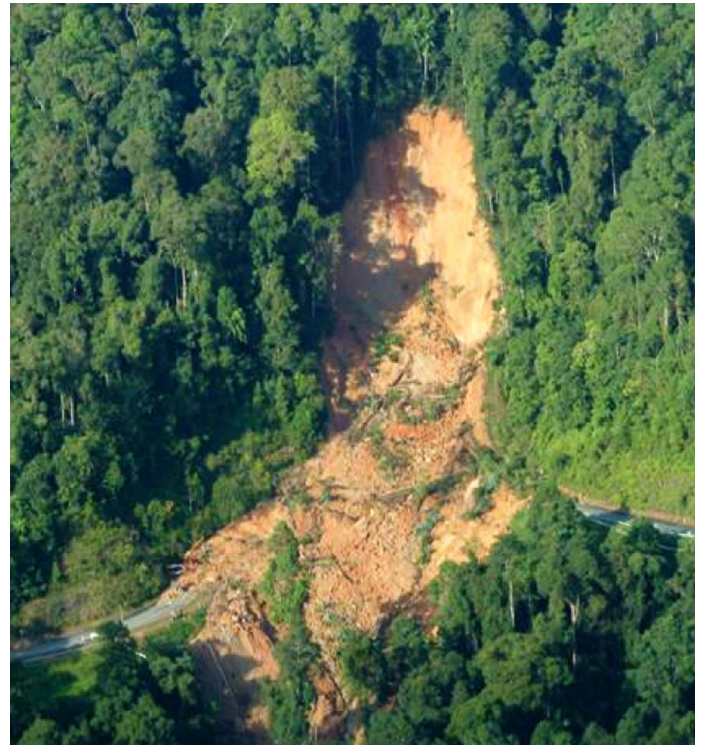
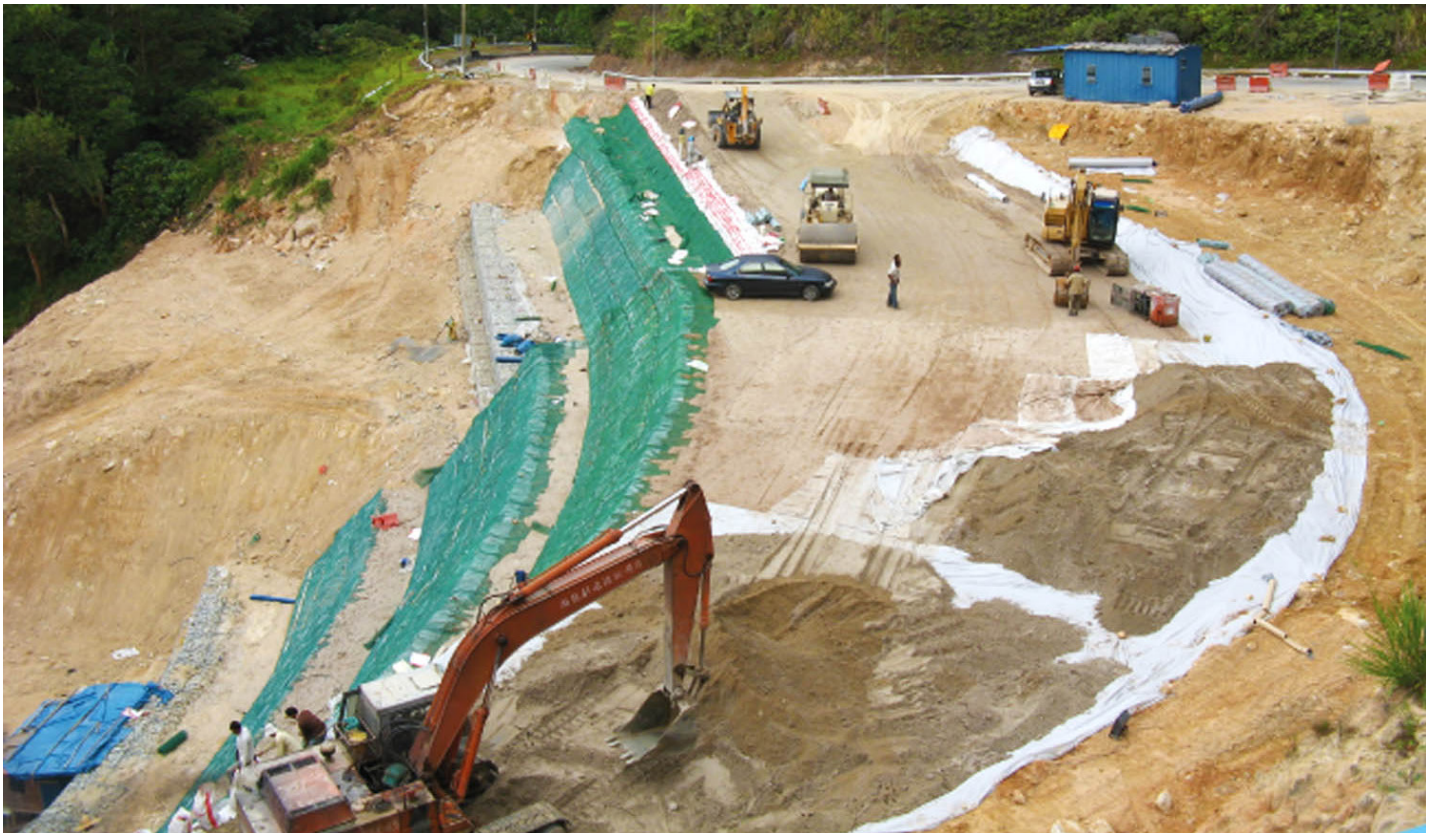
The reinforced soil structure consisted of a 30 m-high (98 ft) slope reinforced from the toe of the failed embankment. The facing system used involved wrapping a net around bags filled with fine-grained soil. This construction method allowed for the practical creation of a curved slope.

MIRAFI Polyfelt PEC was placed behind the gabion and soil bags to enhance the structure's strength. Additionally, a layer of **MIRAFI** Polyfelt TS geotextile filter was installed behind the gabions to prevent soil piping through the voids.

The primary reinforcement direction of **MIRAFI** Polyfelt PEC was perpendicular to the slope's surface. The reinforcement geotextile was pretensioned and secured with wooden pegs. Backfill material was compacted using a 10-ton compactor to achieve a minimum of 90% proctor compaction. Finally, hydroseeding was performed to establish vegetation on the completed slope.
