RODLAUER BRIDGE, STYRIA, AUSTRIA

Safer roads with geosynthetic reinforced slopes

Industry:	Transportation
Vertical:	Roads and highways
Application:	Walls and slopes
Location:	Styria, Austria
Product:	MIRAGRID®

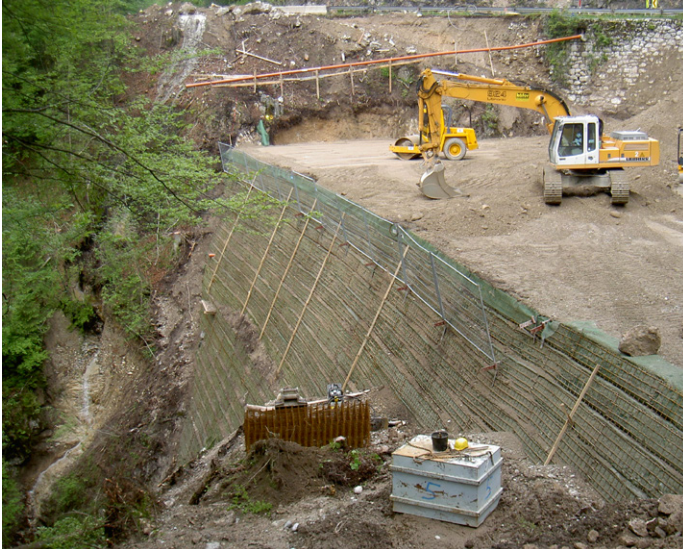
Because of the limited base width available, good quality granular material had to be used throughout as the reinforced fill, and this was compacted to good density specifications.

Depending on the location within the steep reinforced slope, layers of **MIRAGRID GX200/30** and **MIRAGRID GX110/30** geogrid reinforcement, having ultimate tensile strengths of 200 kN/m (44,960 lbf/ft) and 110 kN/m (24,729 lbf/ft) respectively, were used. These geogrids are made of high-strength polyester yarns encased within a robust PVC coating and have excellent strength, extension, and durability properties.

At the toe of the steep slope, it was not possible to provide a graded earth foundation base, so a concrete foundation block was constructed into the rock stratum. This ensured a stable toe foundation for the slope.

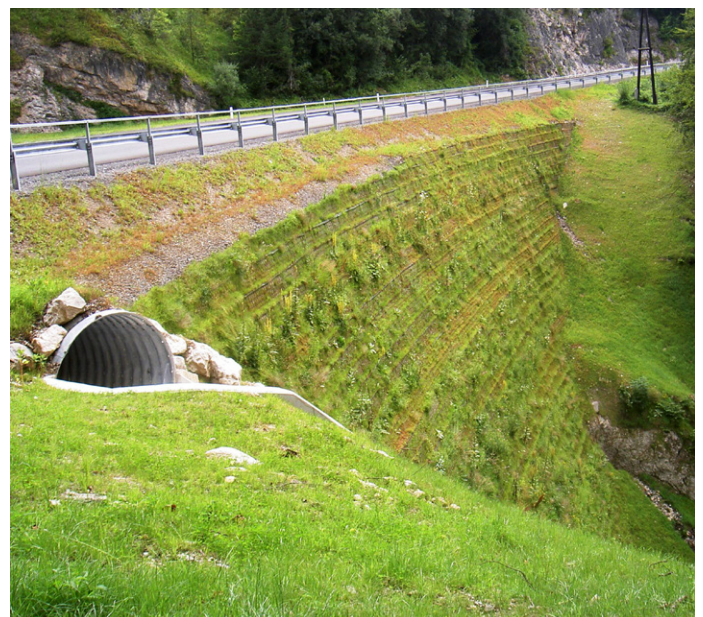
To form a smooth surface at the slope face, a steel mesh facing system was used. The steel mesh was bent to the

required 2V:1H (2 vertical units to 1 horizontal unit) face angle and consisted of units 0.5 m (1.64 ft) high, which coincided with the vertical spacings between the geogrid reinforcement layers.

This steel mesh facing was relatively flexible, which enabled the settlement of the fill during slope construction without creating undue deformations of the slope face. Inside the steel mesh facing, an erosion protection grid made of glass fibers was installed. The role of this glass grid is to protect the soil face from surface erosion until surface vegetation growth has been established. The glass grid also provides long-term local stability to the slope face.

Immediately behind the steel mesh and glass grid facing, good-quality topsoil was placed to enable good vegetation growth, followed by the placement and compaction of the granular reinforced fill. It had been observed that substantial quantities of groundwater seeping out of the hillside had contributed to the failure of the existing stone masonry wall. Consequently, extensive drainage measures were installed in the new slope to manage this groundwater seepage in a controlled manner. In the lower part of the slope, a geocomposite drainage layer was installed at the rock face. In the upper part of the slope, gravel drainage materials were used to intercept groundwater flows. The seepage water was then channeled by drainage pipes through the reinforced fill and out through the face of the reinforced slope, where it was discharged into the adjacent River Enns.
