TITANIUM DIOXIDE PLANT, TERENGGANU GEOTUBE[®] dewatering and containment of gypsum wastes

Mining
Waste management
Malaysia
GEOTUBE®

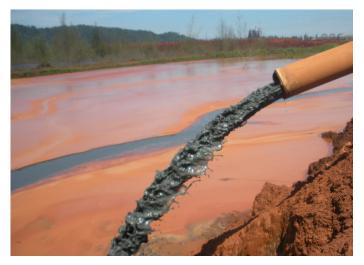
Figure 1

Industrial waste, often in slurry form and containing contaminants, needs to be managed and disposed of properly to protect the environment. This case study focuses on the dewatering of gypsum waste slurry at a titanium pigment plant in Malaysia using geotextile tubes. The plant produces titanium pigments through a process that involves treating ilmenite with sulfuric acid, resulting in the discharge of red gypsum waste in slurry form with a solid concentration of approximately 16%. Initially, the waste was treated using filter presses (Figure 1).

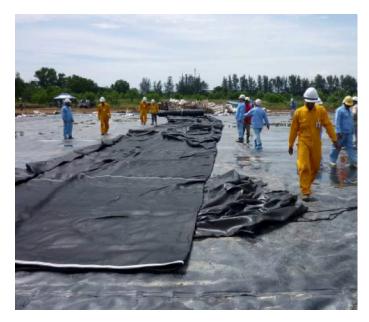
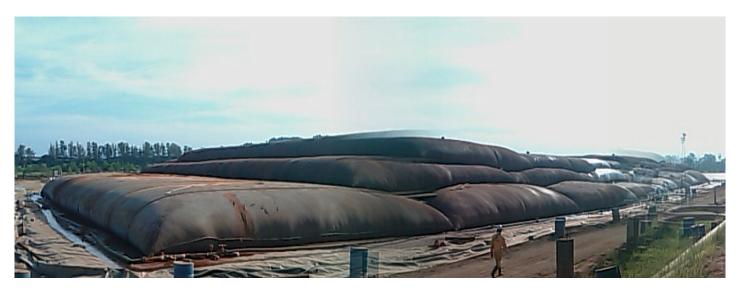
Before deployment, the positions of the **GEOTUBE**[®] units were marked on the geomembrane liner. Each unit, weighing approximately 1.3 tons (2,866 pounds), was lifted and positioned using a mobile crane. The units were then manually unrolled and unfolded by operators or with the assistance of a mechanical winch attached to a 4WD vehicle. A 100 mm (3.9 in) diameter flexible hose was used to connect the slurry main pipe to the **GEOTUBE**[®] dewatering units. The filling ports of each unit were connected with flexible hoses, and the slurry inflow for each port was regulated by a gate valve installed between the main slurry pipe and the flexible hose.

Over the course of a year, more than 100 units of **GEOTUBE**^{\circ} dewatering tubes, with dimensions of 36.6 m (120 ft) 1 circumference and lengths ranging from 57 m (187 ft) to 43.8 m (143 ft), were installed as part of an integrated plant waste capture program. These tubes captured a total of 180,000 m³ (235,710 yd³) of dry solids. The use of **GEOTUBE**^{\circ} dewatering tubes resulted in cost savings in terms of capital expenditure and reduced overall maintenance and operational costs.
