## Vehicle Condition Report Template

| Score | 0 / 0 (0%) | Flagged items | 2 | Actions | 2 |
|---|---|---|---|---|---|
| Purpose of Vehicle Assessment | For Rent | | | | |

| Make | Toyota | |
| Model | Camry (Blue) | |

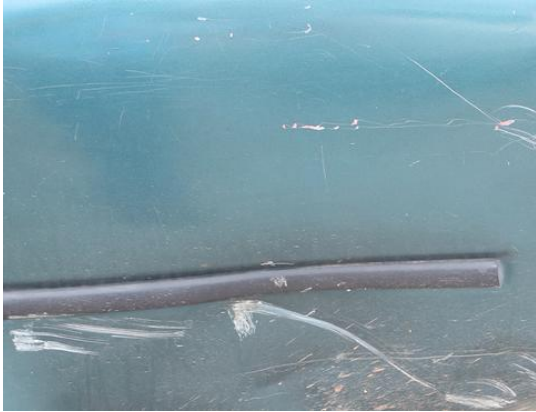
Photo 1

Poor Condition

Scratches and chipped paint on the left back part of the car

Repair chipped paint and fix scratches on the blue Toyota Camry.

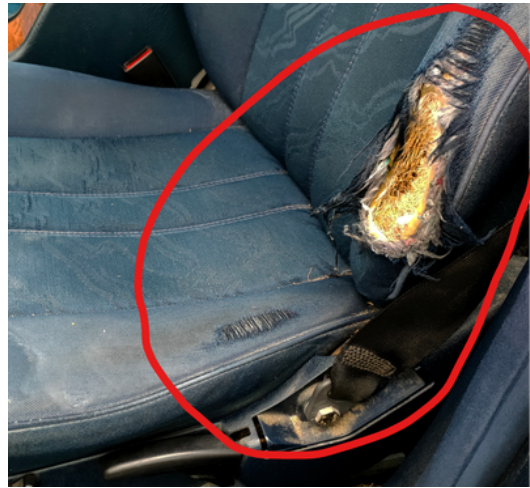
Photo 2

Poor Condition

Damaged driver's seat

Replace damaged driver's seat.
