Fire Door Inspection Checklist

14 Apr 2023 / Ian Scofield

Philadelphia, PA, USA
(39.9525839, -75.1652215)

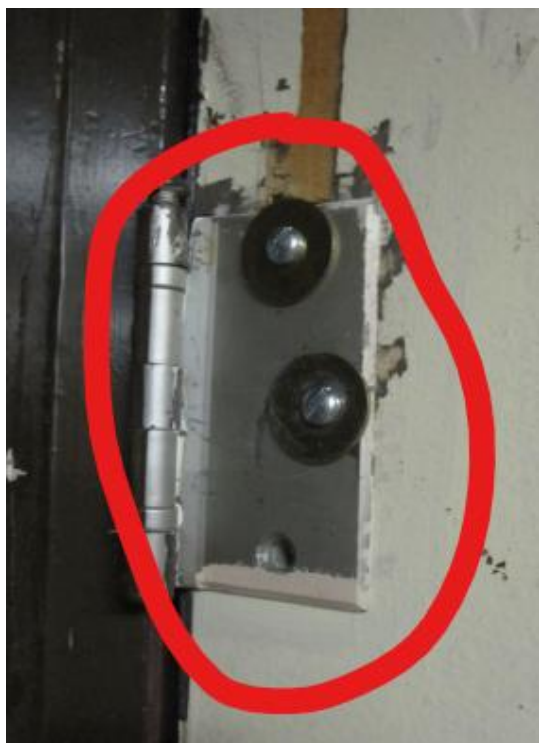
Photo 1

Door does not close completely

This is due to the found issue on the latch (next item). Assigning this action as well for immediate resolution.

Door does not securely latch

The latch needs to be replaced. Also, the wall where it's attached needs to be repaired and repainted as it obstructs the supposedly flat surface.

Repair and repaint the wall where the latch is attached.

Replace the door latch.

- Replace the door latch.
- Repair and repaint the wall where the latch is attached.
