# Crack Diagnosis in Natural Gas Liquids Pipelines

This case study will focus on the deployment of an ultrasonic inline inspection (ILI) technology in an NGL line as well as a comparison of crack data analysis from the tool and Non-destructive Examination (NDE) data from field verifications. The service was deployed for a North American operator to diagnose the potential for axial cracks, including hook cracks, in their 18" pipeline.

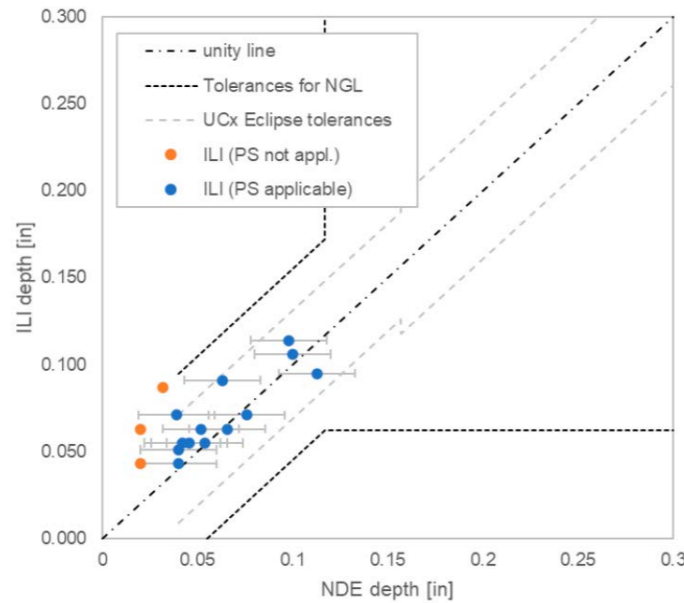
Figure 8 – Unity Plot where ILI performance specification is and is not applicable.

After the completion of the full data analysis process by the NDT Global team, a final report was prepared and delivered to the operator. Several complex crack-like features were identified, sized, and reported including several possible hook cracks. The ILI data was validated using NDE measurements by an independent third-party contractor and NDT Global's field verification team which characterized the complex crack geometries with PAUT. Since the anomalies in question could be located anywhere in or near the weld, as well as possibly titled, a second pass was performed with a different spacing between the seam weld and probe. The outcome was one dataset optimized for internal anomalies, and another optimized for external anomalies. The NDE validation matched the ILI results and demonstrated the excellent ILI data quality as evidenced in the unity plot below (Figure 8).
