# Complex Internal Metal Loss Due to Pitting Corrosion in a Small Diameter Pipeline

## Abstract

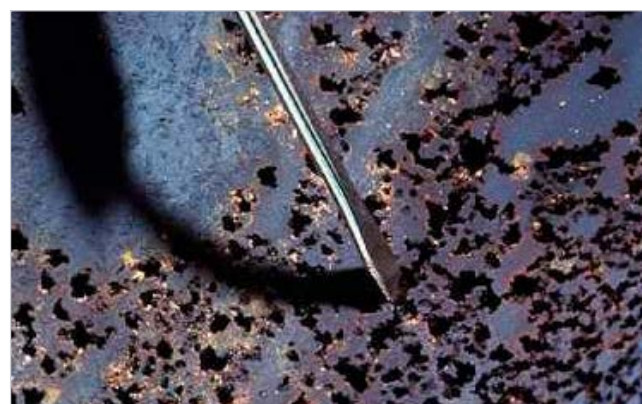
Figure 3 – Pitting corrosion by an aggressive medium (www.watertechnologies.com - December 2023)

This case study contains all ingredients for a highly complex, non-standard data analysis. The internal surface of the 6" pipeline is significantly affected by aggressive medium conditions causing thousands of steep-sided internal corrosion anomalies. Because a cut-out was never made, the real status of the surface is not documented. Therefore, the following Figure 3 and Figure 4 were chosen as representatives to give an idea of what the interface might look like.

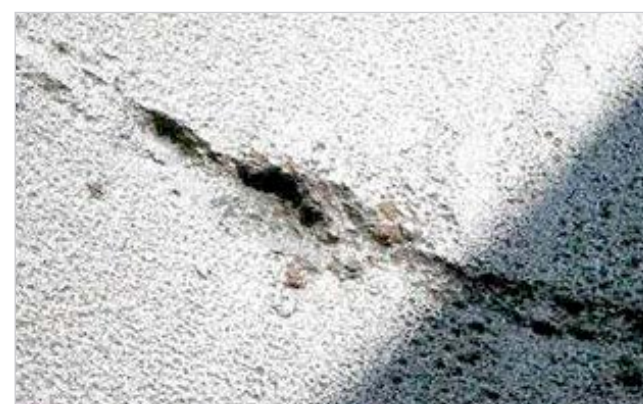
Figure 4 – Metal loss in a girth weld (NDTG 2007)

In addition, the depth sizing in wall thickness data for features which are directly located in or near girth welds may be impaired under certain circumstances. The reason for this is the surface of the weld as well as the weld material itself causing an irregular reflexion behavior.

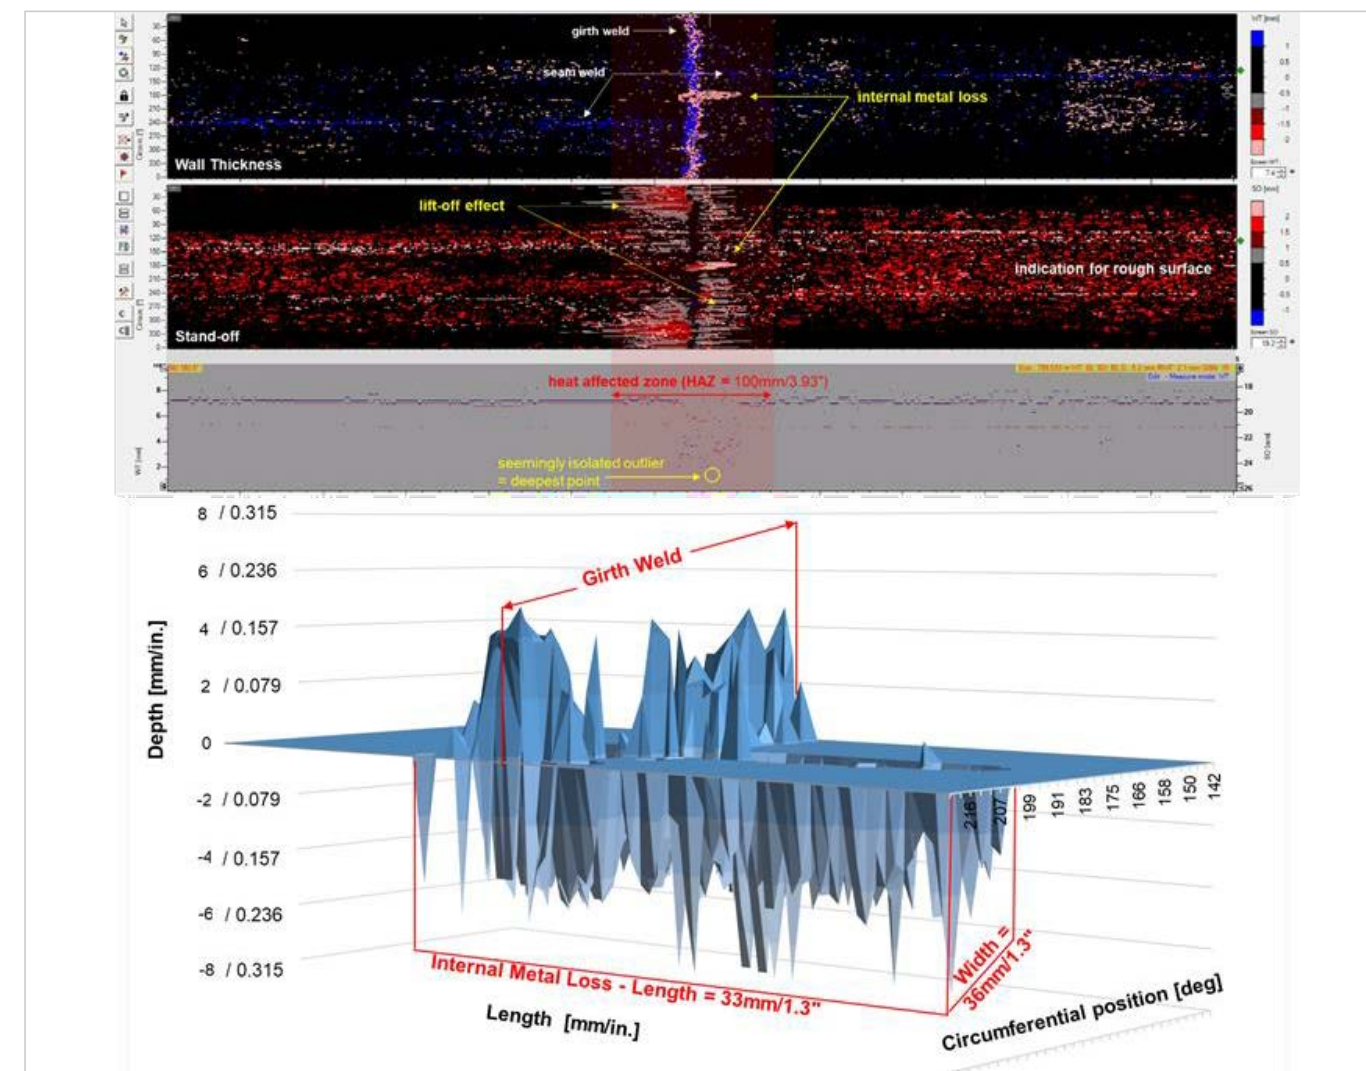
A typical example of that kind of corrosion anomalies is shown in the Figure 5 below. Besides all challenging metal loss indications due to their typical steep-sided shape, an additional challenge was that about 20 % of the internal metal loss features are located directly at girth welds which are characterized by the so-called heat affected zone (HAZ). The HAZ is an area  $\pm 1.97$  in (50 mm) around of the girth weld centerline with a restricted performance specification for the tool. A girth weld can be considered as a natural barrier that

The 3D view of this example shows a sharp edge which is typical for this kind of corrosion, but also a pronounced zigzag pattern. On the one hand this is related to the lift-off effect, while on the other hand the rough surface and additionally the steep-sided feature shape cause noises and unwanted outliers.

The screenshot from the inspection data (top part of Figure 5) shows the encircled depth peak in the B-scan measurement, that could be identified as the deepest

point and is visible isolated from the measurements that show a coherent contour. Helpful for that were 2 circumstances: First, the depth could be confirmed by the next following sensor track which revealed another isolated stand-off value in the same depth dimension. Second, as a very important factor for the whole project was the learning process how to interpret the data in a right manner. As it will be shown later, a significant corrosion growth could be excluded. Basing on that, a positive learning effect can be clearly seen in the number of the reported features as displayed in the following Figure 6.

The difference is even more evident when considering the circumferential welds and their vicinity. Both Table 1 and Figure 14 reveal that a large proportion of the internal metal loss features is directly located at a girth weld. The plot of the features in relation to their position in a pipe joint as illustrated in Figure 14, demonstrates the linkage of the girth welds with the disproportional accumulation of the highest depths, typically with the appearance as exemplified in Figure 5.

Results of data evaluation stand or fall with confirmation through field verifications. In the meanwhile, a total of 29 features have been repaired. 18 of the NDE-results which were shared with reports and detailed numbers could be correlated with the analysis results. Hereby, except for 1, all reported features have a critical depth, partly around 80 % as visible in Figure 16. An example of these features is the corrosion anomaly in Figure 5.

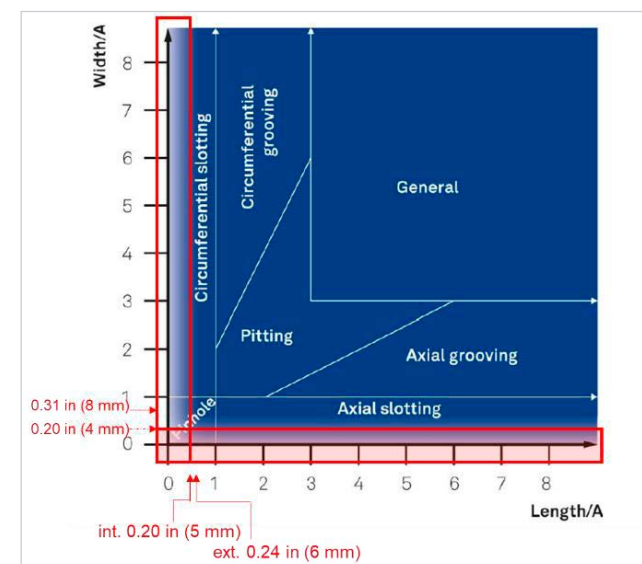
Figure 8 – POF-classification with limits for the UT metal loss detection (highlighted in red)

Figure 8 shows another important challenge of this project: Besides the girth weld as one impact, the width of the features was another significant issue. Also, around 20 % of the anomalies have a width  $\leq 0.315$  in (8 mm). When the first inspection run was performed in 2020 (= 2020 (1)), the state of the art in the industry for UT metal loss resolutions at this time is depicted in Figure 9.

The detection of certain feature types, see Figure 8, dependent upon the technology utilized. Because of their smaller dimensions, slottings and pittings are at the edge of the UT metal loss tool capabilities and are not necessarily covered by the performance specification. A detection of features with small diameters is possible with UT metal loss but might be restricted regarding their Probability of Identification (POI).

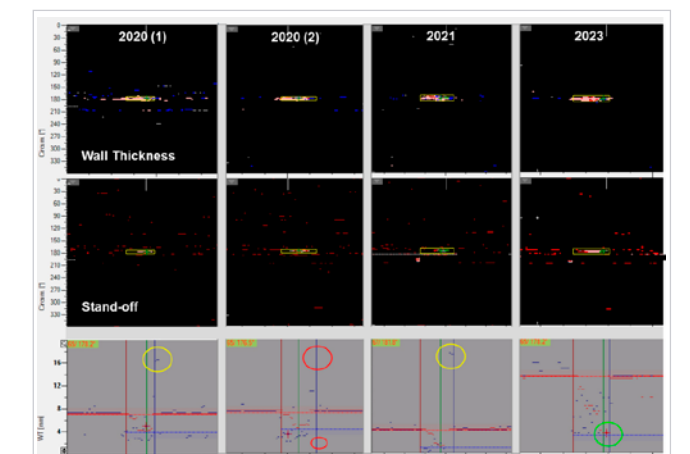
Figure 12 – Different detection results during 4 inspection runs (WT scales in the lower part vary to demonstrate the different details)

off signal is considered as the real first backwall echo of the sound wall, resulting in a thickness value higher than normal. The full understanding of this phenomenon supported the identification of additional internal metal loss anomalies and thus moving the run comparison in the right direction. One of the most prominent examples found in that context is displayed in Figure 12.

This example shows for the first time the correct stand-off feature shape and the real depth by an isolated stand-off pixel (green circle) in the 2023 inspection run. The data of 2020 (1) and 2021 show a clear correlation to the position of the deepest point, however as a kind of "reversed" indications (yellow circles) because of the mixed signal information and their display of an extraordinary thicker wall thickness than in reality.
