Crack Diagnosis in Blended Natural Gas

EVO Eclipse UCx Service

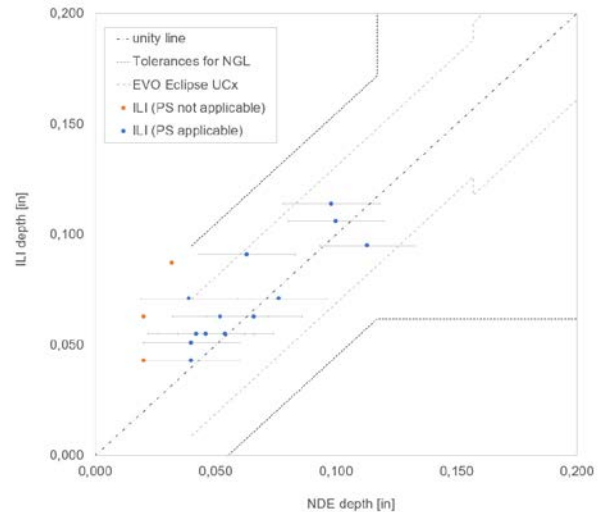
Figure 1 - Unity plot showing NDE field results

- The inspection data was then validated using NDE measurements by an independent third-party contractor. Supported by NDT Global's field verification team, PAUT was used to characterize complex crack geometries. This validation confirmed the results were accurate and reliable.
