High-Density Internal Pitting Corrosion

EVO UMp⁺ Service

A pipeline operator with known high-density internal pitting corrosion located at the bottom of a 6" condensate water pipeline, required a high-resolution inline inspection.

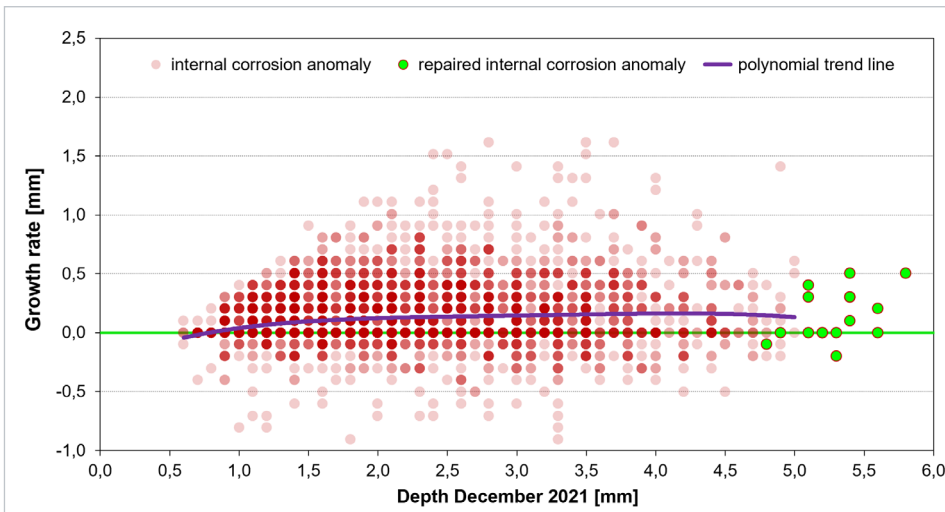
Internal growth rates (Dec 2020 vs. Dec 2021) and corresponding polynomial trend line versus depths of Dec 2021:
No considerable dependence of the growth rates from the depths can be deduced. The deeper anomalies do not show higher growth rates than the less deep anomalies.

To overcome this, NDT Global was contracted to re-inspect the pipeline in December 2020 (10 months after the 1st UMp⁺ inspection) and to perform [a corrosion growth and remaining life assessment](#), enabling the operator to prioritize repairs and introduce measures to reduce internal corrosion growth.

The pipeline was again inspected in December 2021 to investigate if the corrosion inhibitors are successful. Close collaboration between multidisciplinary teams within NDT Global supports the success of these inspections and ongoing corrosion management.
