Providing the Most Precise Diagnosis

For Pinhole and Pitting Corrosion

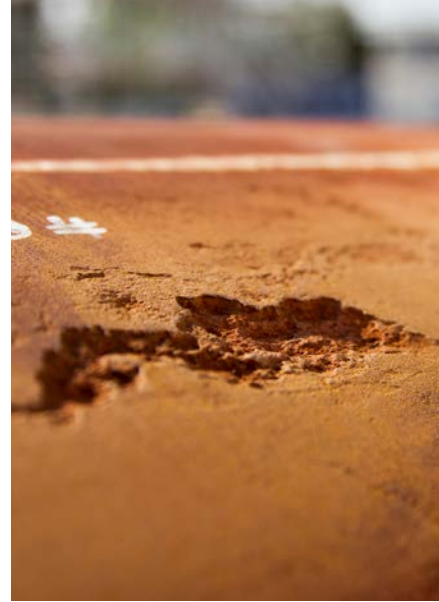
Example of steep-sided pitting corrosion within area of general corrosion

Data analysis scan of same steep-sided pitting corrosion
