UT and MFL Inspection Comparison for Pipeline Integrity Enhancement

A Comparative Study of UT and MFL Inspection Technologies

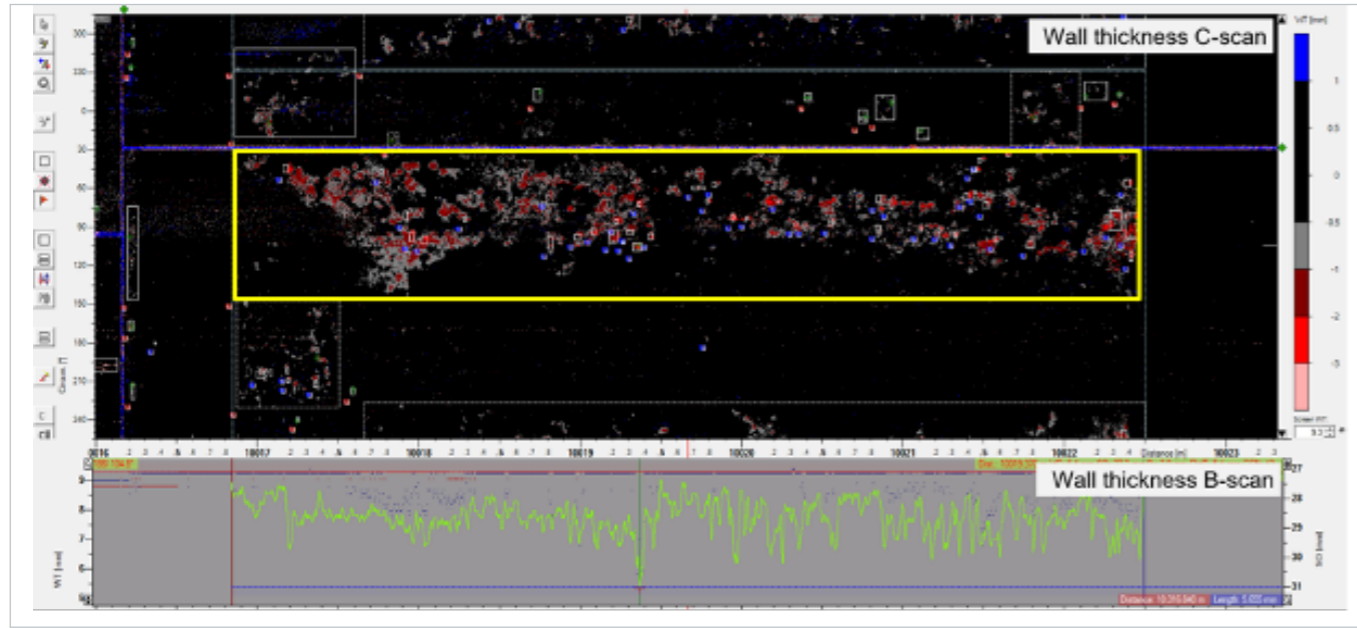
Figure 4 – UT wall thickness inspection data. The yellow box indicates one reported area of external metal loss (length = 5.65 m, width = 0.77 m) matching 42 smaller MFL boxes, seen in white with blue "u" labels. The green curve in the lower part indicates the River Bottom Profile (RBP).

An example is shown in Figure 4 where one UT feature matches to 42 MFL features. Such significant differences in feature boxing are typically only observed for areas of extended general corrosion. In the case of localized metal loss anomalies, UT and MFL reporting results often match quite well.

For extended corrosion areas like in Figure 4, the small MFL boxes might not accurately represent the actual corrosion area, potentially leading to unconservative assessment results. The larger UT boxes provide a better description of the area affected by metal loss, but Level 1 assessment methods like B31G [5], which are based on the box dimensions (maximum depth, total length), might be overly conservative. Level 2 assessment methods like RSTRENG Effective Area (which uses the River Bottom Profile (RBP)) and Plausible Profile (PSQR) [5] account for the remaining wall thickness profile of metal loss anomalies and

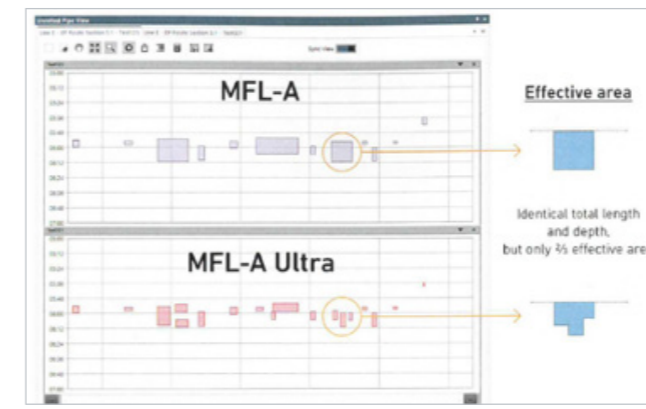
Figure 5 – Comparison of what a remaining wall thickness profile from MFL in lower resolution (top right) versus higher resolution (bottom right) might look like [6].

As discussed previously, MFL data is an indirect measure of wall thickness, and there is not a 1:1 correspondence between feature size and feature morphology. Therefore, it is more difficult to generate remaining wall thickness profiles for metal loss anomalies measured using MFL. One strategy used to generate a profile for MFL data is to combine the depth and width of MFL boxes into clusters. When a higher resolution MFL tool is applied, smaller MFL boxes are generated, which when combined, lead to a more detailed profile (Figure 5) [6]. However, this is still an

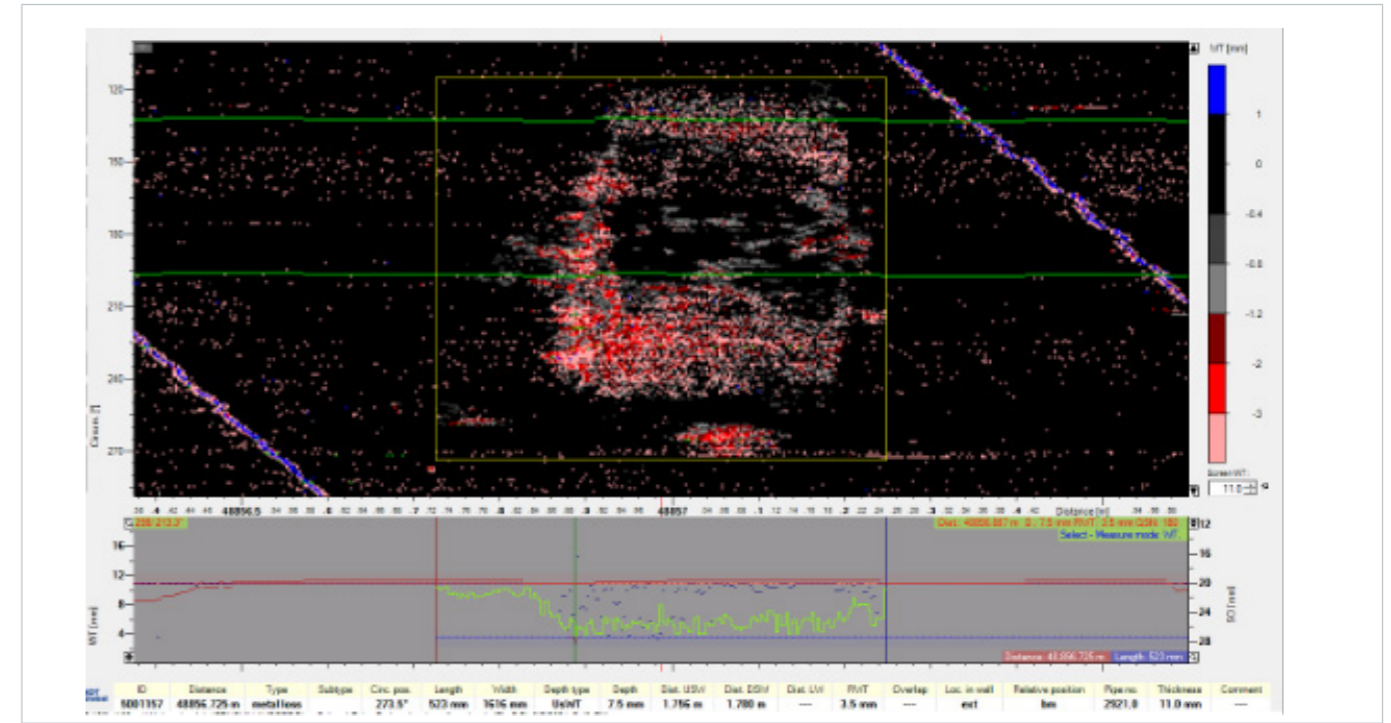
Figure 7 – UT wall thickness data of a general external corrosion area and river-bottom profile (green curve in the Wall thickness B-scan). For this and all subsequent images, the flow is from left to right.

Figure 7 shows UT inspection data of a general external corrosion area detected in a 46" pipeline. The metal loss area has a total length of 0.52 m and a circumferential extent of 1.62 m. The maximum depth is 7.5 mm (68 % of the local reference wall thickness of 11.0 mm).

Based on the total length and maximum depth, a low safe operating pressure of 29.1 bar is calculated using the Level 1 assessment method modified B31G (0.85 dL). Applying the Level 2 RSTRENG Effective Area

assessment method, which accounts for the detailed remaining wall thickness profile, a significantly higher safe operating pressure of 49.2 bar is obtained which is above the local pipeline MAOP. The remaining wall thickness profile (river-bottom profile) is directly available from the UT wall thickness data and is indicated by the green curve in the lower part of Figure 7.

This area of corrosion was reported as 14 smaller metal loss areas with a maximum depth of 55 % in the previous MFL inspection. For these 14 features, the lowest modified B31G (0.85 dL) safe operating pressure is 47.4 bar which in this specific case agrees well with the RSTRENG Effective Area pressure calculated for the UT anomaly.

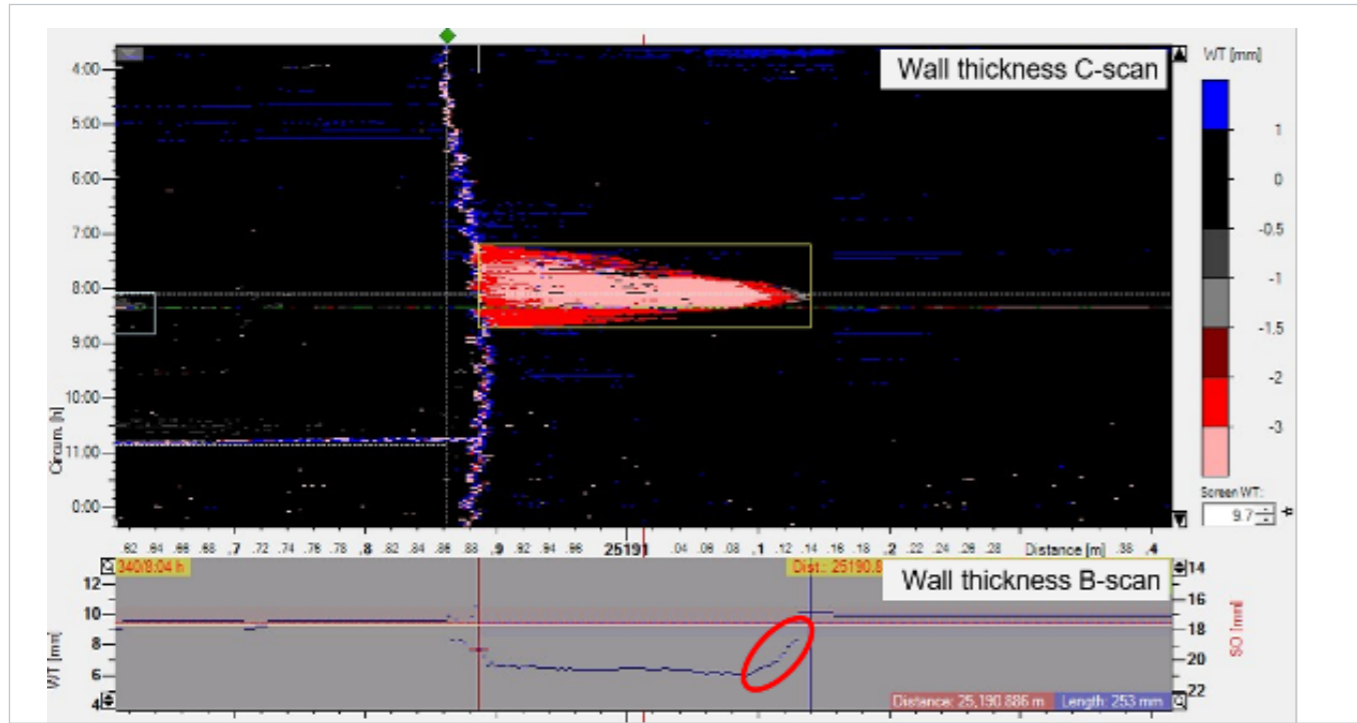
Figure 8 – UT wall thickness inspection data for a sloping lamination located at a girth weld. The sloping portion of the lamination is circled red in the B-Scan

are considered insignificant in terms of pipeline integrity. An example of one of the few detected sloping laminations is shown in Figure 8. This tongue-shaped lamination starts at a girth weld and slopes towards the external surface at the downstream end of the anomaly. The assessment according to API 579 [4] showed that this lamination is acceptable at the established MAOP. However, due to the significant weld contact verification of this feature was recommended.

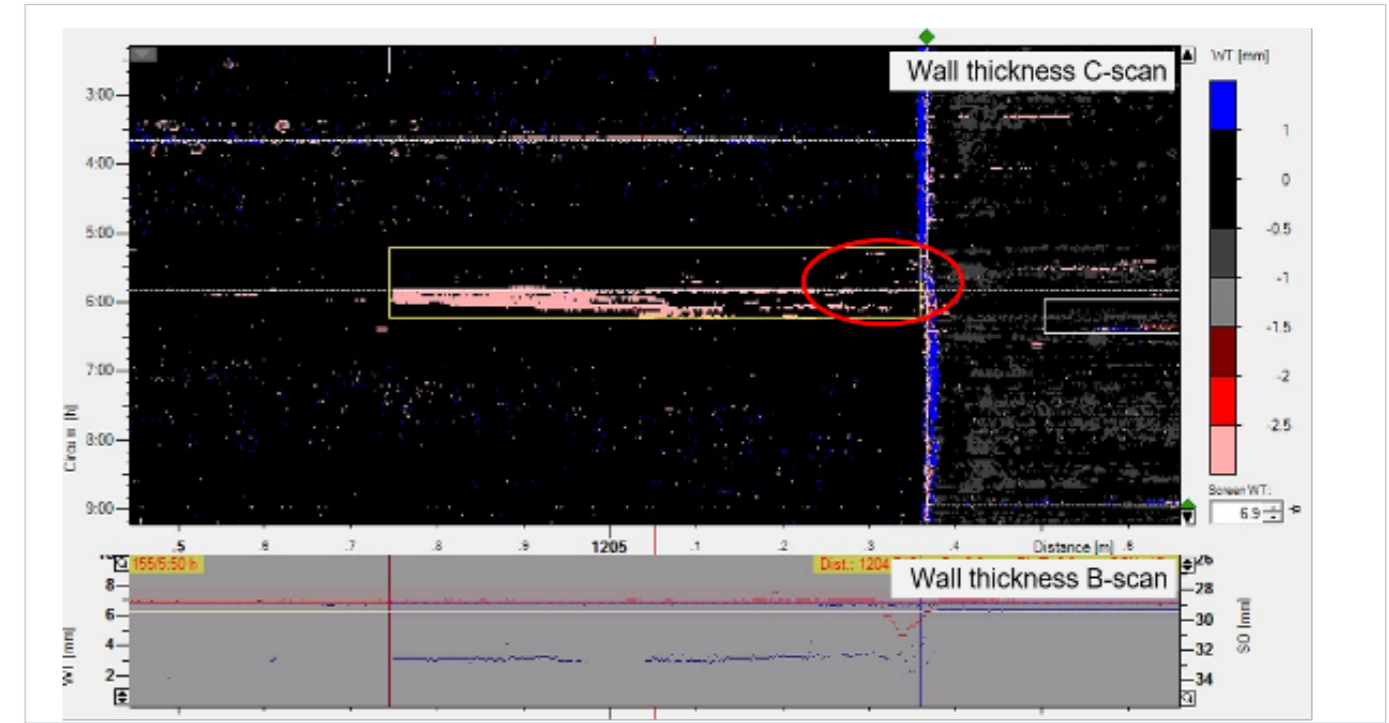
Figure 9 – UT wall thickness inspection data for a planar lamination with no significant contact to the girth weld. The weld area that could be contacting the lamination is circled in red.

Based on the available UT metal loss and axial crack inspection data, it is not possible to determine whether there are indications of through-thickness cracking in the weld zone. For laminations at the long seam, axial cracking towards the outside could be shielded by the lamination, and circumferentially oriented cracking along girth welds would not be detected by the axial crack detection technology. Therefore, potential cracking originating from the lamination cannot be quantitatively assessed. Instead, all laminations reported at welds were reviewed in the UT inspection data and prioritized based on the length of the weld contact zone. The lamination in Figure 8 has significant contact with the girth weld in a zone > 400 mm length and was recommended for verification. Figure 9 shows another example of a lamination reported at a girth weld. Based on the feature list information (lamination at girth weld), this anomaly would have to be considered as a possible threat to the integrity of the pipeline. However, the detailed review of the inspection data showed that this planar mid-wall lamination is intermittent, and the weld contact was judged to be

insignificant. This anomaly was therefore classified as an uncritical feature not requiring verification or repair.

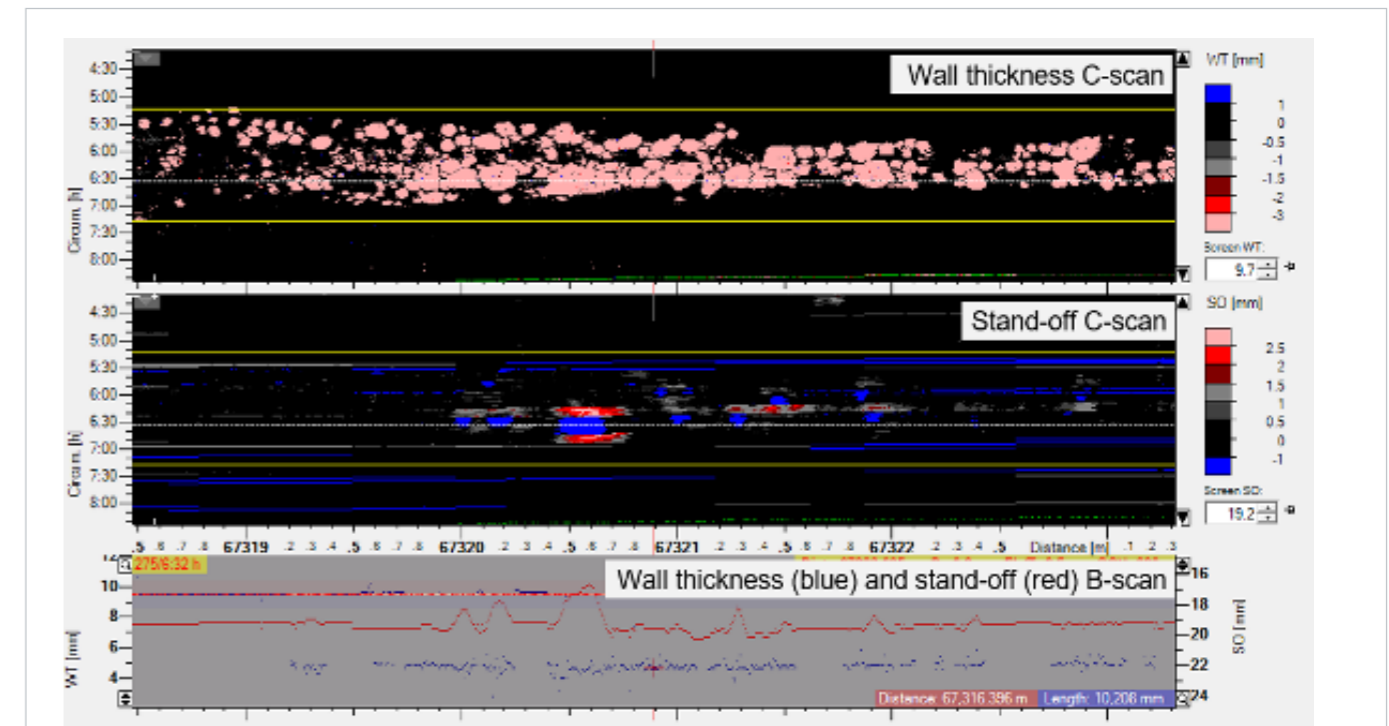
Figure 10 – UT inspection data for a cluster of hydrogen-induced delaminations. The typical circular shape is visible in the wall thickness data (top). The stand-off data (middle) shows blistering on the internal surface. The B-scan display (bottom) shows that the delamination is located in the middle of the pipe wall and also indicates blistering (decrease in stand-off).

Individual hydrogen-induced delamination often shows a typical circular shape and sometimes forms dense clusters. Due to their typical shape, hydrogen-induced delamination can be discriminated from manufacturing-related laminations based on the recorded UT wall thickness data grid. Blistering to the internal pipe surface can be detected using the UT stand-off data (however blistering on the external pipe surface is not visible in the ILI data). An example of a cluster of blistering hydrogen-induced delamination's is shown in Figure 10. While the UT data provides a good picture of this anomaly, the previous MFL inspections were not able to detect this type of mid-wall anomaly.

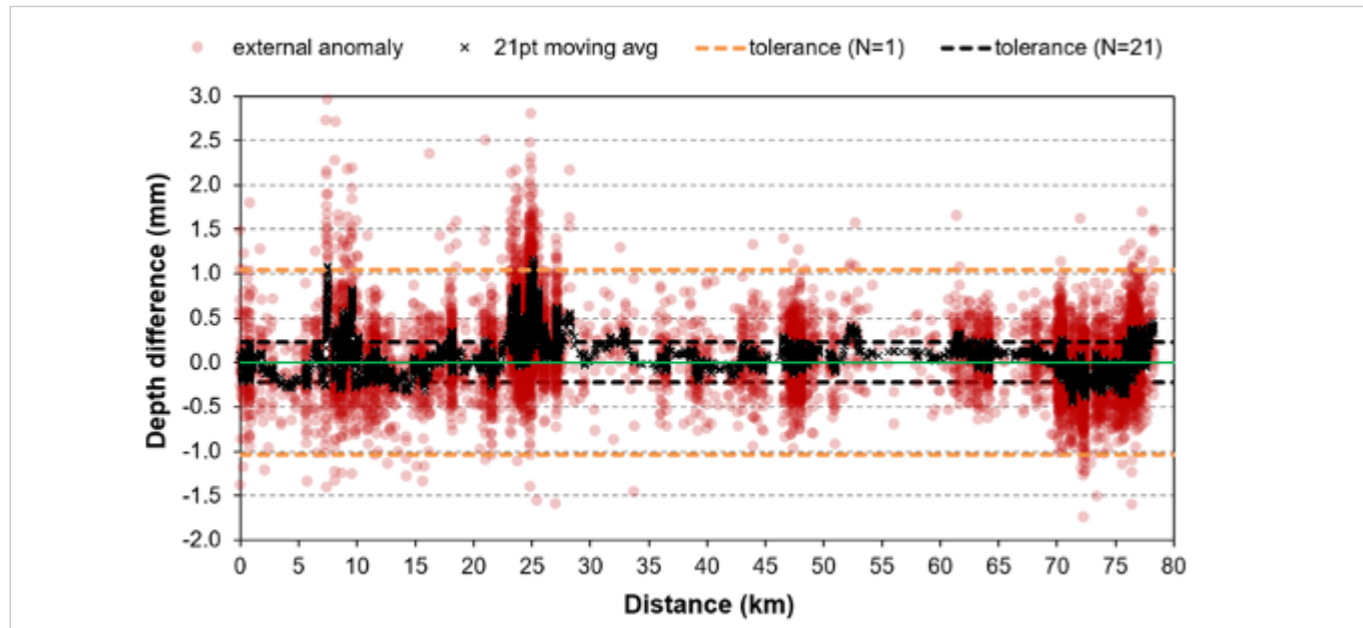
Figure 11 – Change in reported depth (UT – MFL) for external metal loss anomalies (red dots). The black crosses show the average change in depth of 21 neighbouring features. The dashed orange line indicates the comparison tolerance for the change in depth of a single anomaly. The corresponding tolerance for the average change in depth of 21 anomalies is shown as a black dashed line.

A comparison and CGA of the UT and MFL results are shown in Figure 11 and Figure 12. Figure 11 shows the change in depth of external metal loss anomalies versus the distance along the pipeline. The orange dashed lines indicate the comparison tolerance for the predominant wall thickness. For features with a depth difference above this limit, the change in depth is outside the limits of the sizing tolerances indicating a higher probability of corrosion growth. For features between the orange lines, the depth difference is within the limits of the sizing accuracy. Analyzing the moving average change in depth of 21 neighbouring features allows the identification of pipeline sections with a higher probability of growth (e.g. km 5 – 10 and around km 25).
