Case Study

NDT Global

In a Single Run

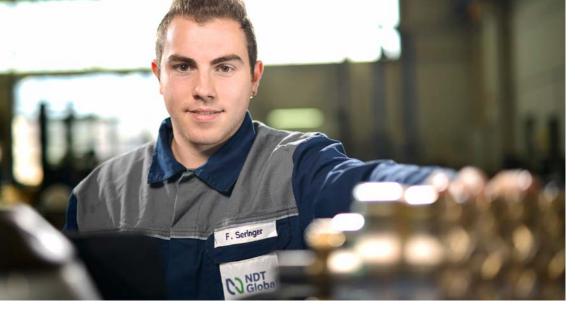
After evaluating available solutions, the operator asked NDT Global to inspect the pipeline. A combined inspection run consisting of EVO 1.0 UC, EVO 1.0 UMp and EVO Geometry tools delivered a comprehensive inspection in a single run. These technologies accurately detect, locate, and size metal loss and axially oriented crack-like anomalies, providing high-resolution mapping and XYZ coordinates for the pipeline. In particular, the company's innovative Enhanced Sizing for ultrasonic crack inspections removes depth sizing boundaries that previously existed for depths above 4 mm (0.16 in).

NDT Global's technology is unique in its ability to perform a combination UT compression wave type ILI tool run, with XYZ mapping, for the detection of metal loss and lamination anomalies, while having the ability to simultaneously complete crack detection.
