# FINDING CRITICAL FLAWS OFFSHORE

**Manuel Valdes, NDT Global, Mexico, explains how a trio of ultrasonic inspection technologies identified a major subsea pipeline flaw for a Gulf of Mexico operator.**

The pipeline requiring inspection was the Manik A Production Platform to Ixtal B Production Platform section. This line has an 8 in. nominal diameter and is 7.3 km in length. The wall thickness is 9.52 mm (predominant) and 14.28 mm in the riser and above-water, deck facilities section, with a steel grade of X-52. Potential threats included manufacturing defects (e.g. laminations, inclusions, seam-weld lack of fusion), gouges, and dents.

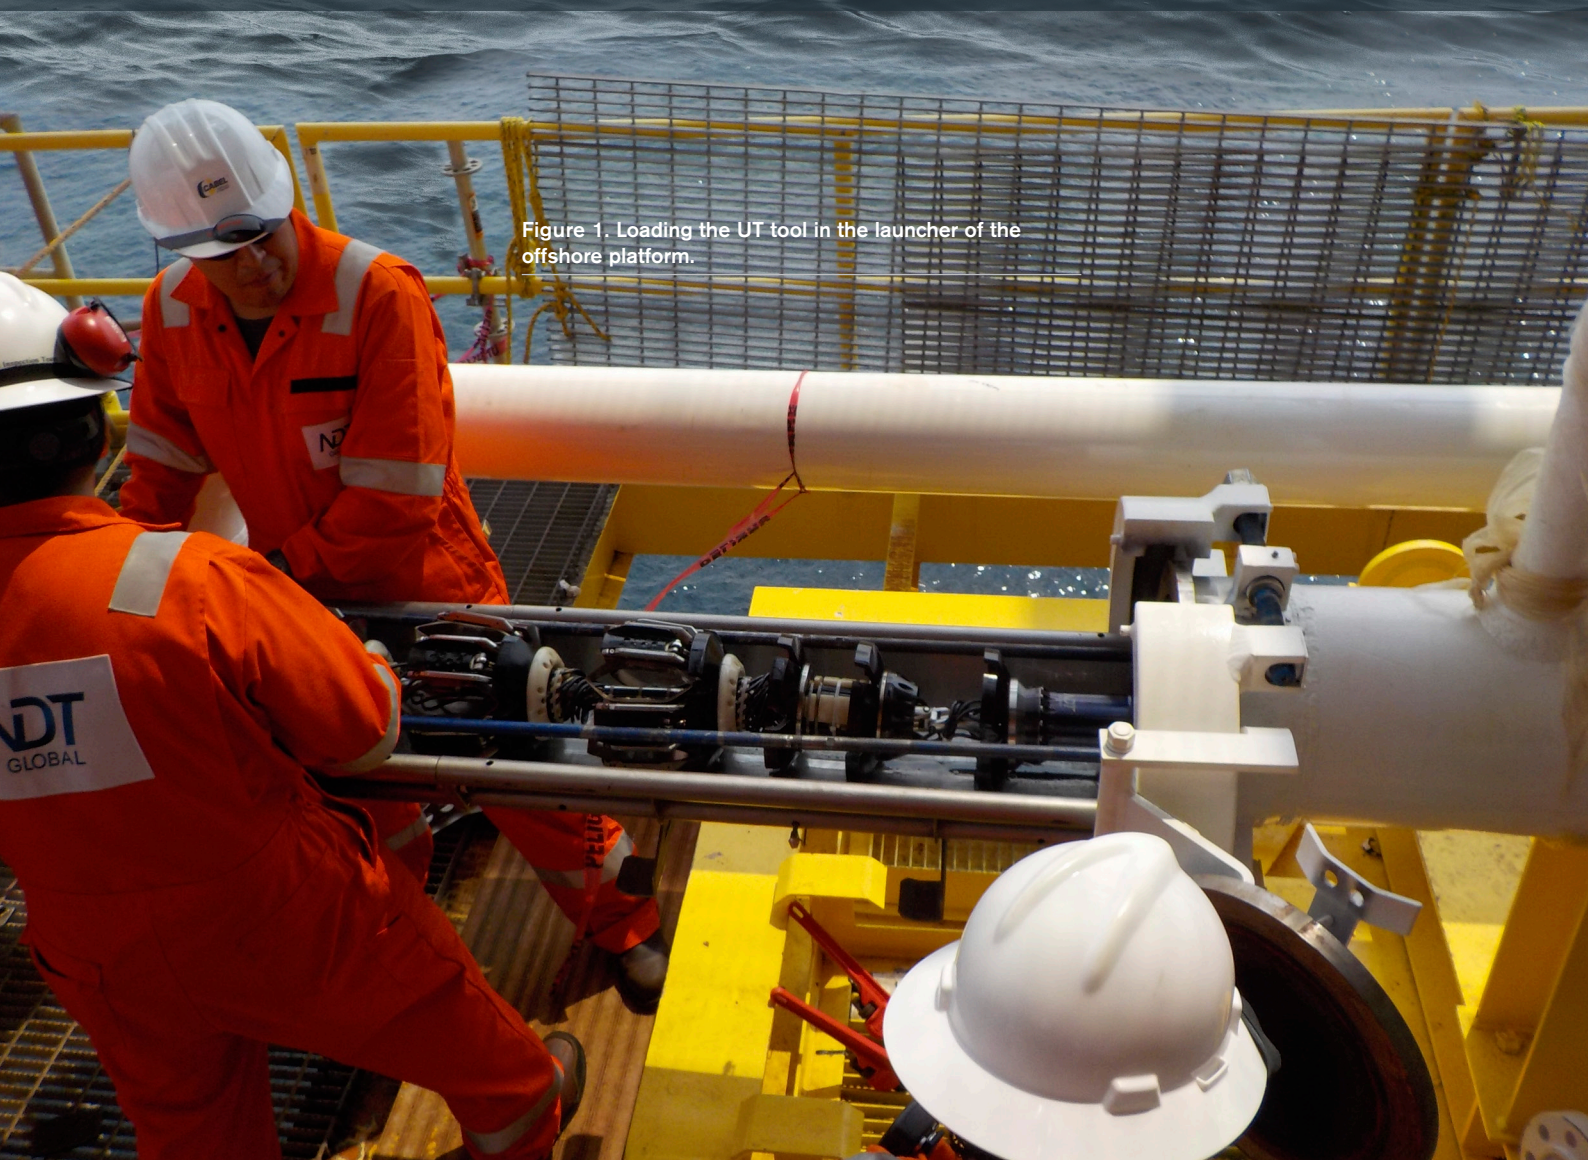
Figure 1. Loading the UT tool in the launcher of the offshore platform.

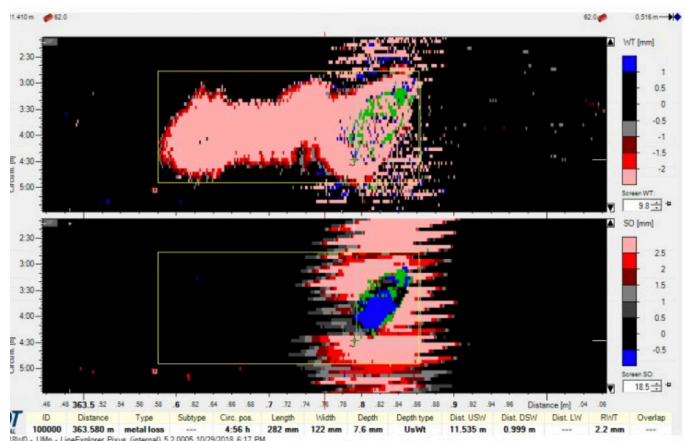
**Figure 2. Top: how the defect appears on wall thickness. Bottom: how the defect appears on geometric data.**

In the pre-commissioning inspection, NDT Global detected a major anomaly during the run validation. This was an interesting feature that combined both metal loss and a dent, which indicated gouge-type damage. In order to conform to the operator's schedule, the scope of work specified a run validation in less than 24 hours, which included reviewing the run data and grading the information quality. NDT Global then immediately reported the findings so that the operator was informed in advance and could plan all necessary actions.

The feature was detected under the seabed at 70 m depth. After the critical anomaly was first reported, the pipeline failed to pass the hydrotest. As a result of the quick, initial analysis and report – less than 24 hours after the retrieval of the robot – the operator was made aware as to why there was a loss of pressure.

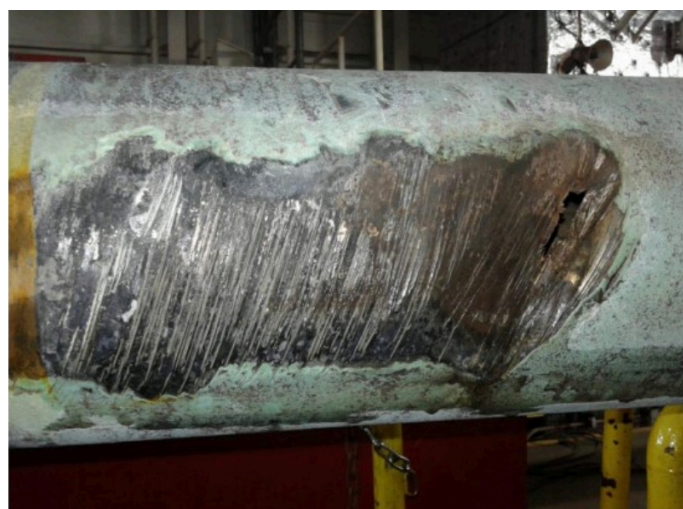
**Figure 3. Physical appearance of the anomaly.**

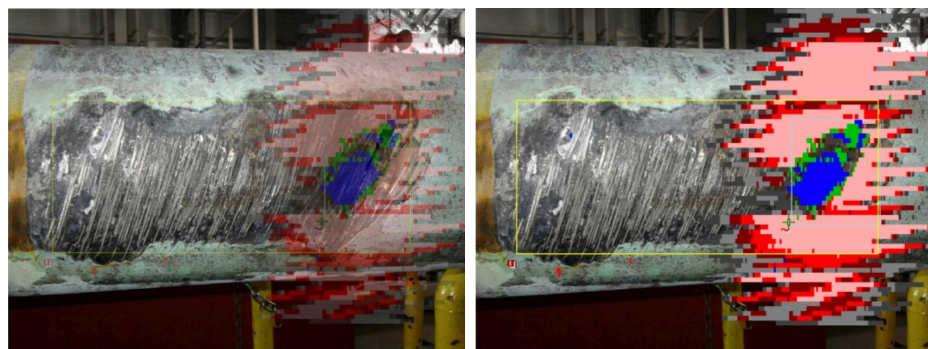
**Figure 4. Wall thickness and geometric software image overlaps actual defect image. The inspection data is highly correlated with the damage.**

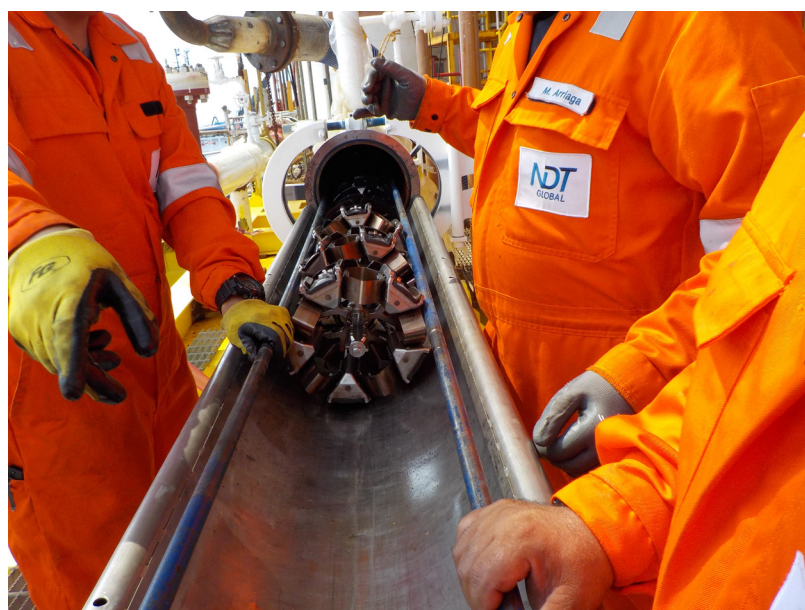
Figure 5. Ump sensor carrier during the loading procedure.

The EVO Series 1.0 UMP compression-wave robot is used for metal loss inspection; mill anomalies such as laminations and inclusions; and quantitative wall-thickness measurement, with high resolution for pitting detection and sizing. Inline inspection with this robot is designed
