By Batching a 12" Natural Gas Line

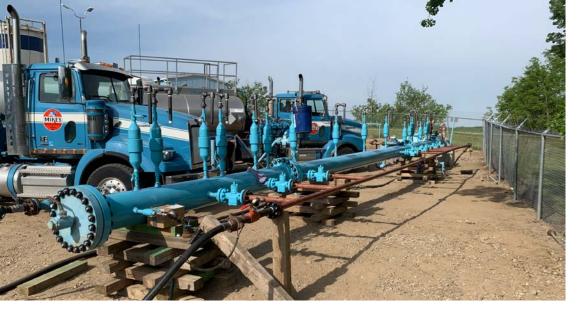
Example of a batch configuration

Another key factor in the success of managing a batching operation is the control of the flow rate and pressure of the liquid slug to ensure that the column of liquid stays together and runs as smoothly as possible. To achieve this, In-line Pigging Solutions employed the use of automatic pressure control valves to assist the operations team in managing any changing pressures and flow rates due to the ILI tool navigating elevation changes. The addition of a detailed execution and communication plan were key factors in this inspection program being completed with zero unplanned events.
