White Paper

Assessing the Accurate Topography of Complex Channeling Corrosion

Abstract

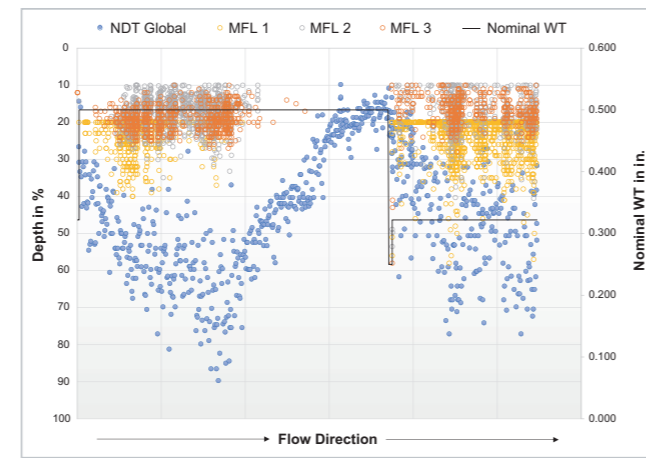
Figure 3 – Depth distribution of features according to the different vendors

For correlation purposes, the operator provided 3 MFL reports from the last 3 years. Each run was carried out by a different vendor. A change of the inspection technology from MFL to UMp was necessary to clarify the cause of a leak that could not be explained by all previous ILI results. An overview of the greatest variances between the different vendors is shown in Table 1. For the complete pipeline, the depth of each feature over the length of the pipeline is shown in Figure 3.

In Figure 3, only the UMp channeling boxes, which reflect the deepest point, are plotted for ease of visualization.

Both Table 1 as well as Figure 3 reveal significant differences in the results between the UMp and MFL measurements, but also significant differences among the MFL vendors.

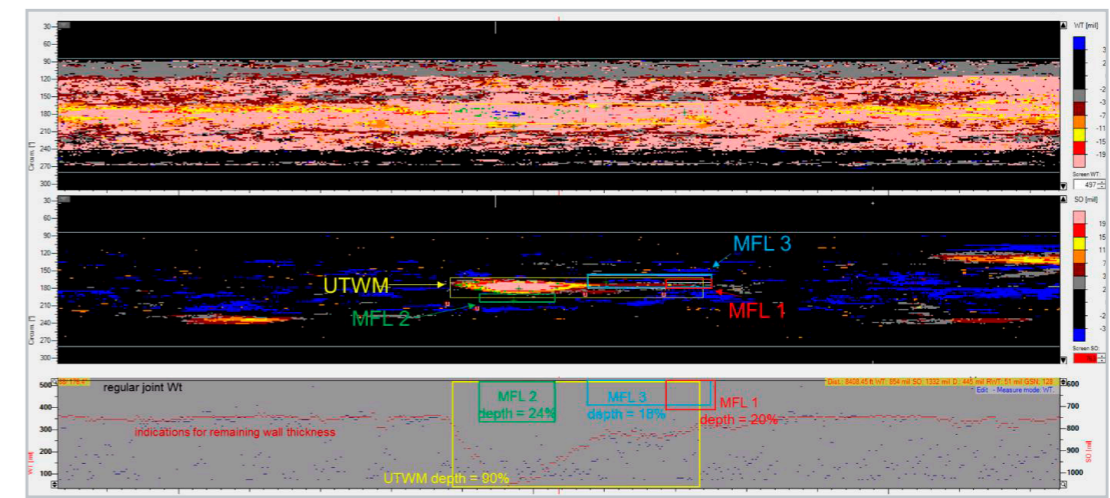
Figure 5 – Top: Wall thickness C-Scan for a section of the joint (~1.5 ft. / 0.5 m) containing the deepest point. Middle: Corresponding stand-off C-Scan. Bottom: Corresponding B-Scan showing the wall thickness through the deepest point. The colored boxes indicate the depth and approximate axial location and depth of the MFL and UMp boxes. Due to slight differences in the odometers for each run, the exact axial position can be neglected.

While not all corrosion spots were consistently identified by vendors along the length of the pipeline, the deepest point was detected by all vendors. But while the UMp measurement delivered a depth of 90 % with indications of a possible leakage for that point, the MFL results delivered significantly lower depths, around 20 %, as the projections in Figures 5 and 6 show. The blue, red, and green boxes in the bottom

third of Figure 5 show MFL detection is only focused on the metal loss due to the channeling corrosion. Examining the figure, the depth of the boxes is close to the local wall thickness, marked in red. The total height of the area represents the nominal wall thickness. The real gap between reference wall thickness and remaining wall thickness caused by the local metal loss within the channeling is not considered. The axial cross-section of the pipe in Figure 6 illustrates the circumferential extent of the channeling corrosion and gives a reference for the size of the deeper metal loss within the channeling. It appears the channeling obscured the axial MFL measurement.

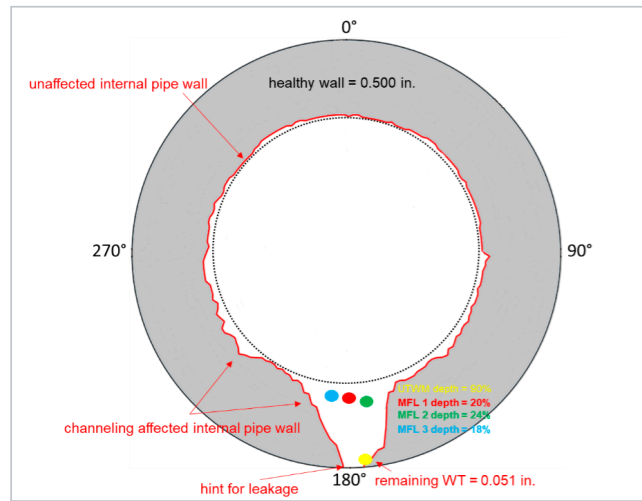
Figure 6 – Depths measured by different tools, shown at the deepest point in a cross-section, constructed from UMp data.

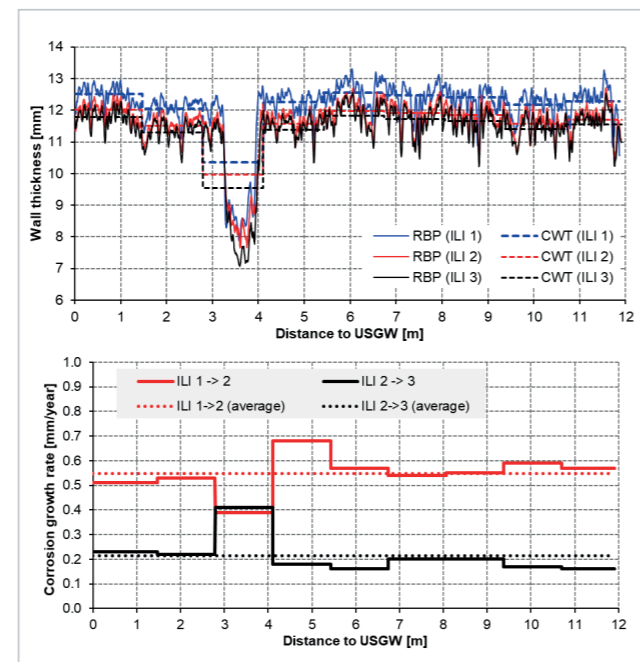
Figure 10 – Example of corrosion growth assessment by comparison of river-bottom profiles (one pipe joint). Top: river-bottom profiles and characteristic wall thickness, bottom: growth rates

The procedure is shown in Figure 10. The top figure shows RBPs of 3 ILIs for one pipe joint. The resulting corrosion growth rates are shown in the bottom part of this figure. In this example, the overall growth rate was reduced from approx. 0.55 mm/year (between ILI 1 and ILI 2) to 0.20 mm/year (between ILI 2 and ILI 3). However, corrosion growth at the deepest spot of this anomaly remained constant between ILI 1, ILI 2, and ILI 3.

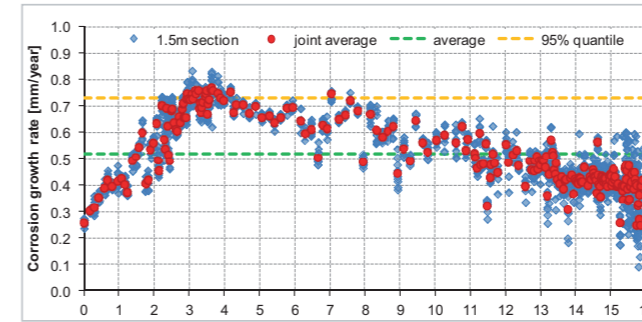
Figure 11 – Corrosion growth rates vs. pipeline distance (red dots: pipe joint average growth rates, blue dots: growth rates for 1.5 m sections)

The corrosion growth rates for all assessed pipe joints are plotted in Figure 11. The corrosion growth behavior varies along the distance, with maximum growth rates observed between 3 and 4 km.

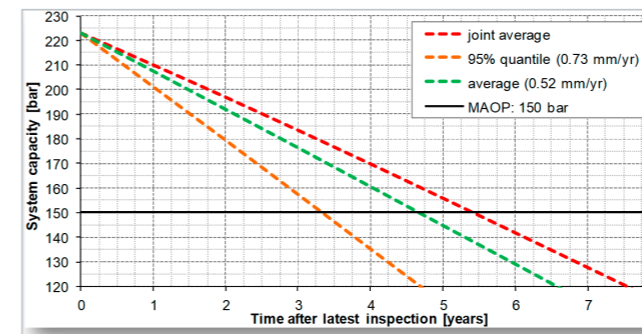
Figure 12 – Extrapolation of pipeline pressure capacity

After the determination of the pipeline pressure capacity at the date of the latest ILI, and after the corrosion growth assessment is performed, the future development of the pipeline-safe operating pressure can be extrapolated. This is achieved by reducing the remaining wall thickness of the RBPs according to the considered corrosion growth rates and by repeating the capacity assessment as described above. Depending on the considered corrosion growth rate, the extrapolated pipeline pressure capacity will reach the MAOP of 150 bar 3.5 to 5.5 years after the latest inspection (see Figure 12).
