## An Esthetic Approach in the Posterior Zone

The high visibility of a premolar justifies an esthetic approach to the outcome of a posterior restoration. In this case, a failed premolar is addressed using two shades of composite as well as a tinted resin to achieve a natural result that blends beautifully with surrounding dentition.

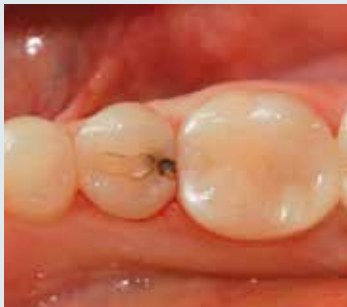
1. Preoperative view of failing Class II restoration with interproximal decay

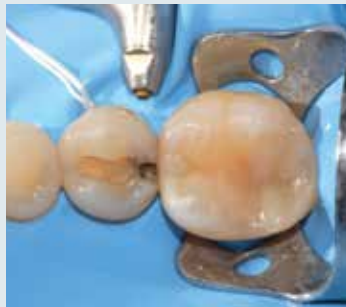
2. Rubber dam isolation to reduce potential for contamination

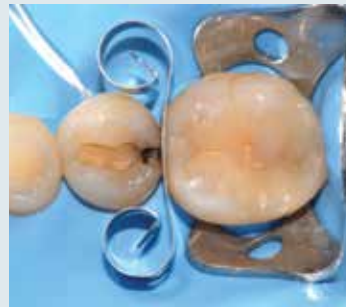
3. Placement of InterGuard<sup>®</sup> proxitector to protect adjacent tooth

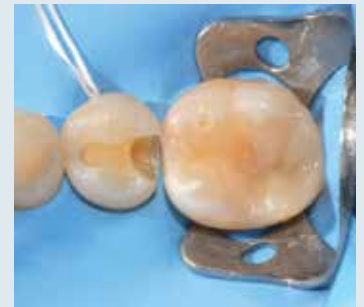
4. Removal of failed composite restoration and decayed portion of tooth

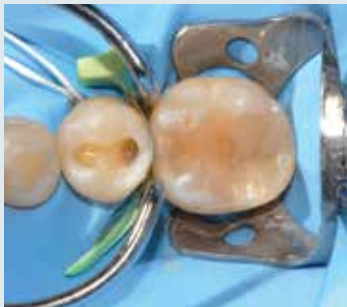
5. After having placed a sectional matrix, placement of Mosaic<sup>®</sup> composite, Enamel White shade, to build a marginal crest

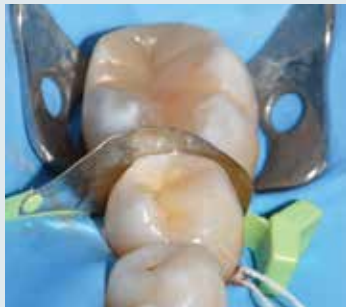
6. Formation of tooth anatomy with Mosaic composite shade A3.5

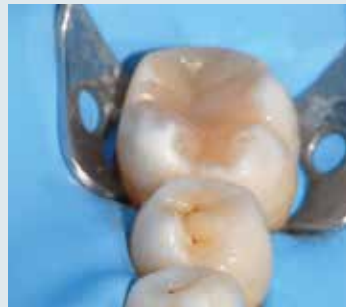
7. Characterization stain added with tinted flowable resin (dark brown)

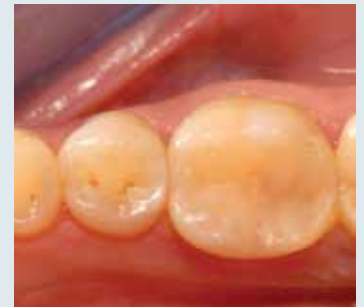
8. Removal of isolation and final polish
