Defying Time: Durability of DYWIDAG DCP Bar Tendons After 30 Years

Case Study

External Post-Tensioning System
Using GR 150 Double Corrosion
Protection (DCP) Threadbars

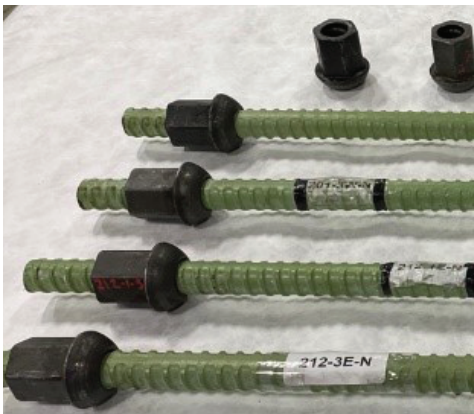
Over the lifespan, DYWIDAG has performed multiple rounds of lift-off testing indicating force verification in line with engineered criteria. These tests show that DYWIDAG THREADBAR exhibits low relaxation properties. Following a period of thirty years in service, a representative selection of tendons situated in the most exposed positions on the exterior surfaces of the outer bents were extracted for examination and subsequent replacement with new tendons. The selected tendons earmarked for removal were meticulously labeled and transferred to a secure facility. Here, they underwent a detailed dissection and visual inspection to identify any indications of corrosion, wear, abrasion, or other surface irregularities. Subsequently, the THREADBARS were dispatched to an independent third-party laboratory for testing of their tensile strength.

The examination of the DYWIDAG DCP system, encompassing THREADBAR tendons along with anchor nuts and couplers, involved a comprehensive evaluation of their state. Initially, visual analysis was performed to document the external condition of the materials. Subsequently, the bar tendons underwent dissection to unveil their cross-sectional profiles, providing insights into the status of the grout, corrugated plastic duct, smooth plastic duct, and THREADBAR. Among these, four bar samples had their ducts and grout removed for a detailed assessment of the bar tendons' condition.

Both the yield and tensile strength of the examined THREADBAR exceeded the minimum guaranteed strength as specified in ASTM A722. The inspections and tests conducted affirmed that the overall structural soundness of the DYWIDAG DCP THREADBAR, anchor nuts, and couplers, had been effectively maintained throughout the three decades of their service. This favorable outcome can be attributed to the layered safeguarding mechanisms of the DYWIDAG-designed DCP system, its inherent durability, and the diligent maintenance efforts carried out over the years by DYWIDAG.
