REPORT #573397

2001 BMW M COUPE

SUMMARY

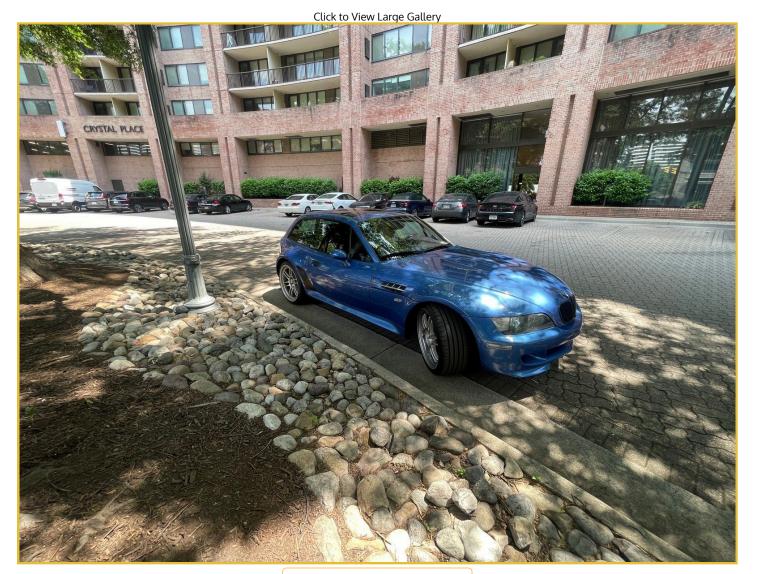
There are minor misc scratches around the vehicle. Normal for mileage and most too small to see in photos. There is one ding at passenger side lower ground effect. The exterior lights were working. The vehicle panel alignment looked good. The wheels looked good and the tires show to have good tread
