1959 Jaguar XK150 roadster (MM)
Team CJ restoration (modified)

Specification (briefly) for this project is as follows:

Team CJ modified restoration featuring a high performance Stage One CJ engine, CJ5 five speed, upgraded suspension, brakes, cooling, ignition, air conditioning, blue tooth capability, etc..

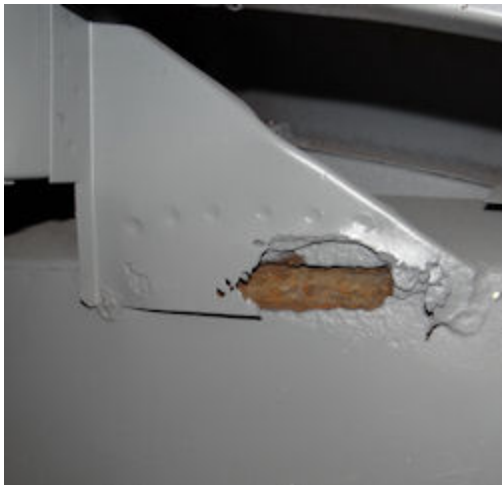
Side panels fabricated and welded in place

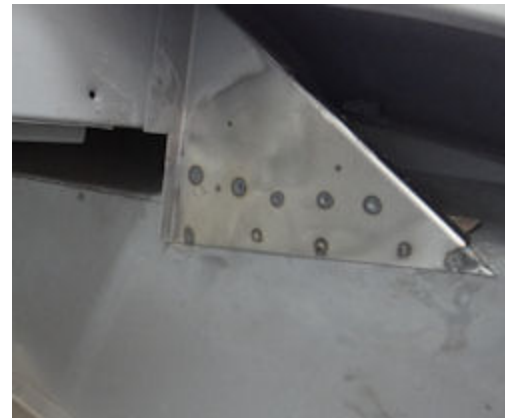
Inner rear cowl support the last rust in the entire car

Rust cut out, new panel fabricated and welded in place

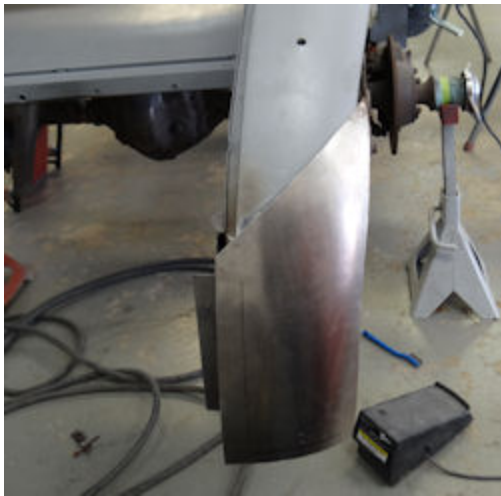
Panel is first reconstructed internally

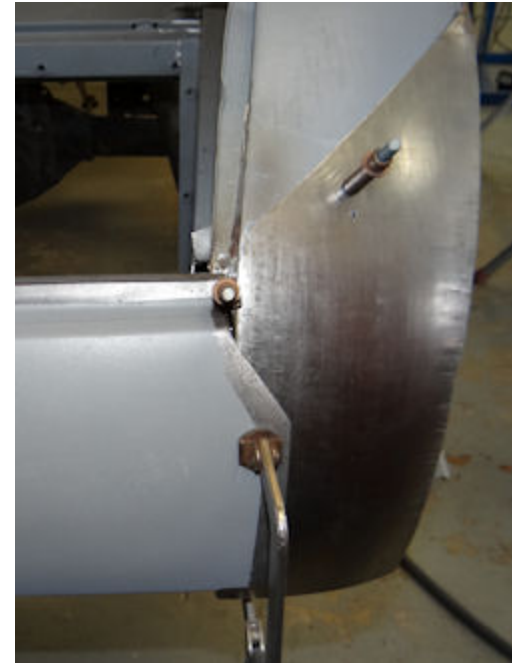
Trial fitting replacement panel

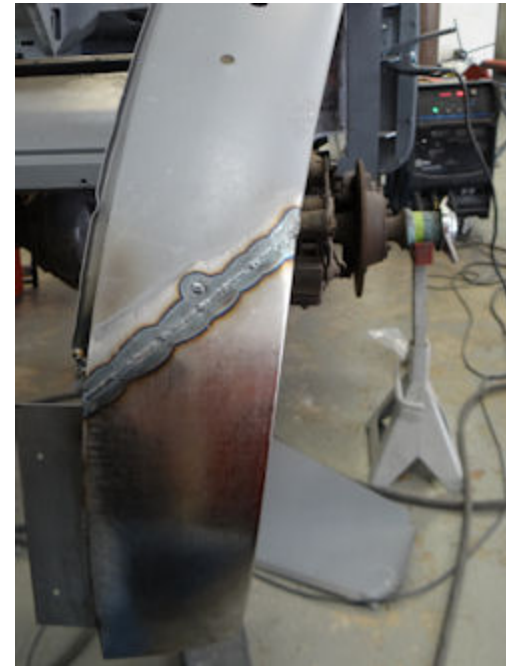
New panel is first tack welded in place

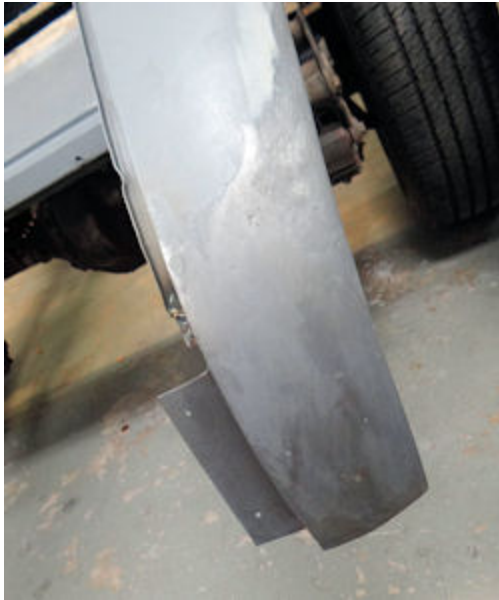
Then the repair seam is TIG welded

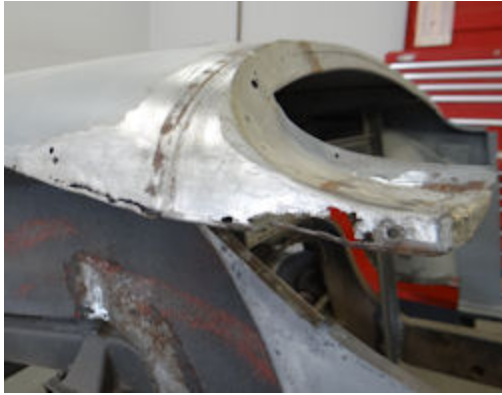
Modifying shut face panel for perfect fit

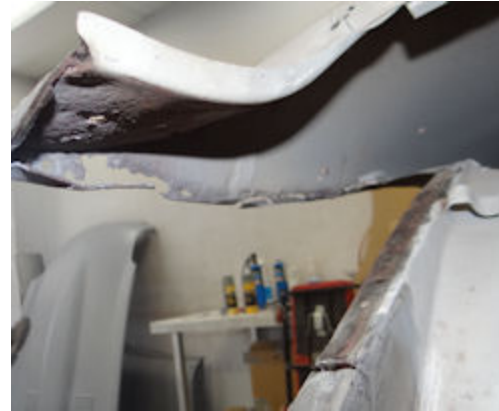
Upper RH cowl needs major repair

Last photo in this sequence shows this area reconstructed

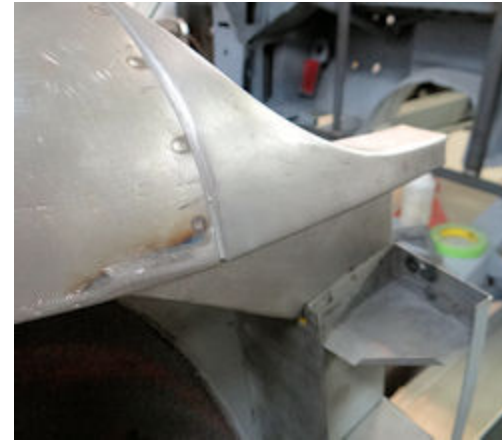
Inner B pillar structure now welded in position

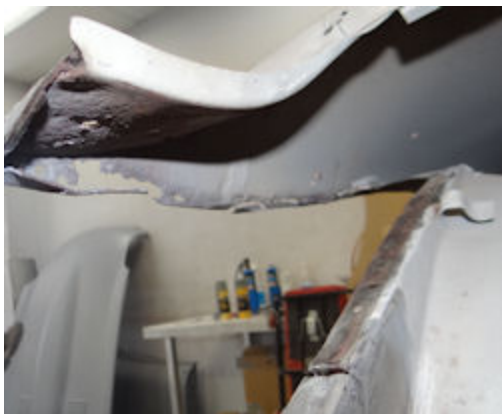
Repair panels now welded in place

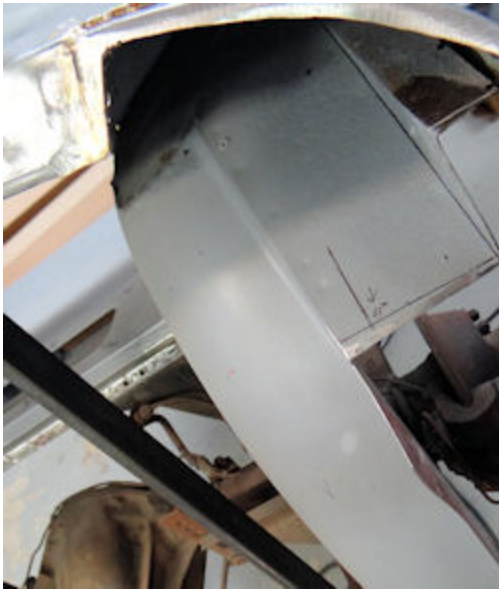
Top of driver's B pillar requires extensive surgery

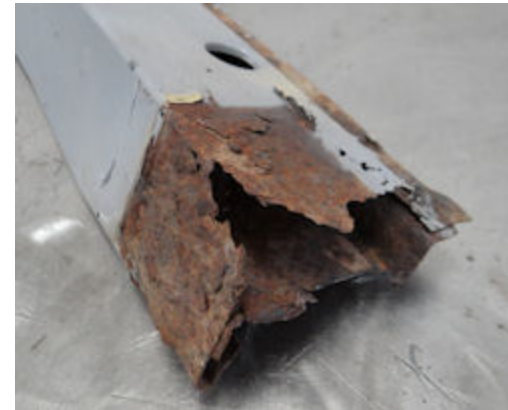
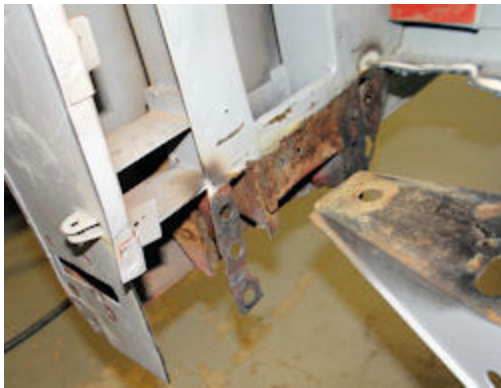
Back side of LH rocker panel where it attaches to the A pillar

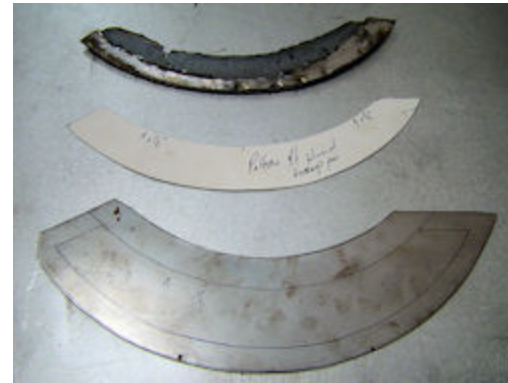
Rusted metal cut away from right hand headlamp pod

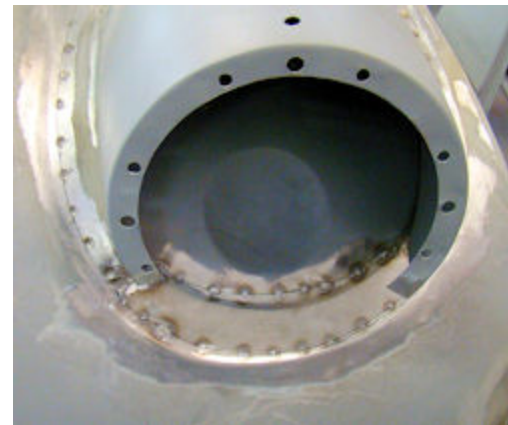
Repair panel clamped in position

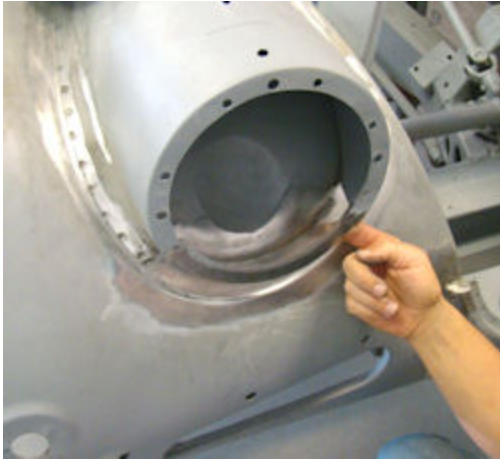
Making repair panel for headlamp mounting lip

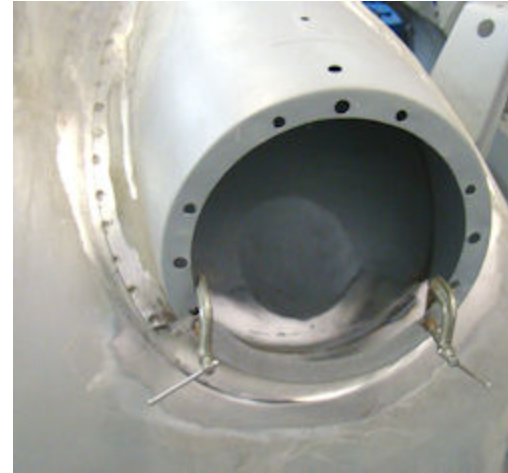
Trial fitting the new headlamp lip repair section

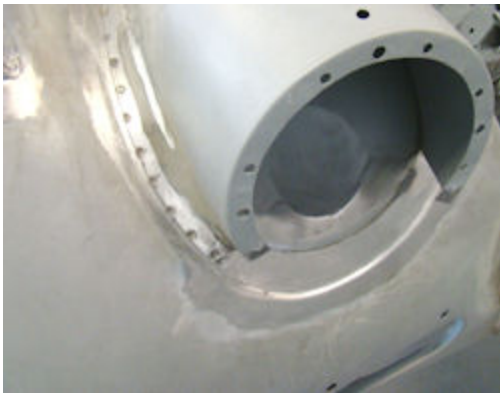
Similar issues on left side...

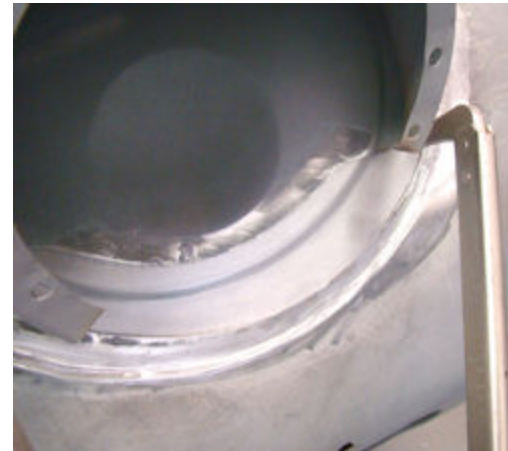
Rusted area cut away from right hand pod

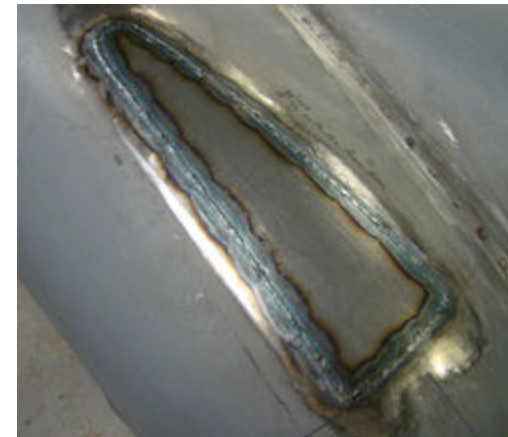
The RH sidelamp repair panel is tack welded in position...

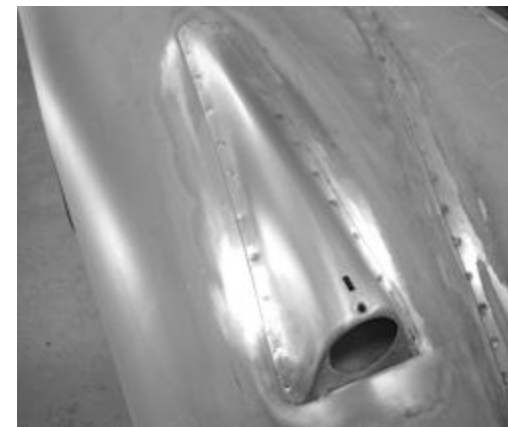
New sidelamp pod then spot welded in place

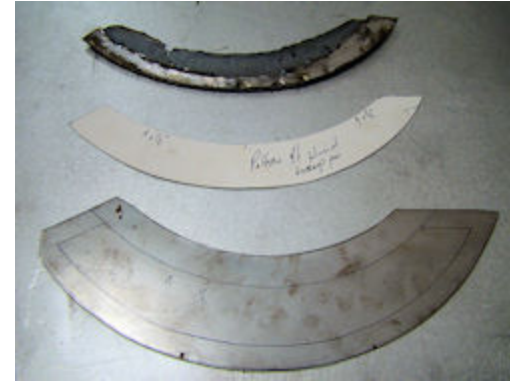
Both headlamp pods were rusty

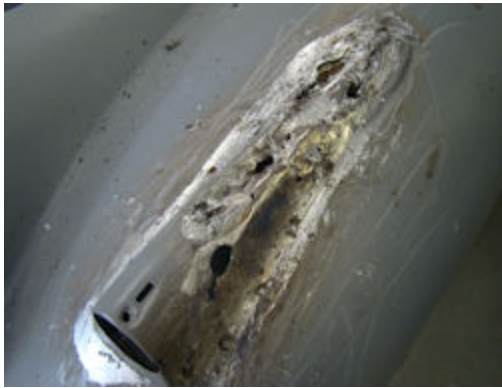
The following sequence of photos show Jake replacing one of the front marker lamp housings. There was significant rust in the housing and the sheet metal beneath.

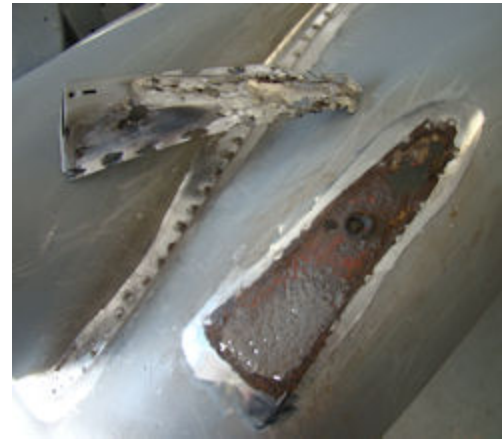
Both marker lamp housings will be replaced

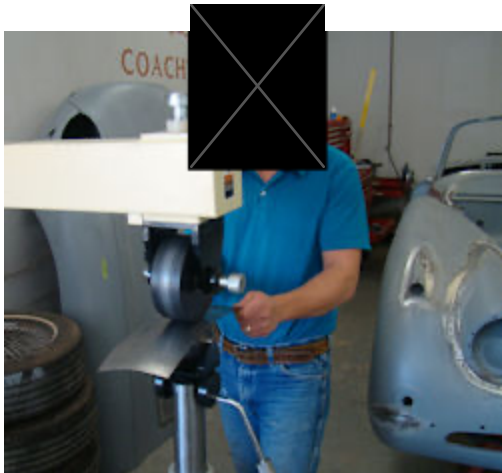
Sheet metal beneath marker lamp housings badly rusted

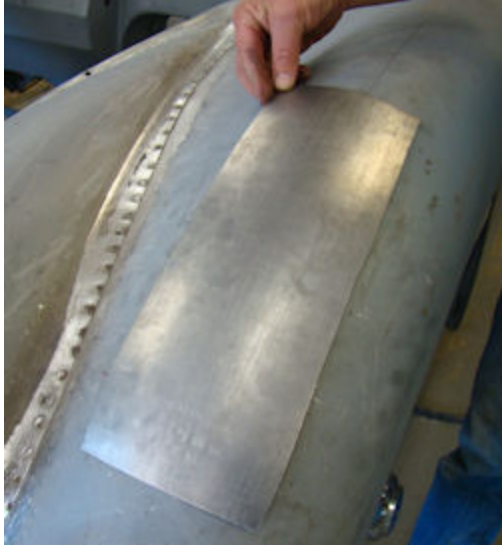
Replacement marker pods differ slightly from originals and will have to be modified

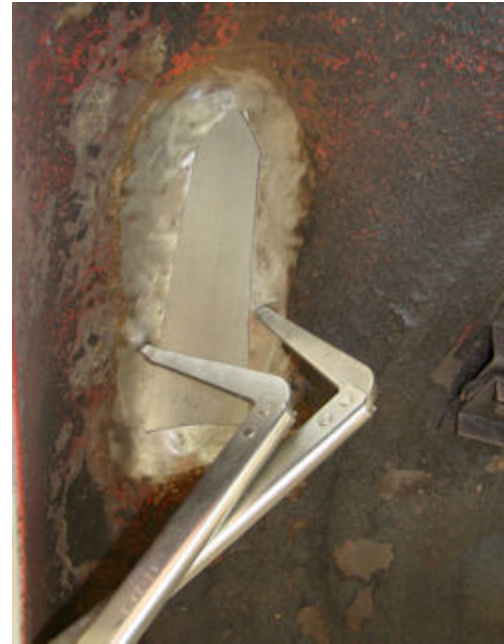
The contour of the replacement sheet metal has to match the top of the wing perfectly

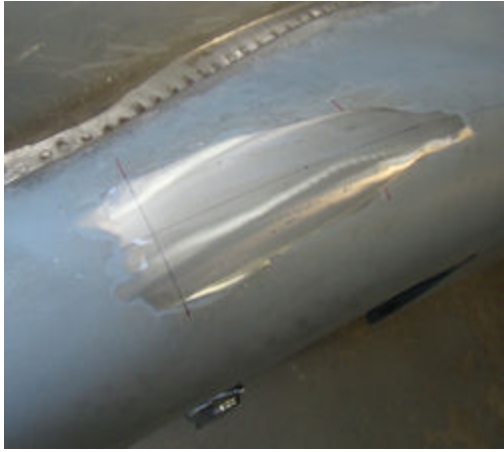
View from beneath

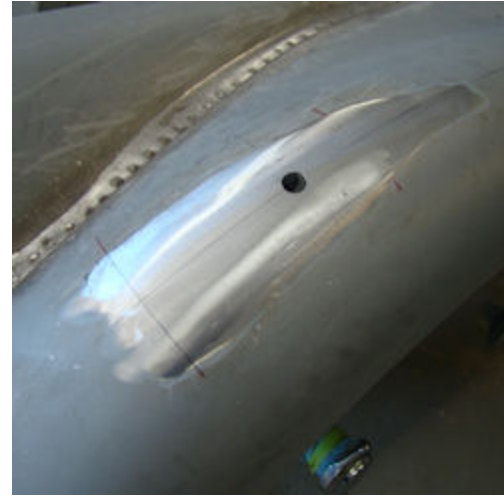
With TIG beads cleaned up, repair is virtually invisible

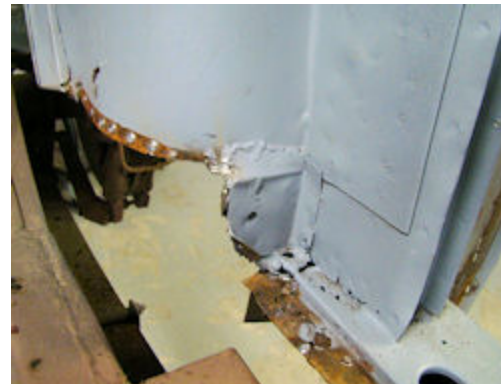
Drilling out spot welds to remove floor section

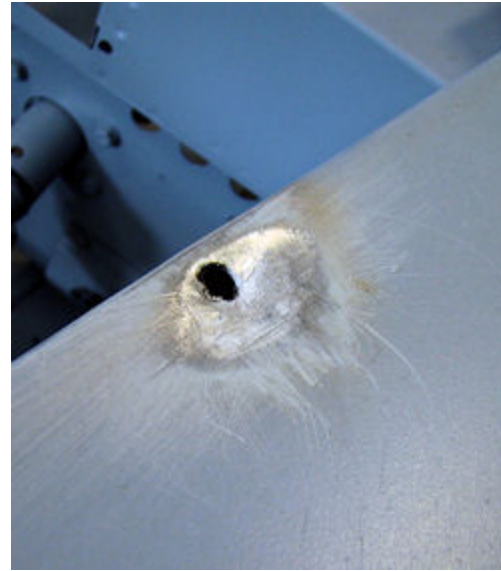
Floors removed in one piece

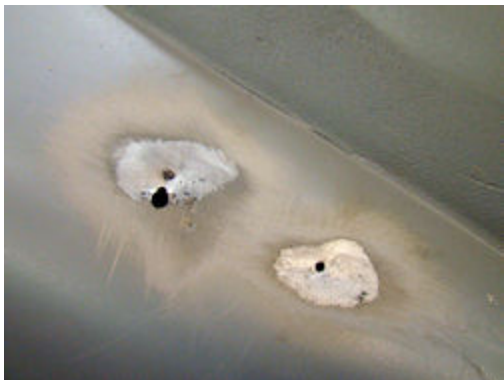
Unfortunately, lead has been used to hide corrosion at a number of locations around the body

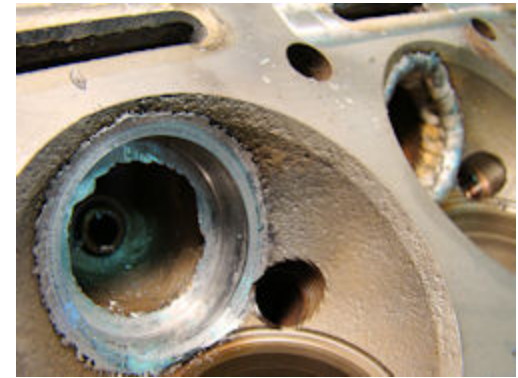
Most of the valve seat pockets had to be welded up and re-cut

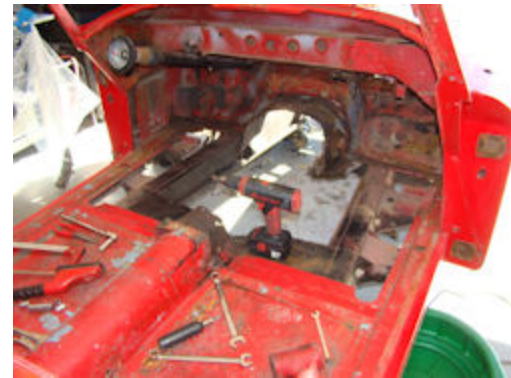
There are a number of places that will require sheet metal repairs, although nothing too serious
