# ASBESTOS TESTING REPORT

## Beautycounter– Talc

EMSL ORDER ID: 041810424      April 20, 2018

## Test Report: Asbestos Analysis of Bulk Material via EPA 600/R-93/116. Quantitation using the 1,000 Point Count Procedure

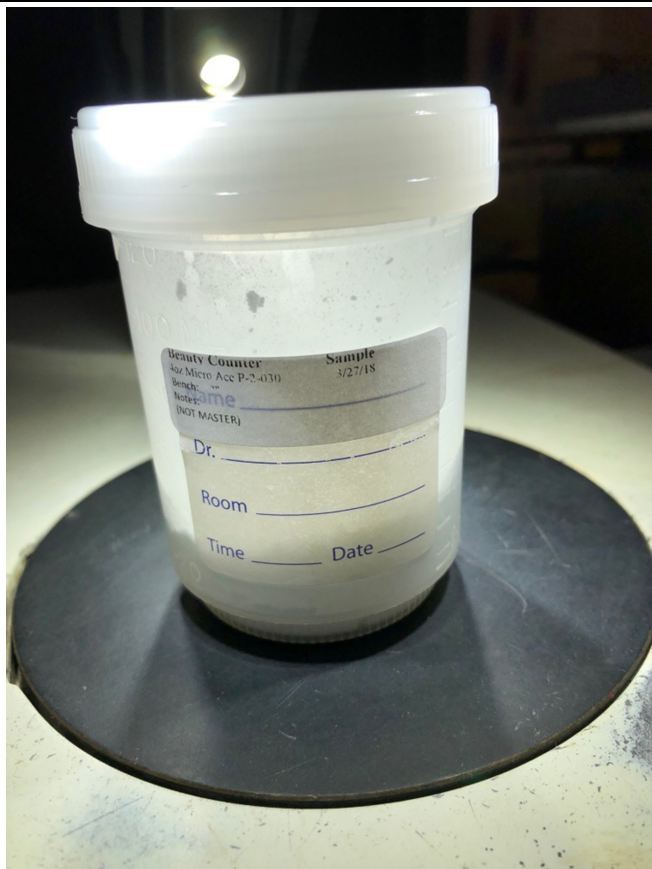
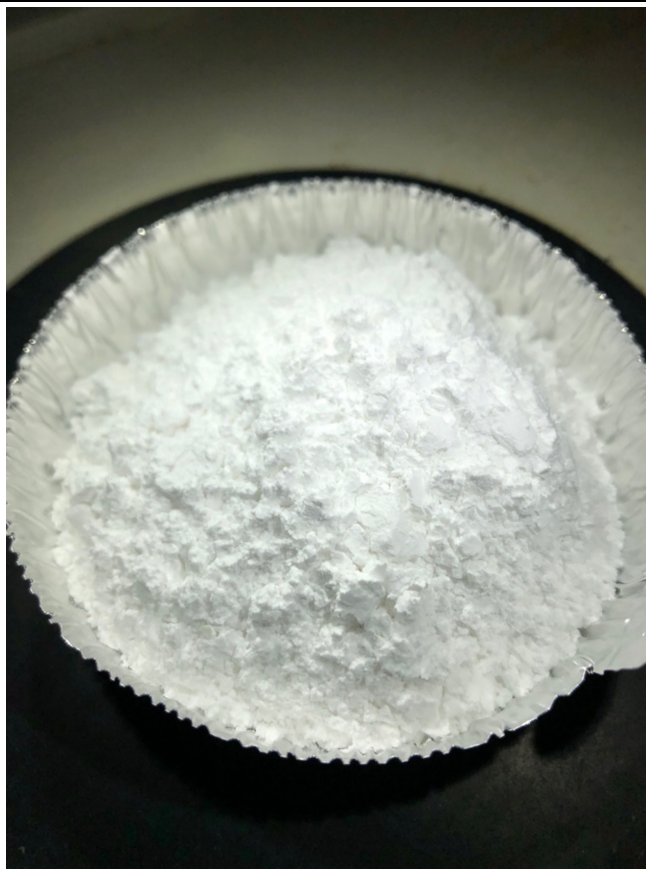
041810424-0001

Representative images of the sample as received (left) and under a stereomicroscope (right).

Representative images of the sample both taken as received and under a stereomicroscope are found in Appendix B.
