Bi-Directional High-Resolution Inspection

Of a Subsea Flexible Riser Pipeline

NDT Global

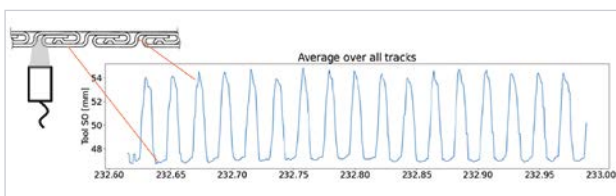
→ **NDT Global provided accurate inline inspection** measurements of the distances between the individual increments of the flexible riser carcasses, indicating any potential areas of over-expansion or compression. The recorded inspection data was also used to evaluate the condition of the end fittings and decide what, if any, remediation was necessary. No damage was detected.

Stretch measurement of the carcass
