# Cabbage Tree Bay Rising Main.

Improving the resilience of the sewer rising main that runs along Marine Parade, Manly is progressing. The next step is to install a sewer liner into the rising main.

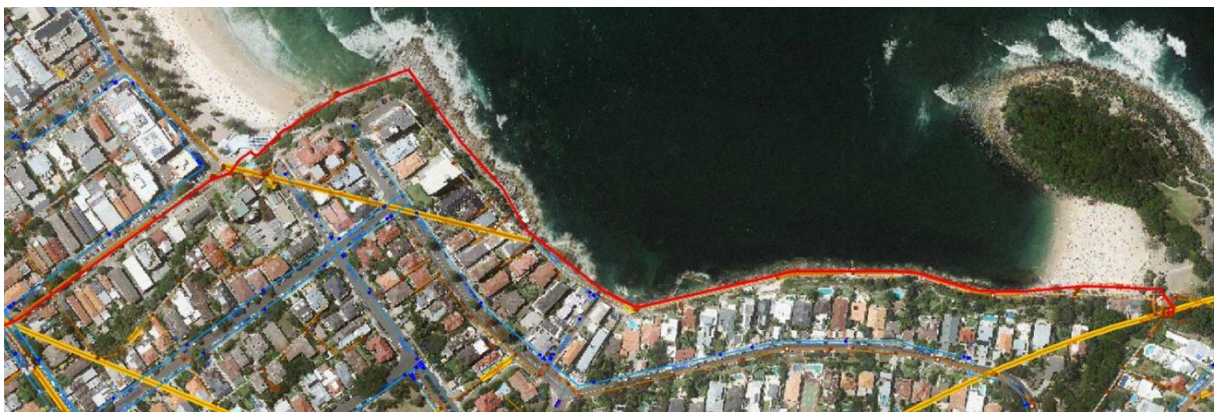
In 1970, The Board discontinued discharges at the ocean outfall by intercepting Manly's wastewater at Shelly Beach and pumping it back to Northern Suburbs Ocean Outfall Sewer at Darley Road. Excess flows during wet weather still being discharged at the outfall. The pumping back is achieved by a pumping station located at Shelly Beach and a rising main that runs along the promenade (red line in the map).
