## Case study for onboard safety meeting

# Container stack collapse in heavy weather

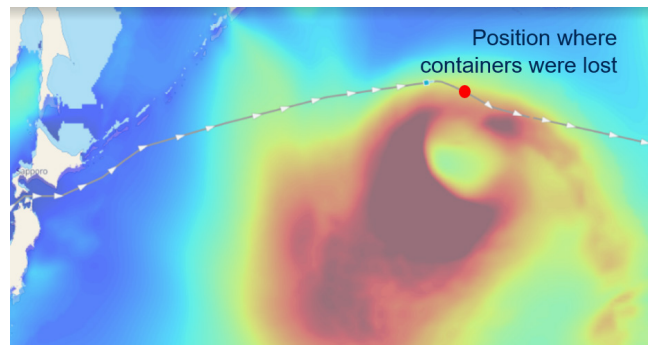
A container vessel with a capacity of 4,000 TEU was en route from Shanghai to Los Angeles. The charterer engaged a weather routing service provider that recommended a route passing through the Tsugaru Kaikyo, a narrow waterway between the Honshu and Hokkaido islands in Japan. The advised path then followed a great circle across the north Pacific to reach Los Angeles. Initial weather projections for this route indicated a maximum wave height of 4-5 meters and a wind force of 6/7. However, the service provider did not ask for information from the vessel regarding weather limiting factors and ship stability.
