Title: Impact testing a sample of GRC Panels for S7 & S8 Stratford TIQ

Certificate of Test Number: 21493

Date: 3 February 2015

Contract :
S7 & S8 STRATFORD
TIQ

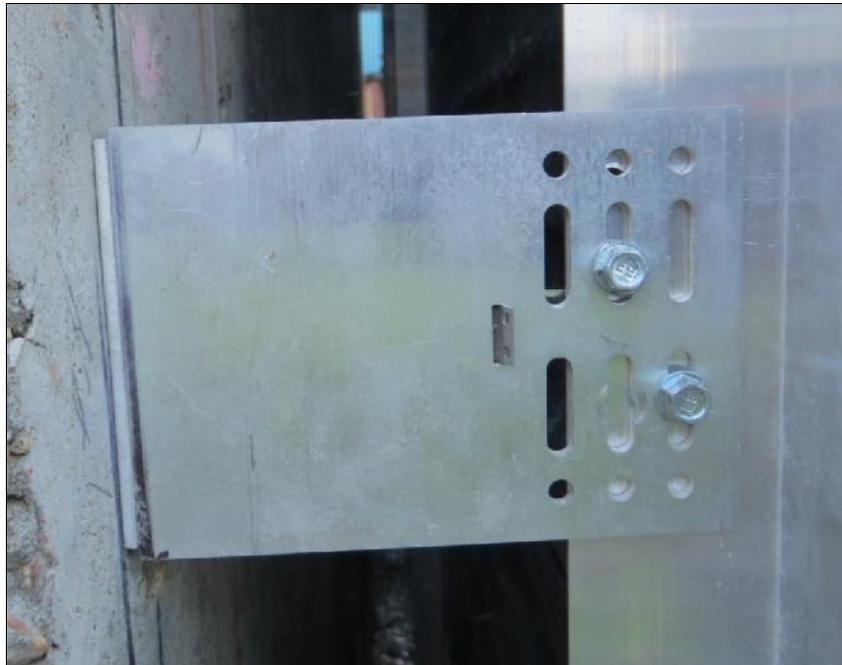
PHOTO 6556

SUPPORT BRACKET FOR CARRIER FRAME

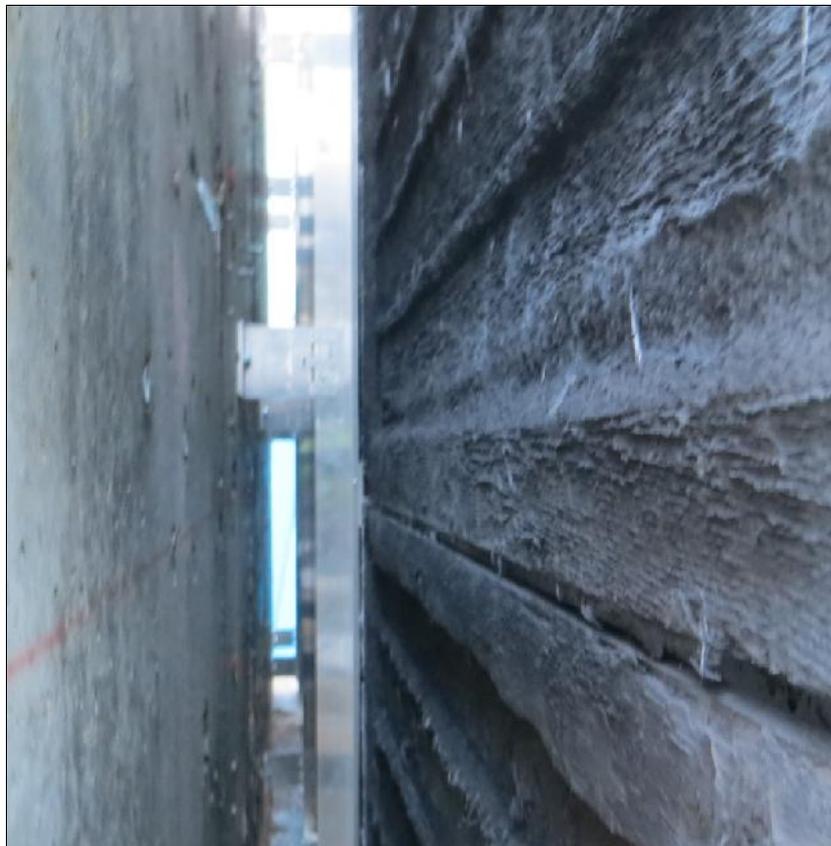
PHOTO 6557

VIEW BEHIND PANELS

During the dismantling of the test sample, no additional damage on the rear of the panels was observed.

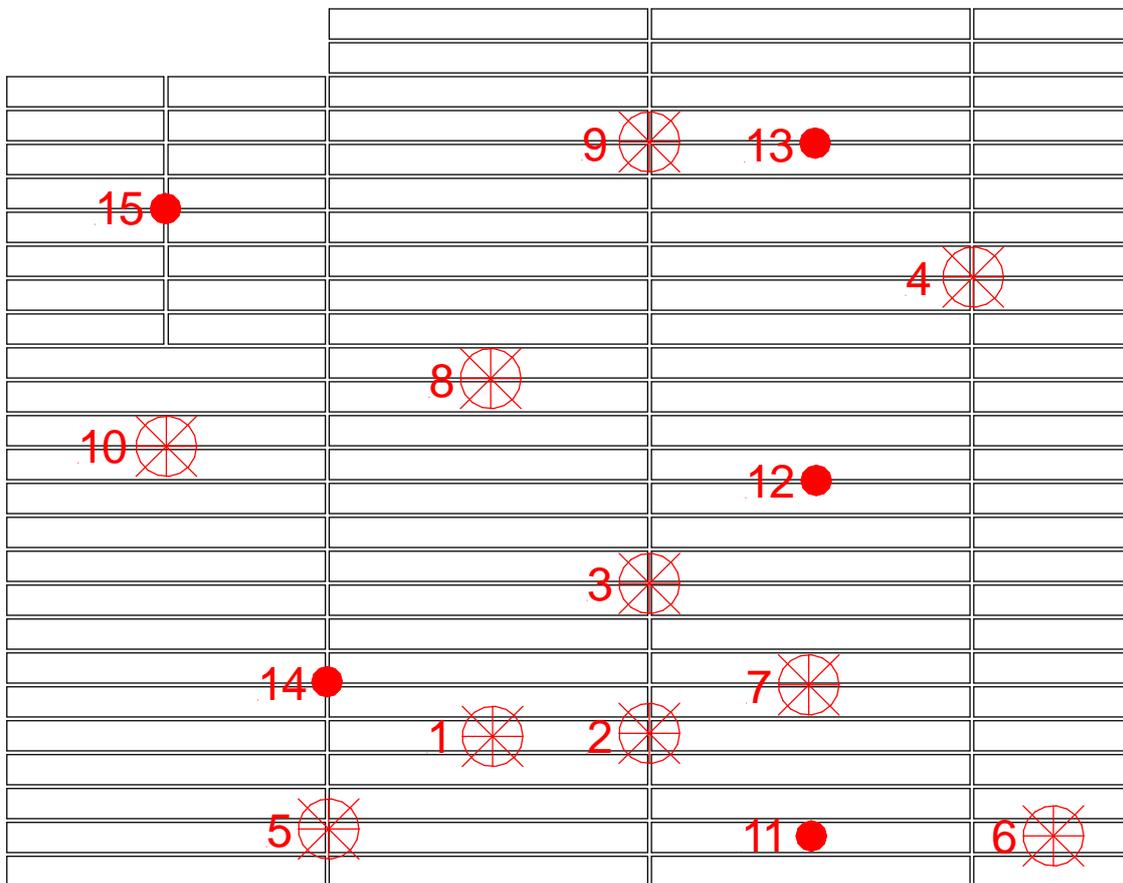
FIGURE 1

IMPACT TEST LOCATIONS

Location	Impact energy (Nm)	Observations
1	120 (x3)	No damage observed.
2	120 (x3)	No damage observed.
3	350 (x3)	Bracket snapped at pack of panel. Panel OK.
4	350 (x3)	No damage observed.
5	500	Bracket snapped at pack of panel. Panel OK.
6	500	Bracket snapped at pack of panel. Panel OK.
7	500	Bracket snapped at pack of panel. Panel OK.
8	500 (x3)	Small crack at top of panel after first impact. Further cracking after second and third impacts but still secure.
9	500	Vertical rail bent in. Panel secure.
10	613	Panel cracked but remained secure.

Location	Impact energy (Nm)	Observations
11	10	Small indent in panel.
12	10	Small chip in edge of panel.
13	10	Small chip in edge of panel.
14	10	Minor edge damage, small crack.
15	10	Small chip in edge of panel.

Only minor damage was observed to the surface of the panels throughout the tests.
