TEST REPORT

Project Title: Hygrothermal Testing in Accordance with ETAG 034:2012 Kits for External Wall Claddings

Client: Telling Architectural Ltd
7 The Dell
Enterprise Drive
Four Ashes
Wolverhampton
WV10 7DF

Telling Architectural Ltd required a programme of testing in order to investigate the durability of a Grade 18 Brick Faced GRC panel, proposed for 19 Colville Estate Balcony Soffits for Higgins Construction. The sample was subjected to Accelerated Weathering in accordance with ETAG 034:2012 followed by a Freeze Thaw regime in accordance with TS EN 772-22.

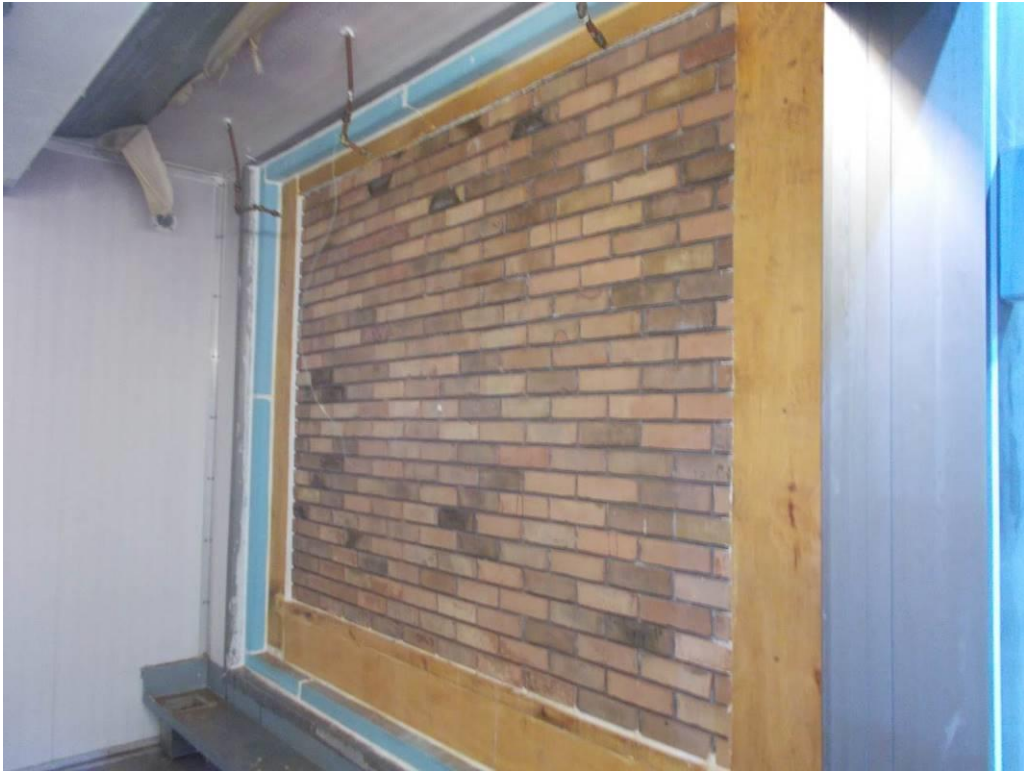
Plate 2 - Typical Damage Hard Body Impact Testing

The results of the hard body impact testing carried out at both 3 Joules and 10 Joules energy are given in the Table 4. Typical damage can be seen in Plate 2 with test locations seen in Plate 7.

Location	Diameter under 3 Joules Impact Energy (mm)	Cracking	Circumference of Cracking (°)	Diameter under 10 Joules Impact Energy (mm)	Cracking	Circumference of Cracking (°)
1	17.89	Corner of Brick Slip	360	21.67	Corner of Brick Slip	360
2	17.00	Damage to Edge of Brick Slip	360	23.87	Cracking of adjacent mortar joint	360
3	9.82	Damage Corner of Brick Slip	360	11.07	Cracking of adjacent mortar joint	360

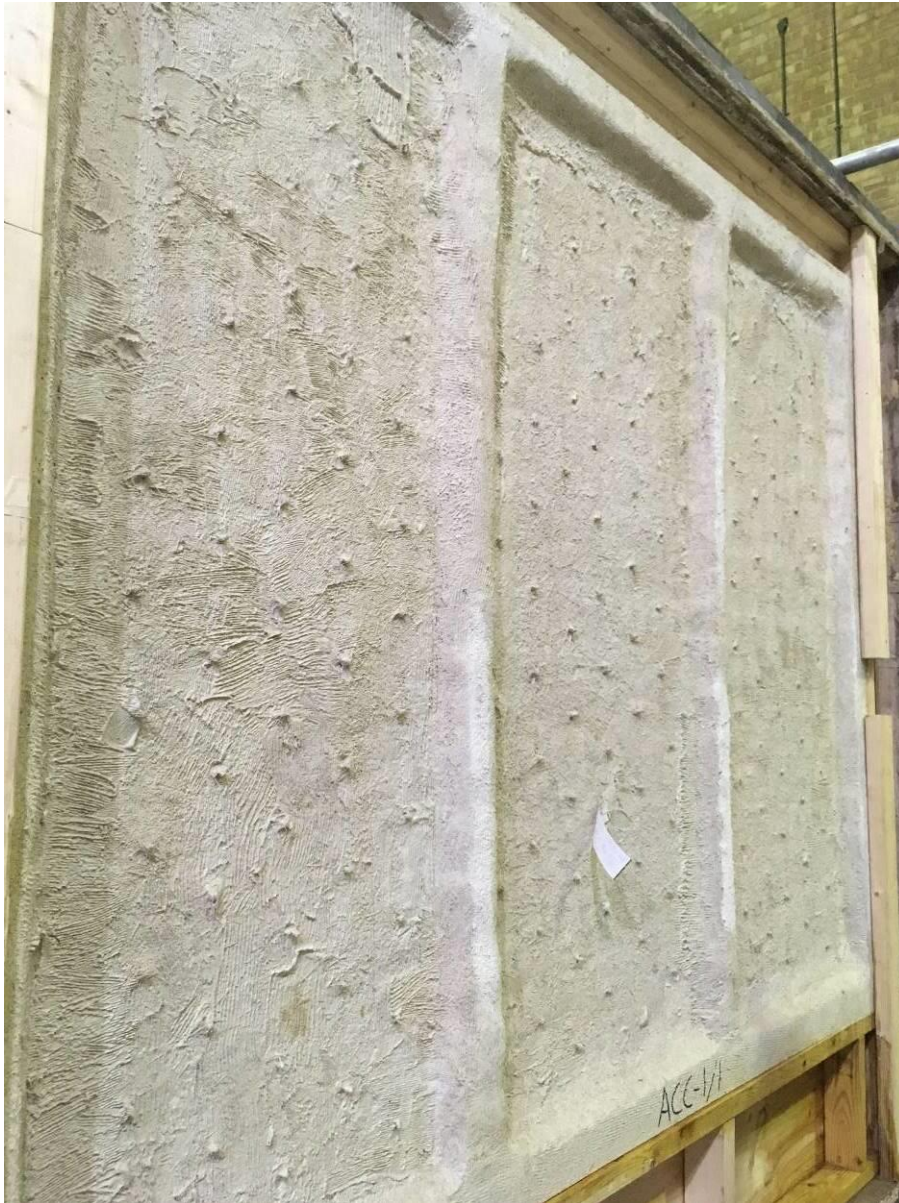
Plate 5 - Front of Panel after Test

Upon completion of the weathering and freeze/thaw cycles the panel was visually inspected to determine if any deterioration had taken place.

Visual inspection concluded that there was no damage to the Grade 18P GRC Panel.
