Bulletin 005/2013

Subject: Incorrectly Manufactured Hydraulic Hoses (80bar)
Affected Product: Cat6060/6060FS (RH340, RH340B)
Serial numbers: 340094 to 340125
Risks Identified: Defective hoses may result in serious injury or death.

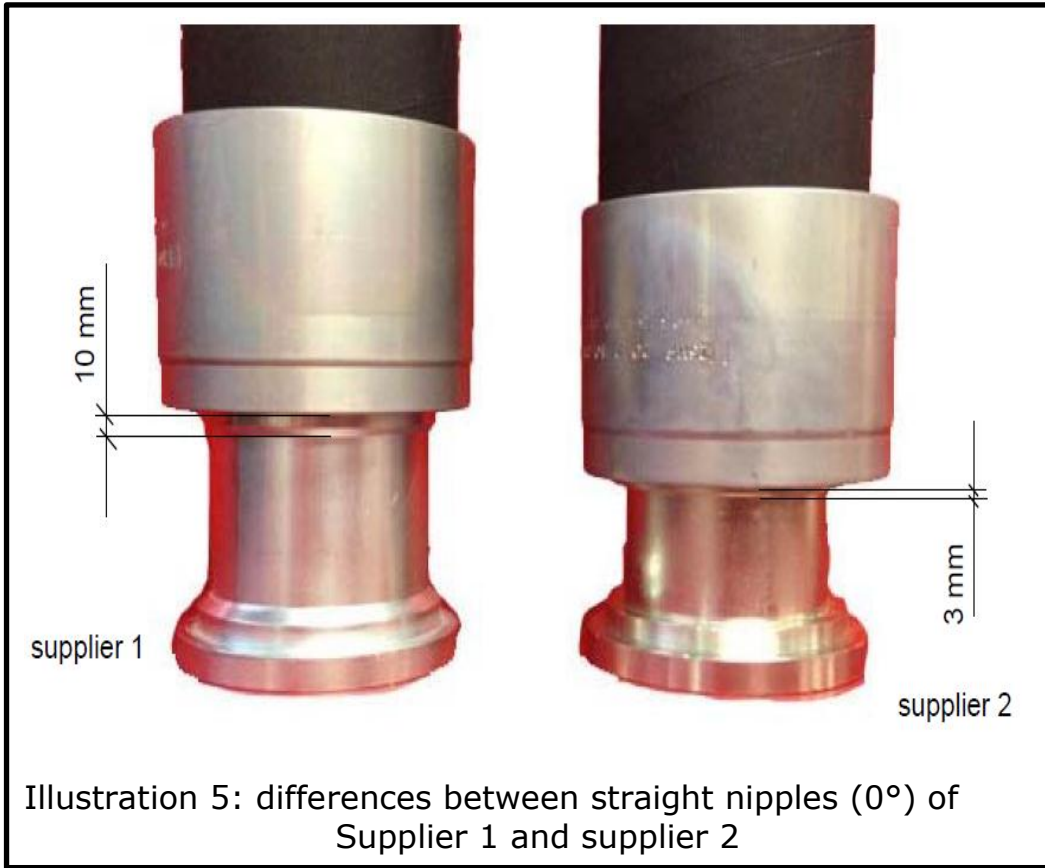
Possible Combinations of nipples and sleeves		
	sleeve supplier 1	sleeve supplier 2
nipple supplier 1	good crimping	bad crimping
nipple supplier 2	bad crimping	bad crimping

Illustration 4: **Supplier 2** sleeve always with two machined rings on circumference. (**Bad**)

1. Inspect machines in the affected serial number range. If the inspection shows defective hoses are fitted, replacement hoses must be ordered and fitted immediately.
2. Inspect parts stock holdings of affected part numbers shown in this bulletin. Defective hoses identified in this inspection must be replaced.
3. Destroy defective hoses by cutting the hose at the crimped fittings at each end to render the hose unusable and attach a picture of destroyed hose to the warranty claim.
