TECHNICAL REPORT

Edison amplifier horn restoration
John Bump

Introduction

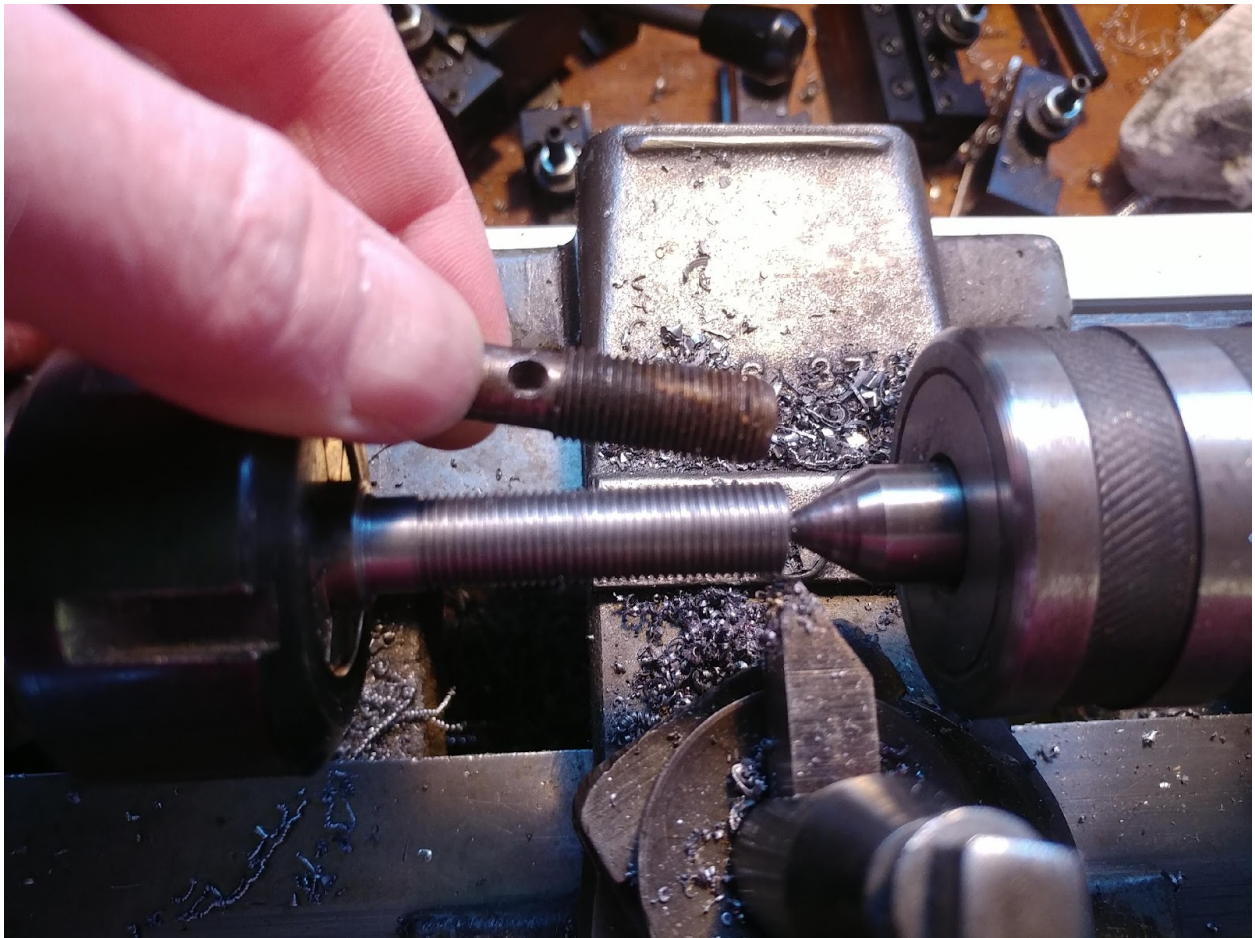
Fig. 2: can cut threads great, can't focus the camera

I cut this as an all thread stub, with a chamfer on each side, in some mystery steel (probably 12L14) and as it turns out it is approximately 7/16-24tpi. Thread form is

60 degree taper with a slight rounded root, as per SAE standard.

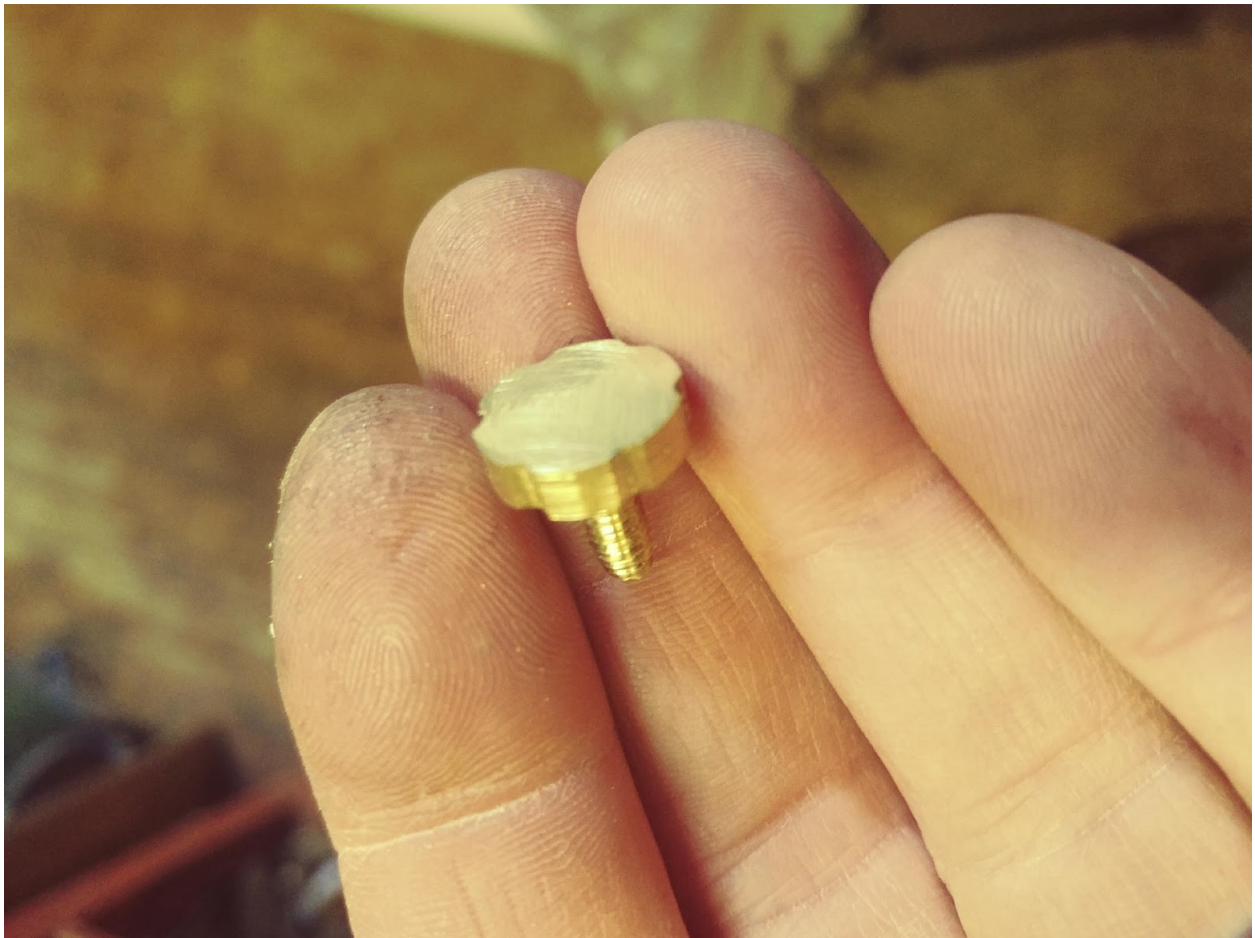
Fig. 4: one thumbscrew, 10-24.

The thumbscrews were cut on the lathe, threaded, moved to the mill and grooved for increased gription, then moved back to the lathe and parted off. They're in brass with chamfered ends so they don't damage the steel threads, as they bear on the sharpest/weakest part of the steel thread.

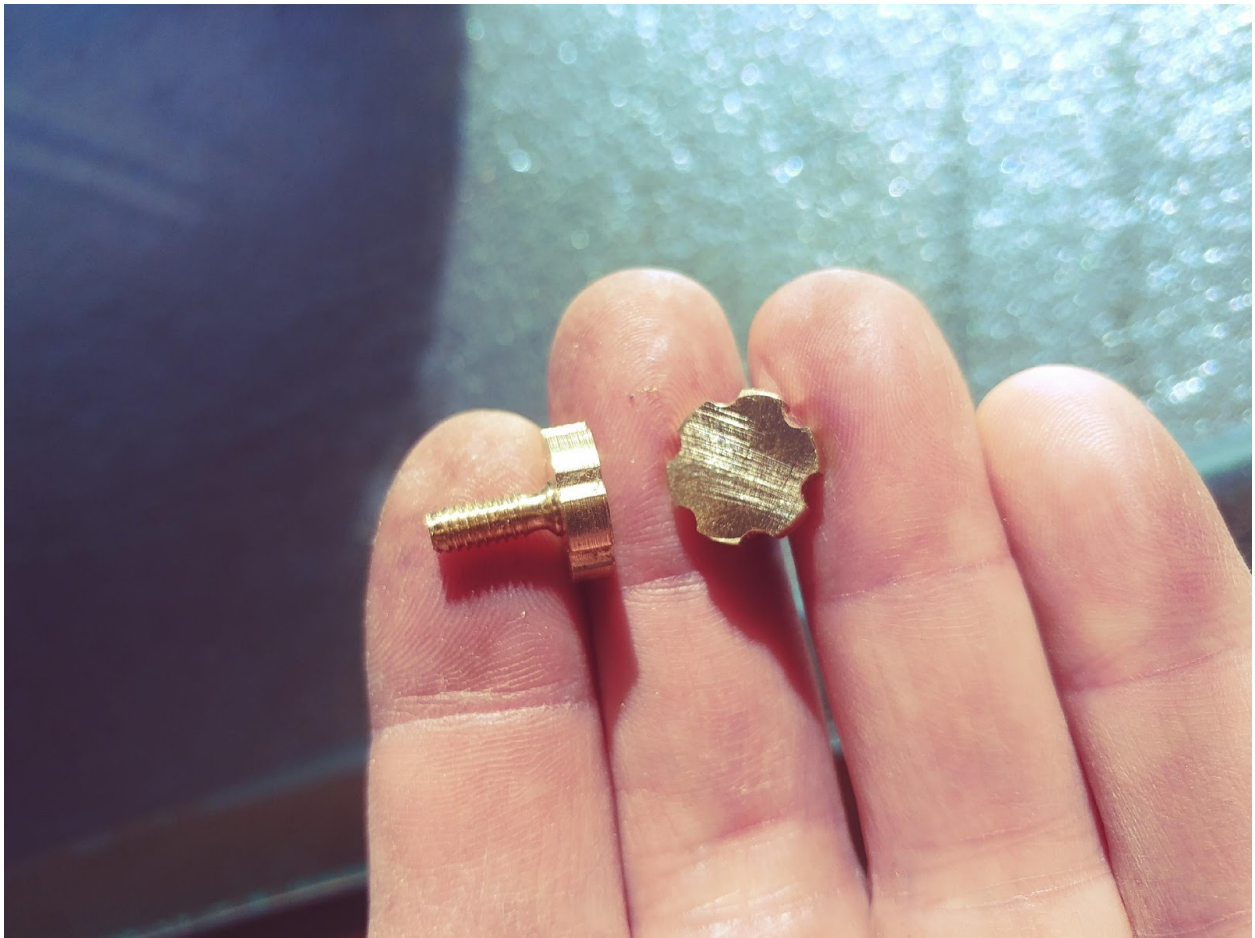
Fig. 5: both screws.

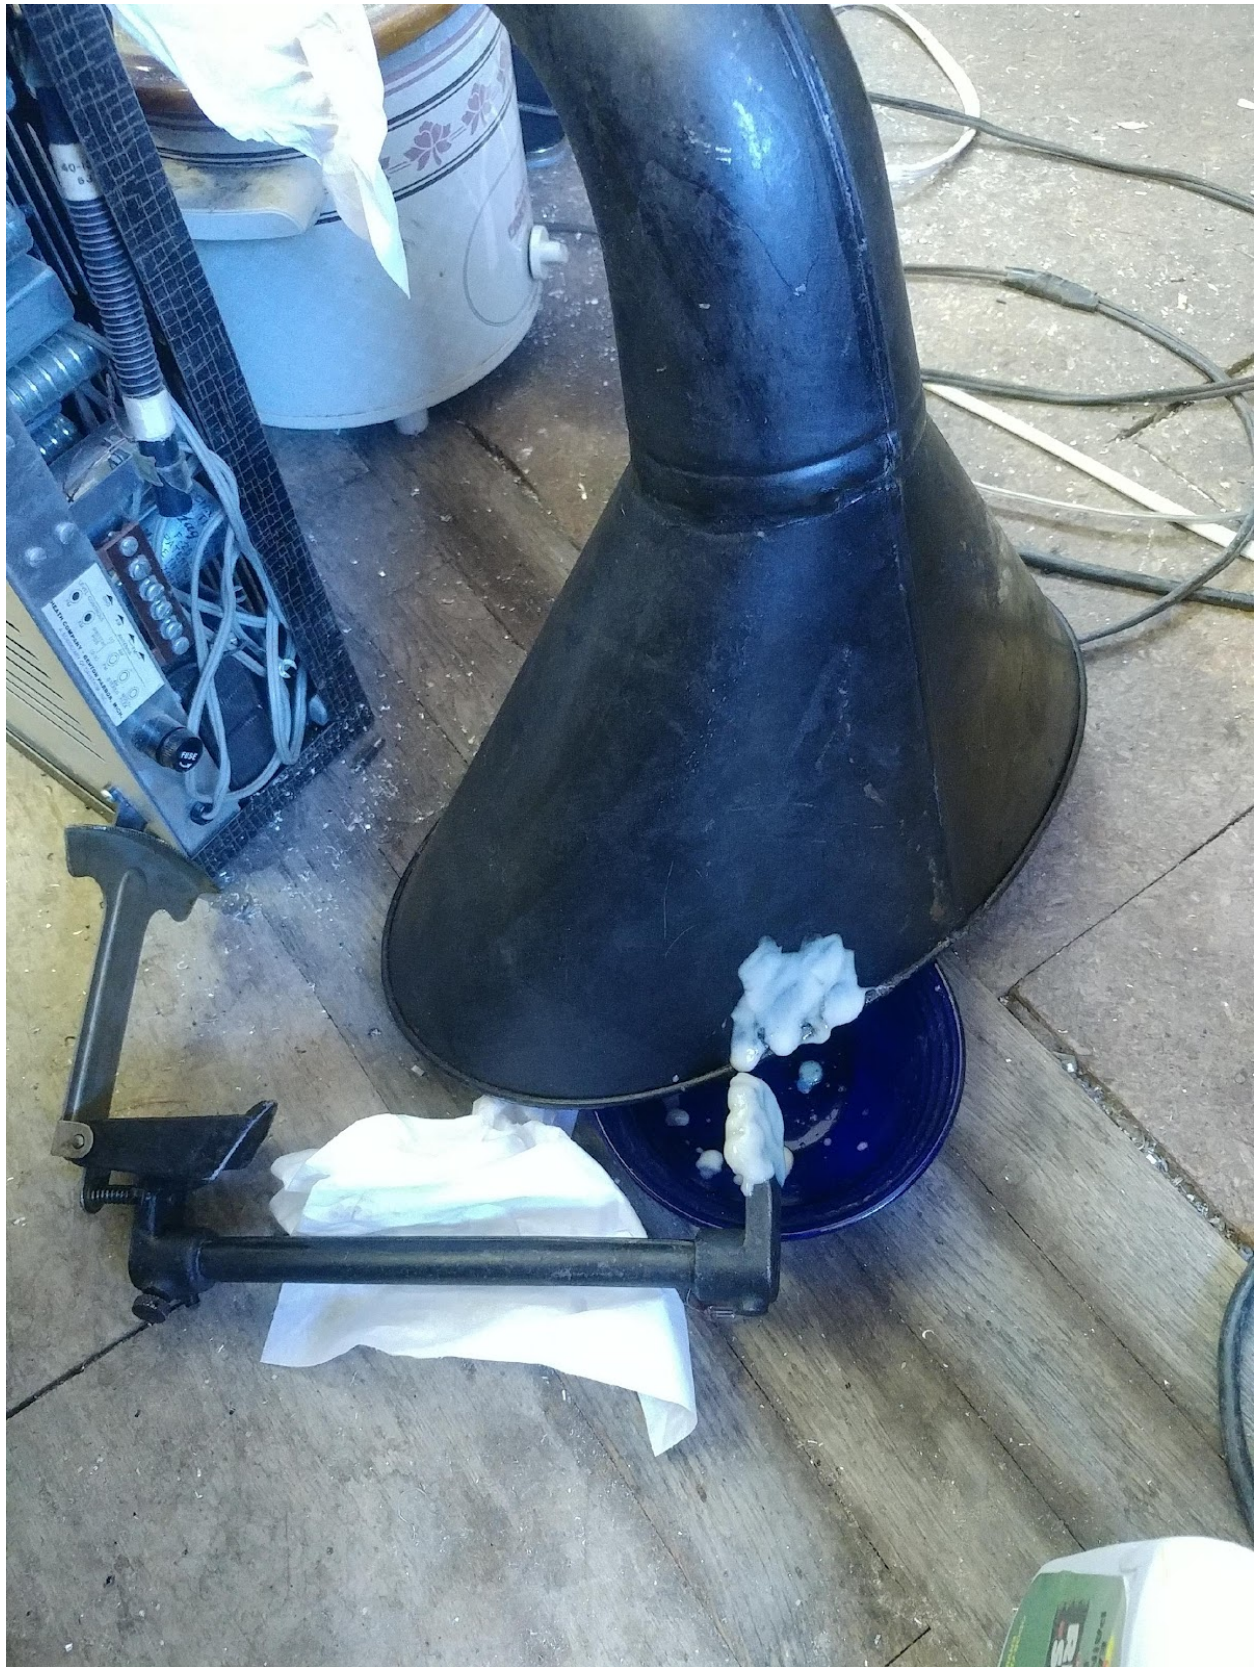
Fig. 8: more stripping.

This stuff worked well. The horn needed to have the coating stripped on inside and outside of each solder joint (bottom and top) and the brackets similarly needed their contact points with the horn and with each other stripped prior to re-soldering.

All joints were wire brushed post-stripping in preparation for re-soldering.

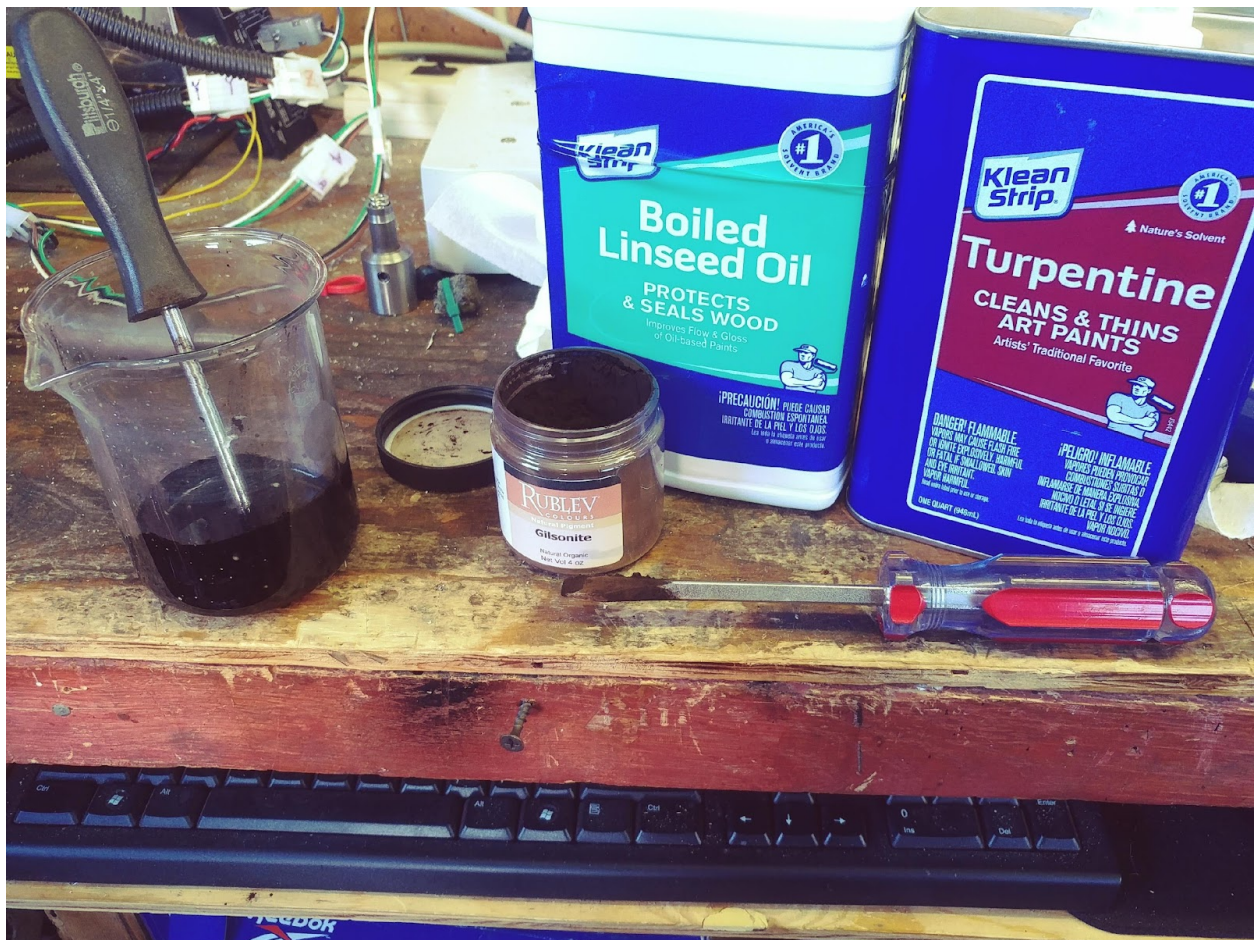
Fig. 13: vile brew

Emily Velasco suggested a YouTube video by a guy who had worked with it a bunch and had some recipes. What I ended up using was a 4:1 ratio of turpentine and linseed oil and adding gilsonite to that.

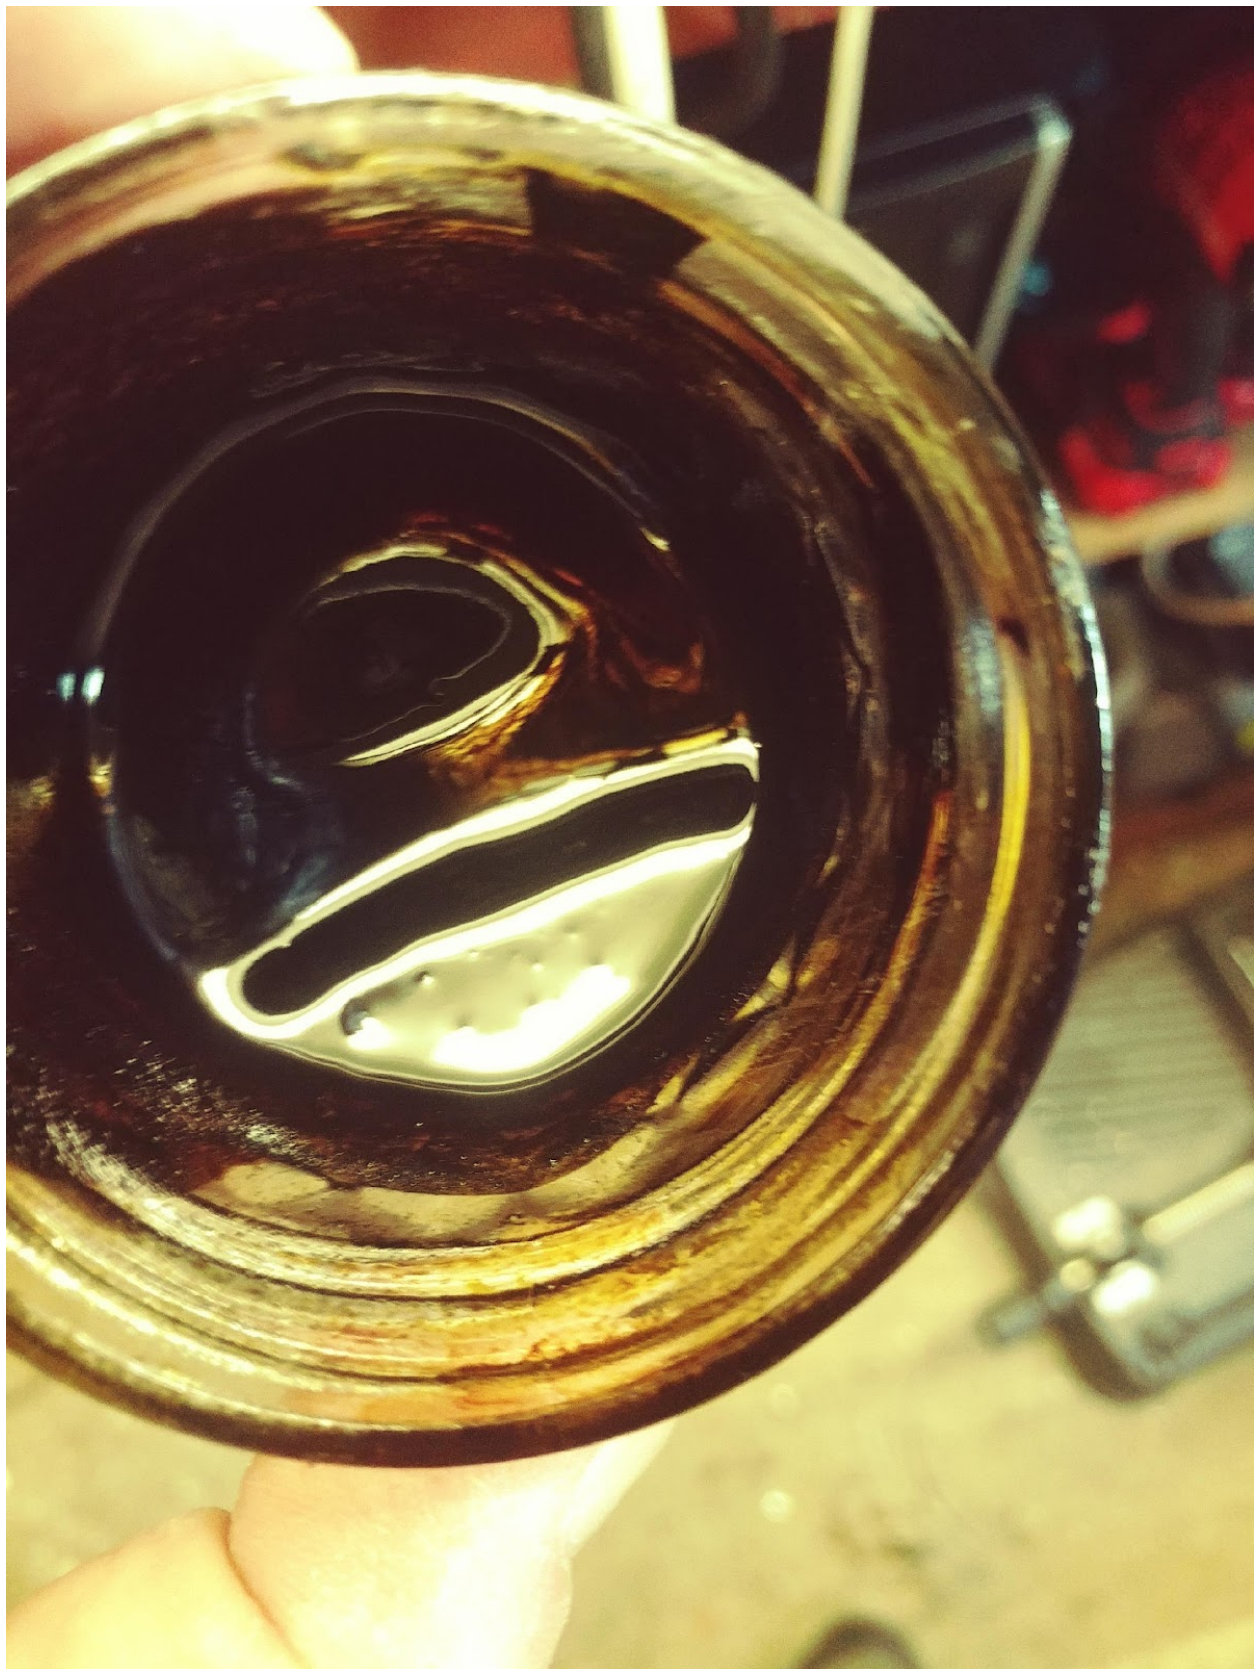
Fig 15: consistency of molasses.

This is the mix I used on the pivot extension. It's very thick and not smooth. So the second time, I made the same mix of the liquids, added the recommended amount of asphaltum, and used a stirring hotplate to mix it. At a heat of 45C, with low stirring, after maybe five minutes it fairly quickly dissolved fully and became a molasses-like mix that painted on very nicely.
