## Vehicle Inspection Checklist

Robbie White / Jason Reyes / 21 Jun 2023

| Enter identification type | | Ford Everest 2015 Dark Blue |

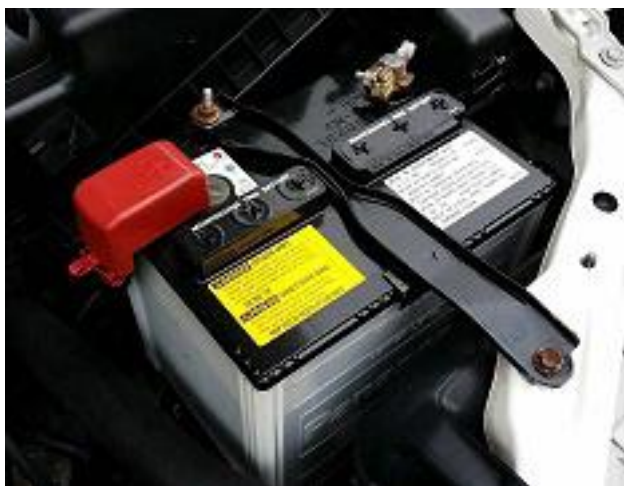
Photo 3

| <b>Battery</b> | Needs Repair |

REFERENCE: Vehicle Battery clean and maintained regularly  
[This is an example of how you can use iAuditor to include best practice reference images in your templates to assist with inspections]

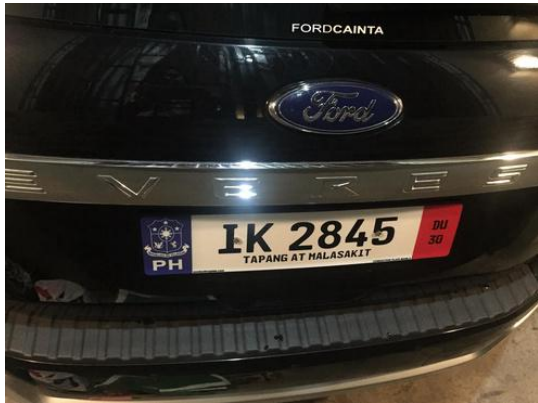
Photo 1

| Enter License Plate No. | | IK 2845 |
