# Leveraging Destructive Testing for Complex Cracking in LF-ERW; Case Study Phase II

## Abstract

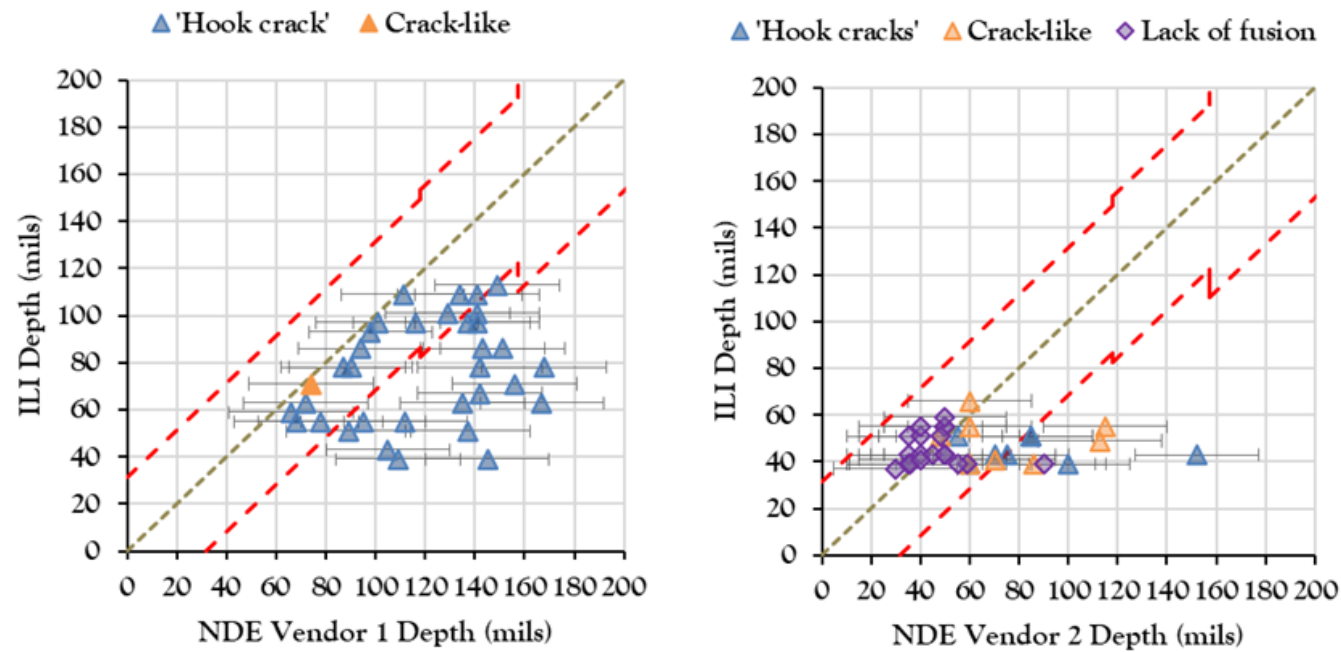
Figure 13 – Unity plot for NDE Vendor 1 (left) and Vendor 2 (right) results compared to ILI results

The starting point of this investigation was the NDE result list from Vendor 1 where 33 anomalies were identified as 'hook crack' in the field and the depth sizing of these anomalies were raising concern about the performance of the ILI tool used for the inspection. As can be seen in Figure 13 the unity plot for ILI reported depth compared to the Vendor 1 NDE depth shows a clear tendency for the ILI tool to underestimate the field verified depths. It needs to be noted that Vendor 2 results were taken using TFM methodology after Phase 1 of this investigation was published. The dashed red lines in the following figures are the tool tolerances specified in the NDT Global performance specification at 80% confidence level and each anomaly error bar is based on a field depth tolerance of ±25 mils at 80% confidence level.

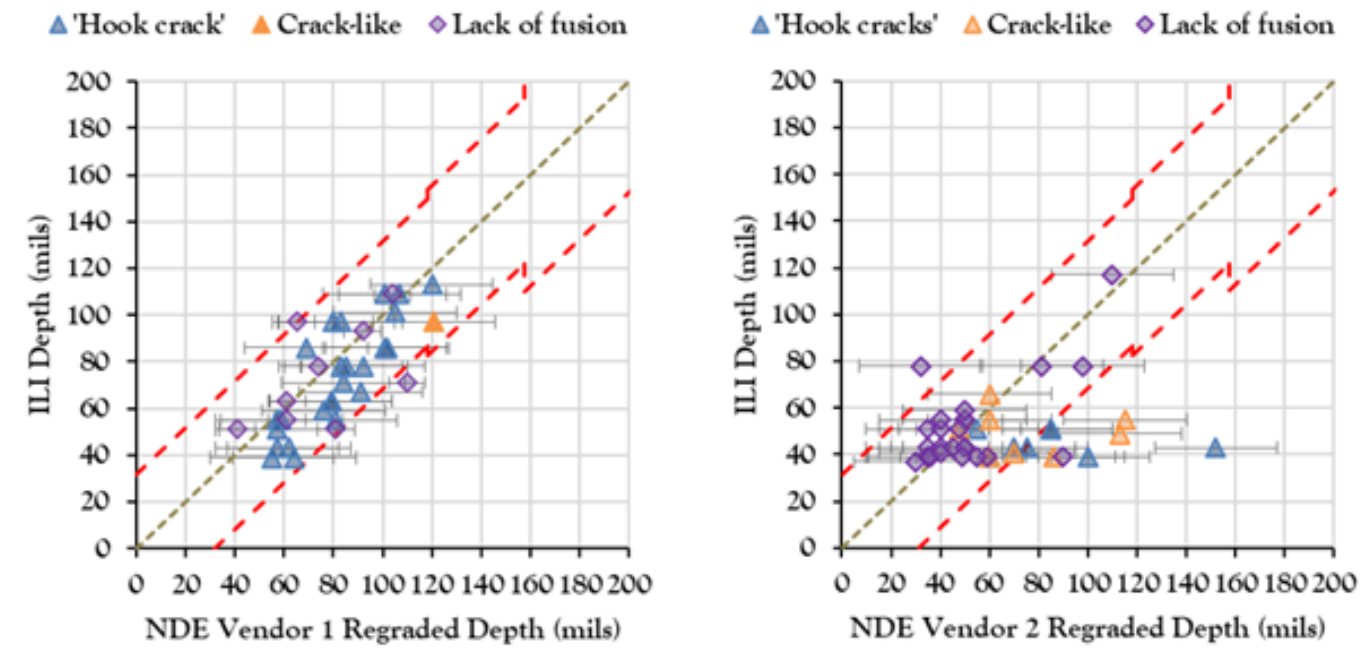
Figure 14 – Unity plot for NDE Vendor 1 (left) and Vendor 2 (right) regraded results compared to ILI results

The laboratory destructive test results were shared with the NDE vendors to give them the opportunity to review the field data and adjust the identification and depth sizing of the reported anomalies based on the metallurgical results. Figure 14 shows the unity plot for ILI reported depth compared to the Vendor 1 and Vendor 2 NDE reviewed depth based on the lab results. It can

be observed that on the right-hand side, the regraded depths for the Vendor 1 field data are close to what the ILI tool properly sized in the first instance. The regraded depths for Vendor 2, which were sized using the TFM method, have very little changes. In addition, Vendor 2 added some additional anomalies observed in the field that were also included in the ILI results list.

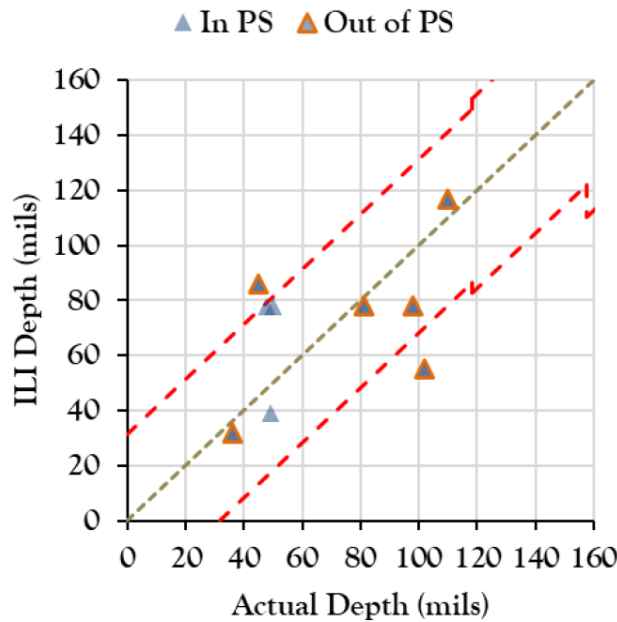
Figure 15 – Unity plot for laboratory results compared to ILI results

Following the same idea, as can be seen in Figure 15, the ILI depth results compared to the anomalies' actual depth based on the metallurgical report show that the 6" high resolution UT tool was properly sizing the anomalies and no regrade was needed. Anomalies depicted with an orange edge are anomalies out of the performance specification (PS) of the tool by length and/or depth, meaning that their actual depth was lower than 39 mils and/or their actual length was lower than 0.98 in. at the time of the inline inspection.

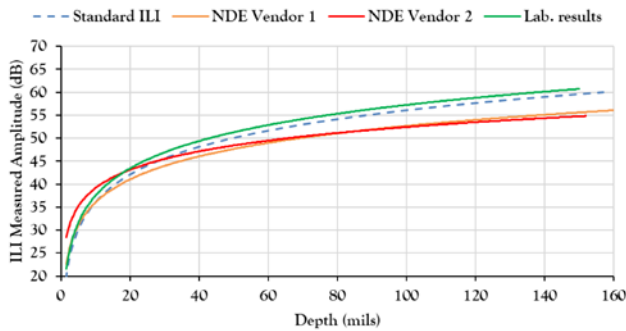
Figure 16 – Different sizing curves based on the NDE results from Vendor 1 and 2, and the measured amplitudes for the ILI anomalies

If the original NDE Vendor 1 and Vendor 2 results are plotted against the reflected amplitude of the anomalies in the ILI data, different sizing curves can be obtained based on each NDE population. Sizing curves establish the relation between the amplitude recorded by the ILI tool and the predicted depth of the anomalies. Figure 16 shows the laboratory depth results in front of these different sizing curves. It can be observed that the ILI standard sizing curve (blue dashed line) is the best fitting to the truth depth results sizing curve (green line).

Modifying ILI sizing curves based solely on NDE results can lead to significant inaccuracies (Figure 16), introducing a general bias in depth estimations. Adjusting ILI sizing curves should rely exclusively on ground-truth data obtained from confirmed, peer reviewed sources, and, preferably, direct measurements (e.g., destructive testing). Additionally, such adjustments must be treated as specific to the asset in question, ensuring data relevance and integrity.

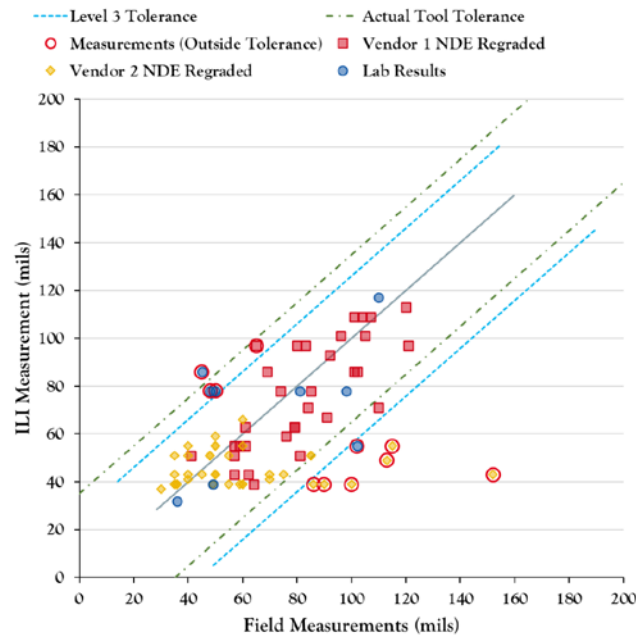
Figure 17 – Level 3 validation unity plot for lab results and NDE vendor 1 and 2 regraded results in front of the ILI results

The findings are based on the regraded NDE results from Vendor 1 and 2, and on the laboratory results. Which add up a total of 80 anomalies. 72 of the 80 measurements were within tolerance, yielding pupper = 94.42% and plower = 82.96%. These results exceed the certainty of 80%, corresponding to Outcome 3 of the level 2 validation described in API Standard 1163:2021. The ILI performance specification is feasible.

There are sufficient field results to proceed with a level 3 validation analysis. Level 3 validation analysis, as described in API Standard 1163:2021, seeks an estimation of the actual ILI performance as indicated by the available validation measurements. The statistical evaluation concluded that the tolerance interval for a given ILI measurement is [-26 mils, 44 mils]. Therefore, the actual tool tolerance is  $\pm 35$  mils with a certainty of 80%.
