Railway Electrocution Monitoring

LIFE DANUBE FREE SKY (LIFE19 NAT/SK/001023)

Final Report

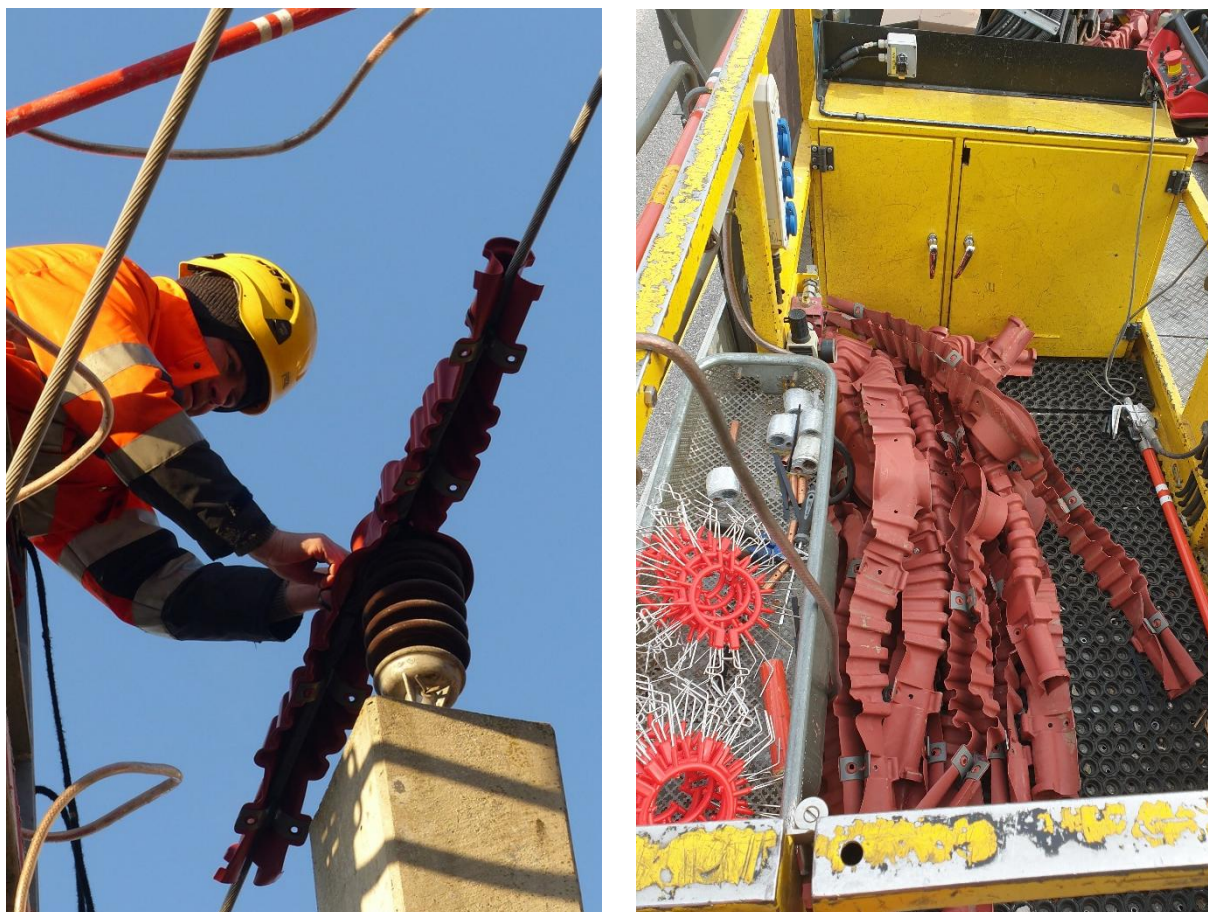
Figure 1: Installation of bird protection devices: **a)** mounting of protective caps on railway pylon top insulator (Photo: Renate Wunder); **b)** protective caps (center) and Animal Guards (bottom left) prepared for installation work (photo: ÖBB Infrastruktur GmbH)

The goal of our study was to assess the effectiveness of protective measures against electrocution taken within the framework of the LIFE DANUBE FREE SKY project. Within the scope of the project, ÖBB Infrastruktur GmbH retrofitted 1,263 pylons, or 63,1 km of railway lines respectively, according to current standards (T. Schuh, pers. comm.). To this end, protective caps have been installed to the insulators on the pylon tops (Figure 1). These caps prevent birds and climbing animals from getting in contact with current-carrying parts of the line while sitting on top of the pylons or the insulators. Furthermore, the lower insulators at the bracket arms (supporting the contact and messenger wire) have been equipped with Animal Guards (see Figure 1b). These devices, mounted on the insulators, prevent animals from sitting on or crossing the insulator by administering small electric shocks, comparable to an electric fence.

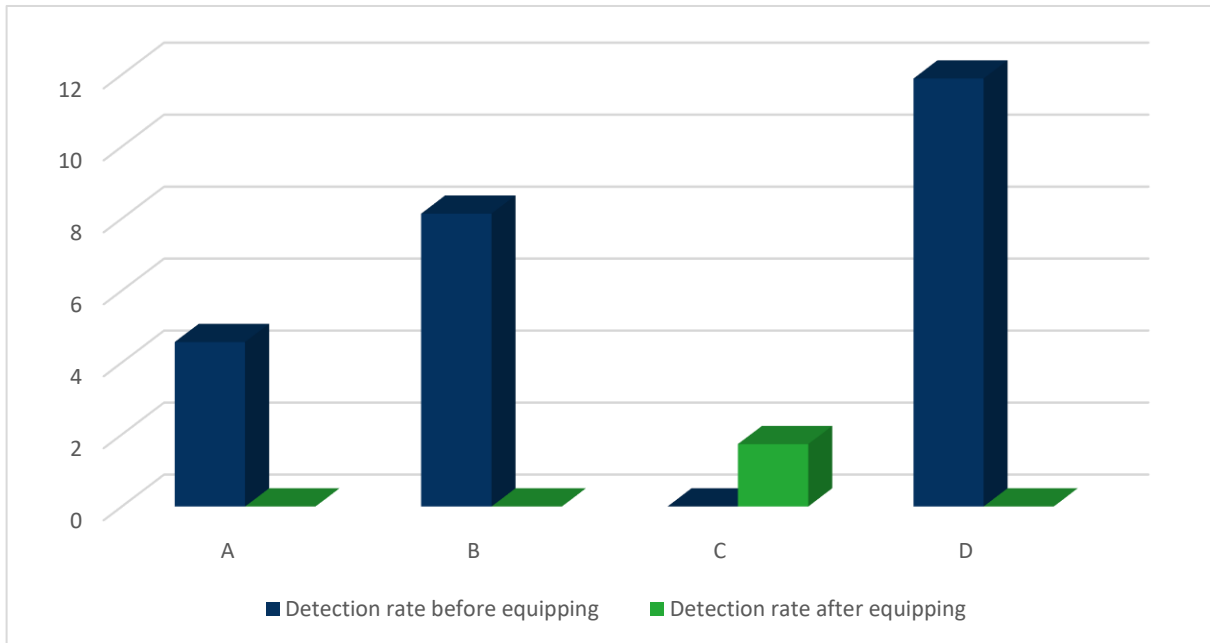
Figure 14: Comparison of detection rates (findings per 100 000 pylon days) before and after equipment of BPD in the four subsections on KMSYS94

The detection rate across all evaluable sections combined was 5.27 finds per 100 000 pylon-days. This rate was considerably higher than the post-installation detection rate of 0.59 finds per 100 000 pylon-days. Figure 14 and Table 2 provide the detailed data of all four sub-sections.

In section C of KMSYS94 (Gattendorf train station to Pama train station), no electrocution victims were detected before equipping (detection rate 0). After equipping, one case was recorded, corresponding to a detection rate of 1.73 finds per 100 000 pylon-days.

In section D of KMSYS94 (Pama train station to Kittsee train station), the detection rate before equipping was 11.89 finds per 100 000 pylon-days (five victims). After equipping, no further electrocutions were recorded, resulting in a detection rate of 0.

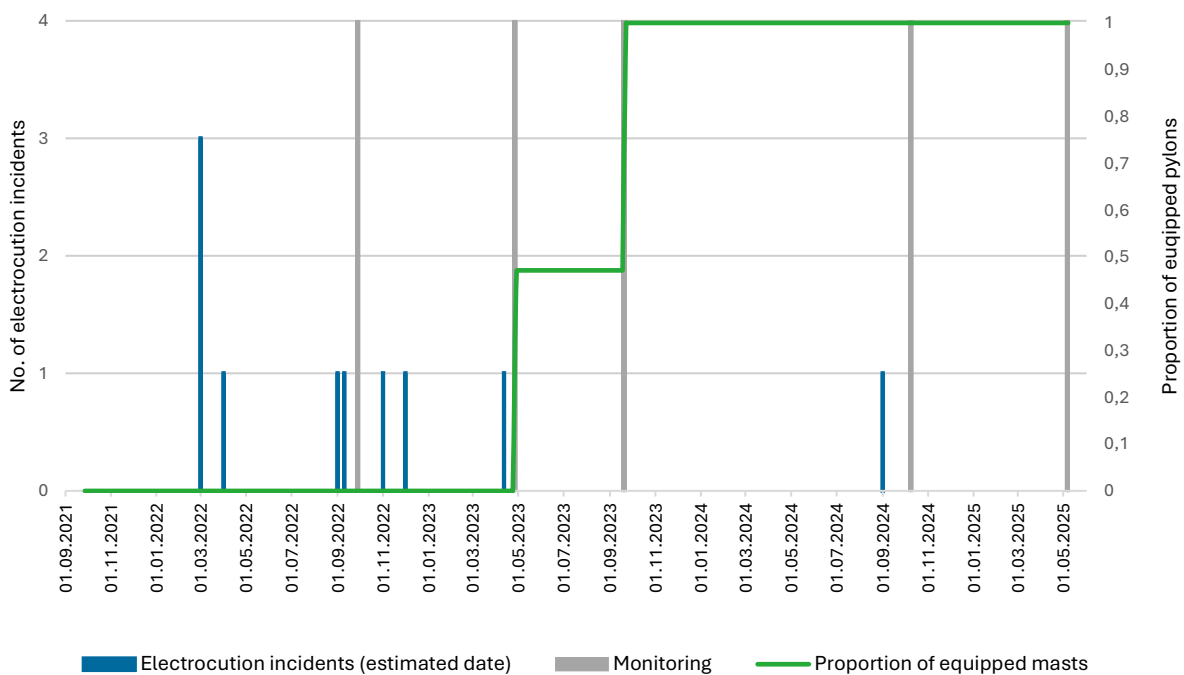
Figure 15: Electrocuting monitoring Parndorf-Kittsee before and after equipping the pylons.

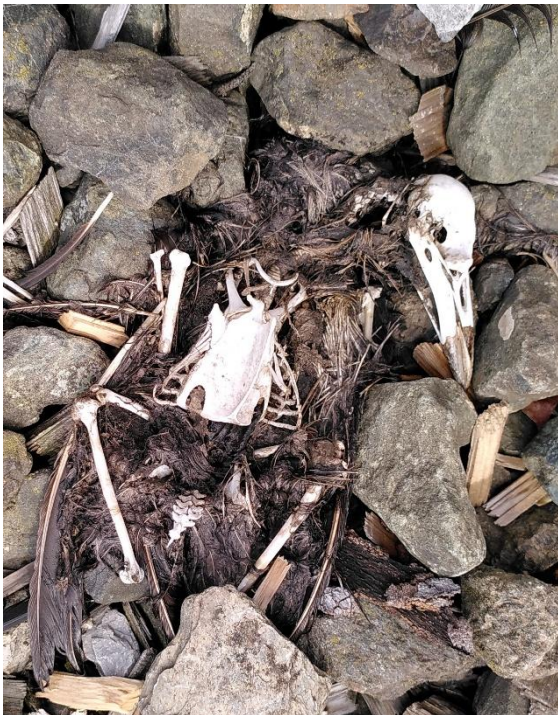
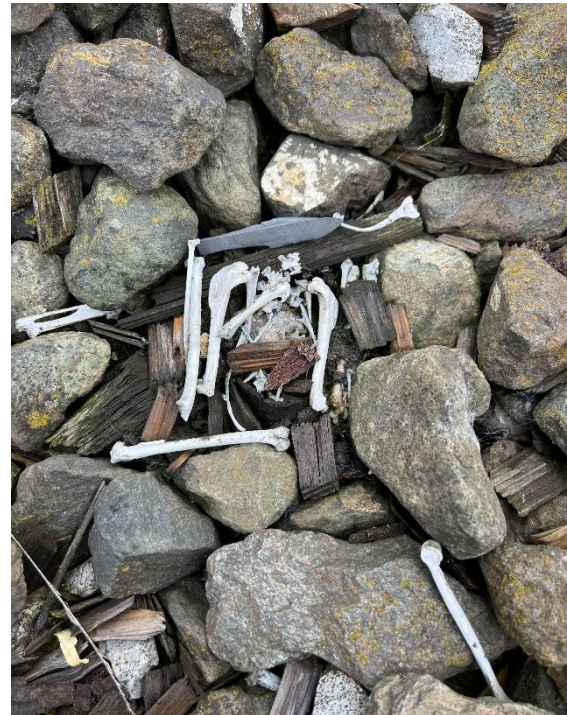
Figure 17a,b: Decomposition progress of a Carrion Crow carcass between 26-09-2022 and 05-05-2025 (952 days)

The estimates for mortality dates are based on expert opinion and are therefore prone to errors. We tried to minimize the estimation error by different means. Assessment was made by experienced staff working on bird carcasses for multiple years. Furthermore, we carried out cross-checks on carcass photos with known approximate time of death (from repeated detections of the same carcasses, compare Figure 17). In this way, we could calibrate our assessment to the site-specific conditions and estimate our error. Based on these cross-checks,
