MC8704

T3_0_2_1AP & T3_0_2_1BT

Release Notes & Upgrading Instructions

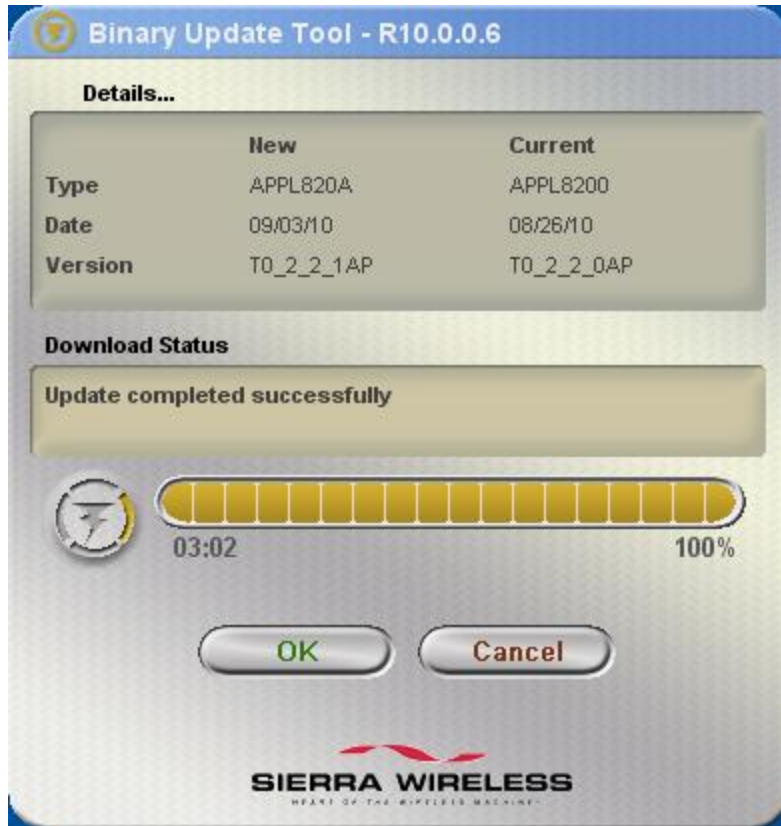
NOTE: The download can take up to 10 minutes to complete. Do not remove the power to either the laptop or the card until the Binary Update Tool announces that the upgrade has been successful, as shown here:
