**SWI6600S\_02.04.04.00**  
**Customer Release Note**

**[SL9090/MC9090]**

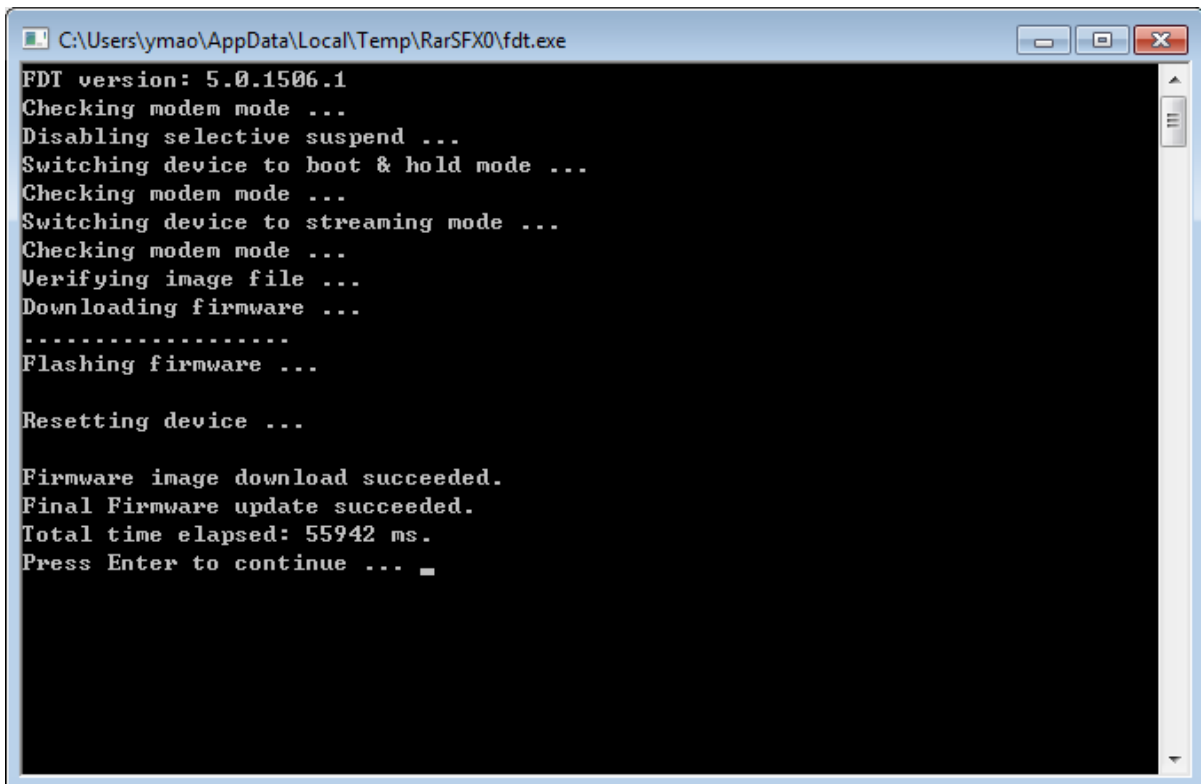
1. If USB driver is not installed. Unplug the USB cable of SL9090 module, run the USB driver SWIQMISetup and reset PC.
2. Power on the modem and plug USB cable to computer.
3. Make sure the boot loader is SWI6600X\_02.00.02.02BT or higher. Open AT terminal, input AT!BCINF to get the boot loader version.
4. Close all applications using the modem such as Connection Manager, HyperTerminal, QXDM, etc.
5. Double click one of the exe files (SPKG exe is recommended) to download the FW.
6. After downloading finished, the output as below:

```
C:\Users\ymao\AppData\Local\Temp\RarSFX0\fdt.exe
FDI version: 5.0.1506.1
Checking modem mode ...
Disabling selective suspend ...
Switching device to boot & hold mode ...
Checking modem mode ...
Switching device to streaming mode ...
Checking modem mode ...
Verifying image file ...
Downloading firmware ...
.....
Flashing firmware ...
Resetting device ...

Firmware image download succeeded.
Final Firmware update succeeded.
Total time elapsed: 55942 ms.
Press Enter to continue ...
```
