MGOS 4.4.3

RELEASE NOTES

About MGOS 4.4.3

MGOS 4.4.3 includes updates specifically for customers with MG90 5G routers containing EM9190 5G radio modules.

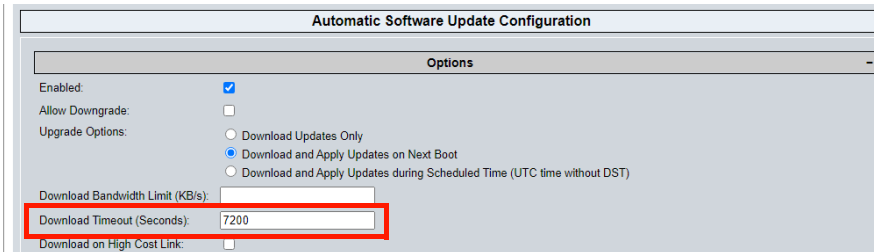
In Download Timeout (Seconds), enter 7200.

The screenshot shows the 'Automatic Software Update Configuration' page. The 'Options' section is expanded. The 'Enabled' checkbox is checked. The 'Allow Downgrade' checkbox is unchecked. Under 'Upgrade Options', three radio buttons are present: 'Download Updates Only' (unchecked), 'Download and Apply Updates on Next Boot' (checked), and 'Download and Apply Updates during Scheduled Time (UTC time without DST)' (unchecked). The 'Download Bandwidth Limit (KB/s)' field is empty. The 'Download Timeout (Seconds)' field is set to 7200 and is highlighted with a red box. The 'Download on High Cost Link' checkbox is unchecked.

1. Go to General > Auto Software Updates.
2. Semtech recommends setting the download timeout value to 7200 s, to ensure the download completes in one attempt. (Otherwise, if the download times out, it will resume at the next opportunity — for example, when the active link changes, the next scheduled update window, when the device reboots, etc.)
