MC8704
T3_0_4_1AP & T3_0_4_1BT

**Release Notes &
Upgrading Instructions**

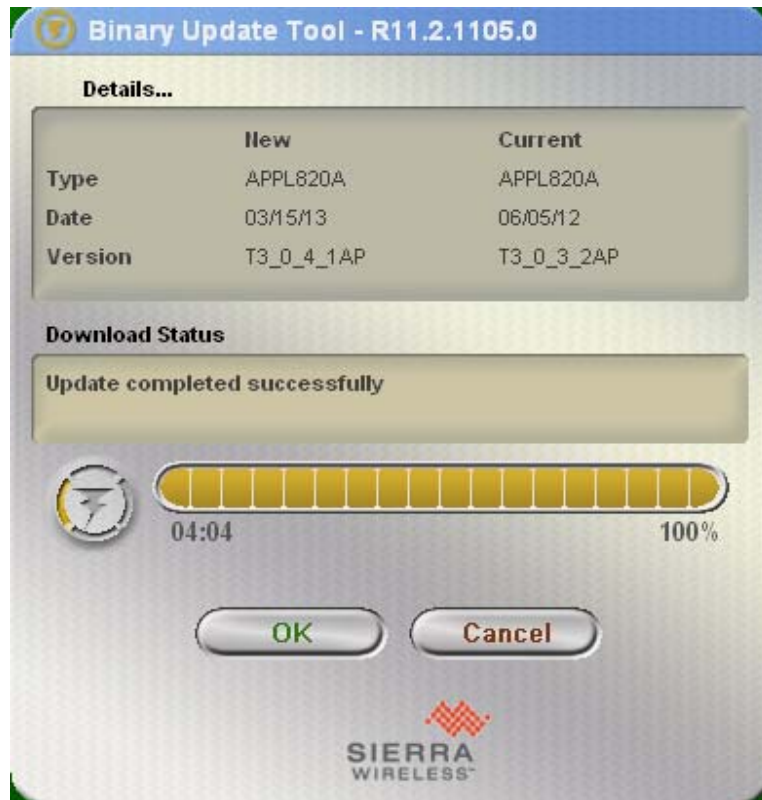
NOTE: The download can take up to 10 minutes to complete. Do not remove the power to either the laptop or the card until the Binary Update Tool announces that the upgrade has been successful, as shown here:
