TAPPING

Direct Service Connection Installation Comparison Ductile Iron Pipe vs. Polyethylene Pipe

by Richard W. Bonds, P.E.

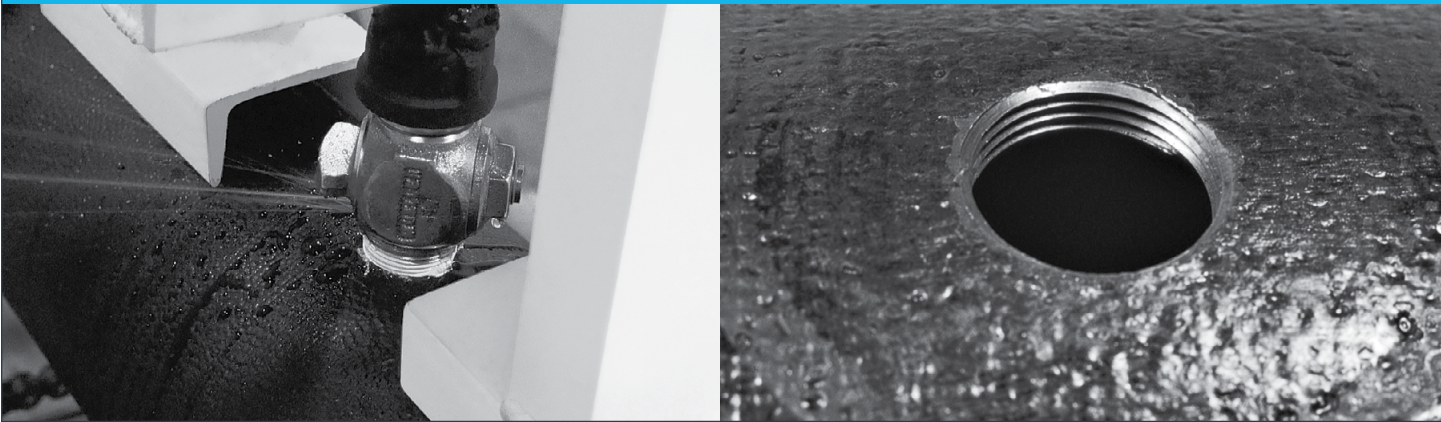
FIGURE 2

Pull-Out Test — Ductile Iron Pipe

Forces exerted during pull-out tests, when sufficient, resulted in failure of the corporation stop, not the Ductile Iron Pipe or threads. The photo on the left shows leakage at the plug key of the corporation stop. Ultimate failure occurred to the corporation stops’ threaded connection for the service line. The undamaged Ductile Iron Pipe and threads are shown on the right.

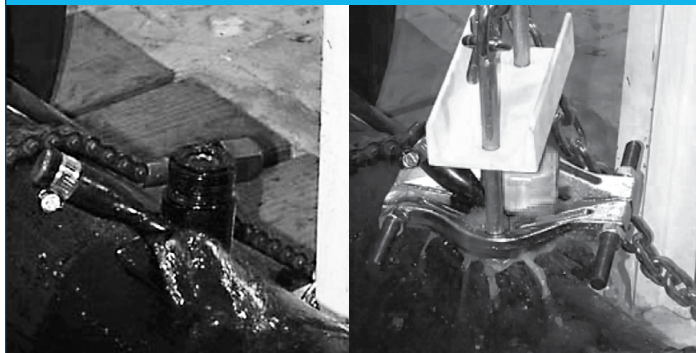
FIGURE 4

Pull-Out Test — Polyethylene Pipe

The pull-out tests on the polyethylene specimen resulted in leakage at the cutter cap of the butt tap tees, rolled threads on the cutter caps, and destruction of the butt tap tees at an average of 1,065, 1,638, and 2,973 pounds of pulling force, respectively. Such failures in the field would require the pipeline to be taken out of service and a section of the polyethylene pipe cut out and replaced. Simple or quick mechanical clamps/couplings/sleeves might not work well on HDPE, and butt-fusion repair might be necessary – but not easy to accomplish – in some field conditions.
