SITE PRACTICE & TROUBLESHOOTING

EFFLORESCENCE

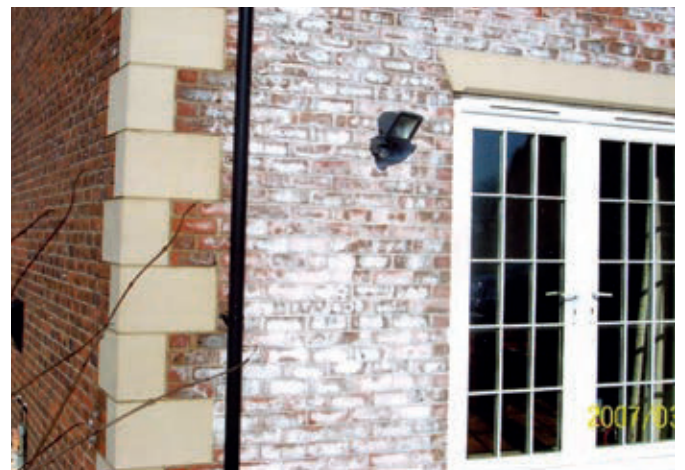
- Bricks should be stacked onto a clean, firm level surface. They should be protected from rain, mud splashes etc. by covering with waterproof sheeting.

The first 3 to 5 days after laying (dependent on season), brickwork is most vulnerable to the elements as mortar is still undergoing the hardening process. Newly erected masonry should be covered by waterproof sheeting to protect fresh mortar and open cavities to stop masonry becoming saturated. Hessian is not waterproof. Once the structure is watertight, i.e. roof and windows in place, the building can commence the drying process.
