# Greater Manchester's Clean Air Plan to tackle Nitrogen Dioxide Exceedances at the Roadside

## Note 20: Greater Manchester Specialised Goods Surveys: Results Summary

Salford City Council

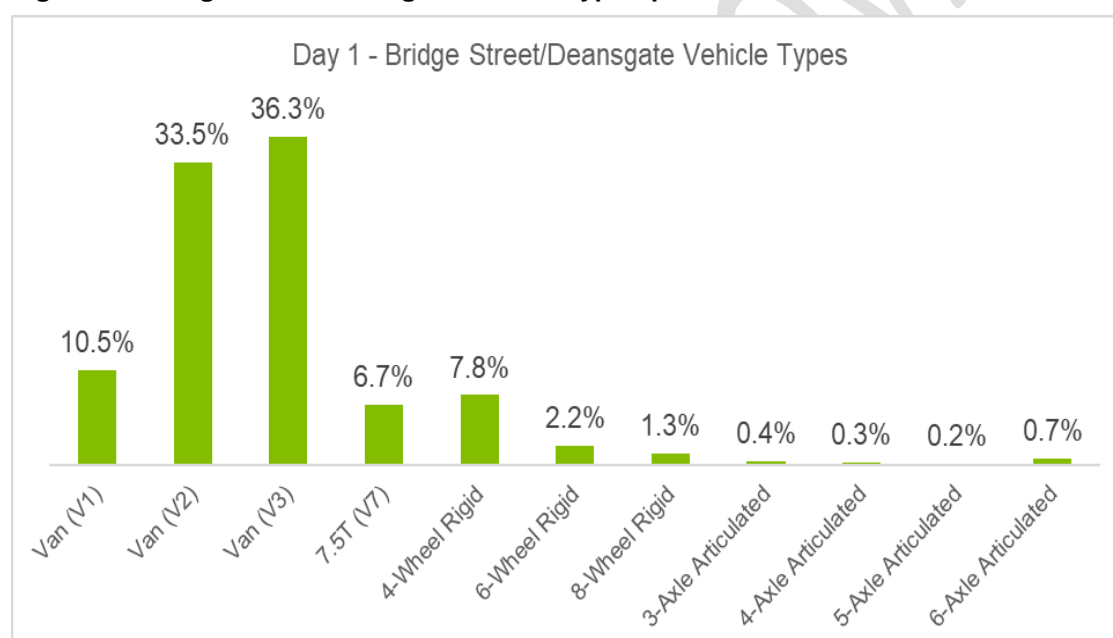
**Figure 2-2 Bridge Street/Deansgate Vehicle Type Split**

2.2.1 **Figure 2-2** below shows the split of vehicle types observed at the Bridge Street site.

2.2.2 Vans dominate in this location, which is expected given it's the proximity of it to the city centre. Where there were observations of HGV traffic, this was dominated by 4-wheel rigid lorries. Articulated lorries made up less than 2% of the total observations at the site.

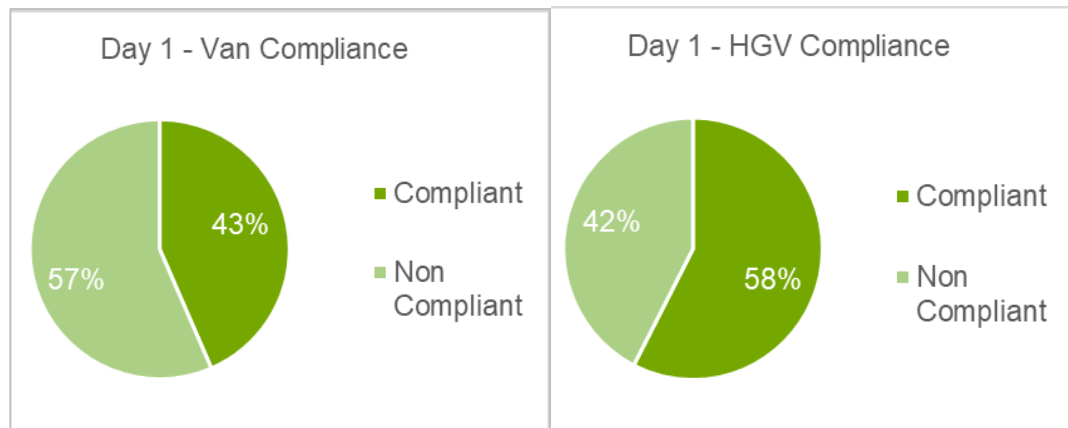
**Figure 2-3 Bridge Street/Deansgate van compliance split**

2.2.3 **Figure 2-3** below shows the split of vans and HGVs separately at this location based on their compliance with clean air regulations.

2.2.4 While the majority of vans are non-compliant (57%), this is not the case for HGVs, where 58% of observations were of compliant vehicles.

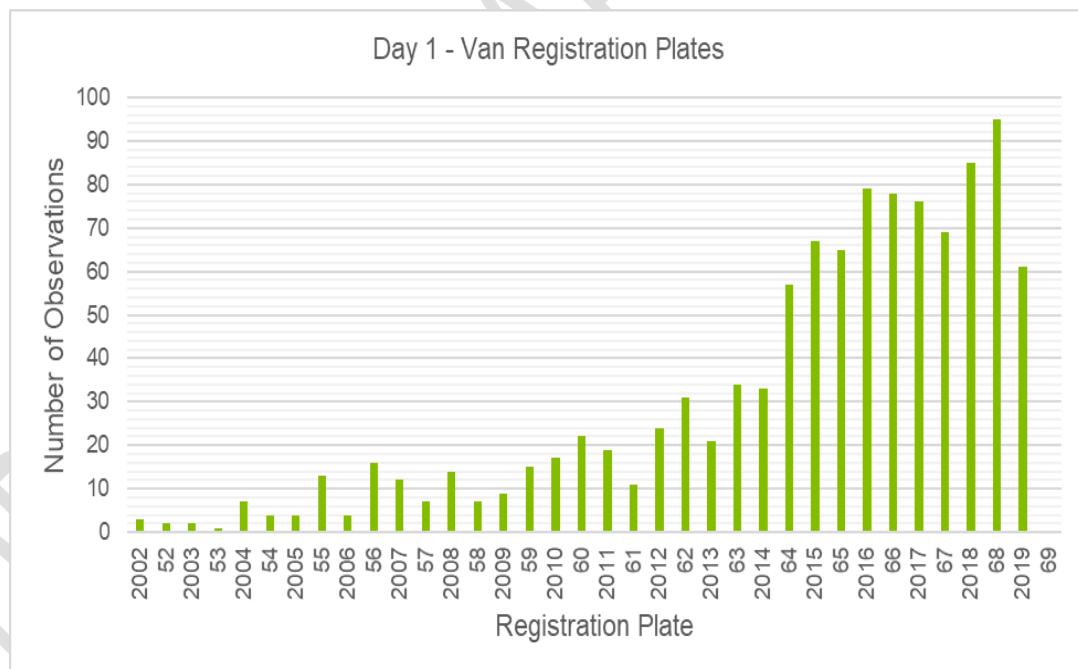
**Figure 2-4 Bridge Street/Deansgate van registration years**

2.2.5 Further, **Figure 2-4** and **Figure 2-5** below shows the total observations by year of registration at this site, where red bars represent registrations which are non-complaint, and blue bars represent registrations which are compliant.

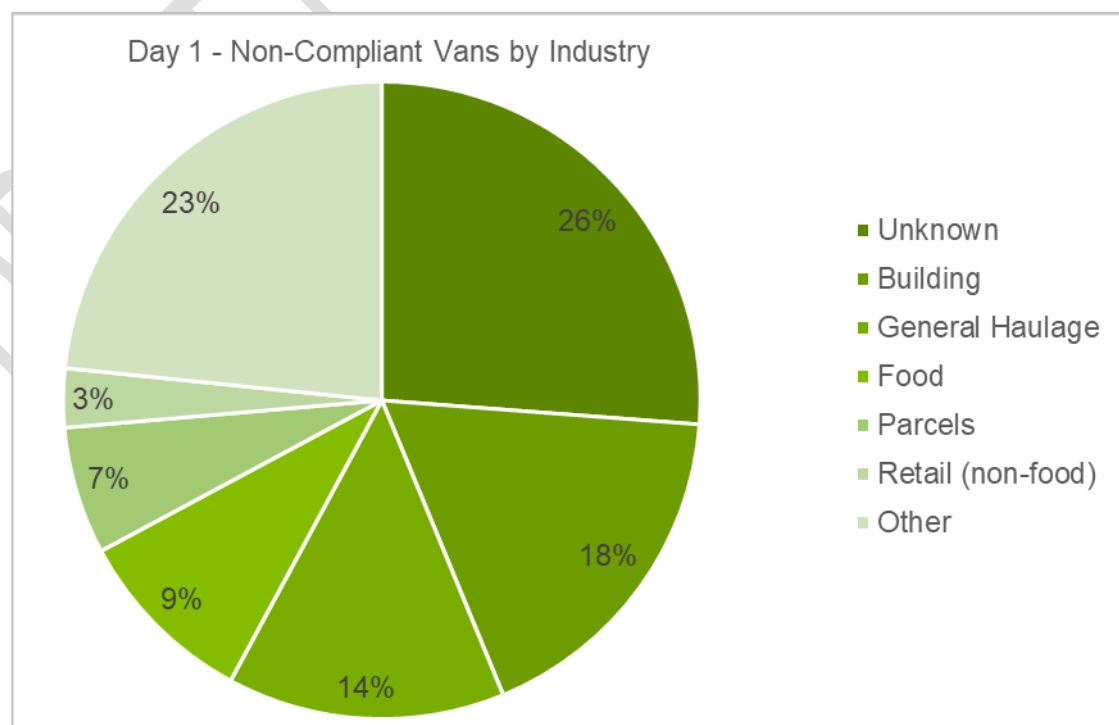
**Figure 2-6 Bridge Street/Deansgate non-compliant vans by industry**

2.2.8 Of the non-compliant vans, it can be seen here that there is a high prevalence of unmarked vans that could not be categorised to a particular sector (26%). The largest proportion of non-compliant vehicles attributable to an industry comes from the building and construction industry (18%). General haulage accounts for the second largest proportion of non-complaint vehicles (14%). The food industry (9%), the parcel/post industry (7%), and the non-food retail sector (3%) also make up notable proportions of the non-compliant vehicles.

2.2.9 The 23% of non-compliant vehicles listed as 'other' above are made up as follows:

- 14% as 'other' – vehicles that could not be categorised into one of the industries used in this survey;
- 3% as vehicles linked to utilities;
- 2% as vehicles linked to waste;
- 2% as vehicles linked to the vehicle and automotive industry;
- 1% as vehicles linked to the media and telecommunications industry;
- 1% as vehicles linked to the drinks industry; and
- Less than 1% each linked to the manufacturing, agricultural, chemical, container, and steel industries.

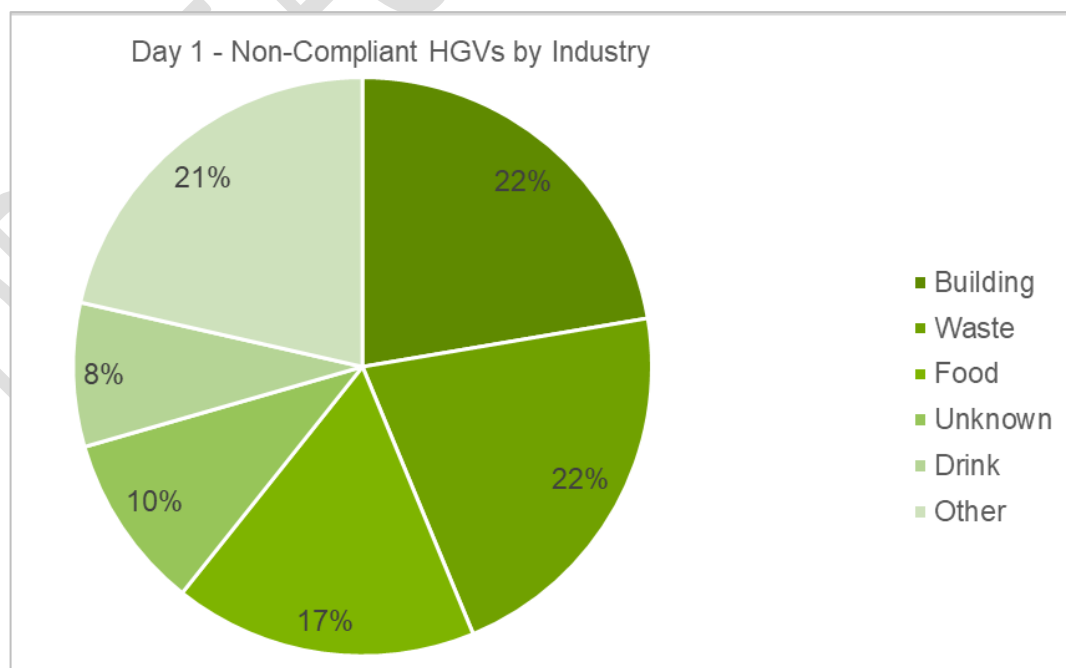
**Figure 2-7 Bridge Street/Deansgate non-compliant HGVs by industry**

2.2.10 The building and waste industries both contribute 22% each of the observed non-compliant vehicles. The majority of the observations of non-compliant vehicles from the waste industry are from bin lorries or skip-carrying lorries, which are specialised and often expensive to replace. The third highest proportion of non-complaint vehicles came from the food industry (17%). All of these vehicles had box-fridge type bodies, which, similarly to the vehicles used in the waste industry, are likely to be costly to replace. A significant proportion of non-compliant HGVs were unmarked and could not be attributed to a particular industry (10%). The drink industry contributed 8% of the non-compliant vehicles.

2.2.11 The 21% of non-compliant vehicles listed as 'other' above are made up as follows:

- 5% as 'other' - vehicles that could not be categorised into one of the industries used in this survey,
- 5% as vehicles linked to non-food retail,
- 5% as vehicles linked to the vehicle and automotive industry,
- 4% as vehicles linked to general haulage,
- 2% as vehicles linked to the parcel and post industry,
- Less than 1% each as vehicles linked to the steel, and utilities industries.

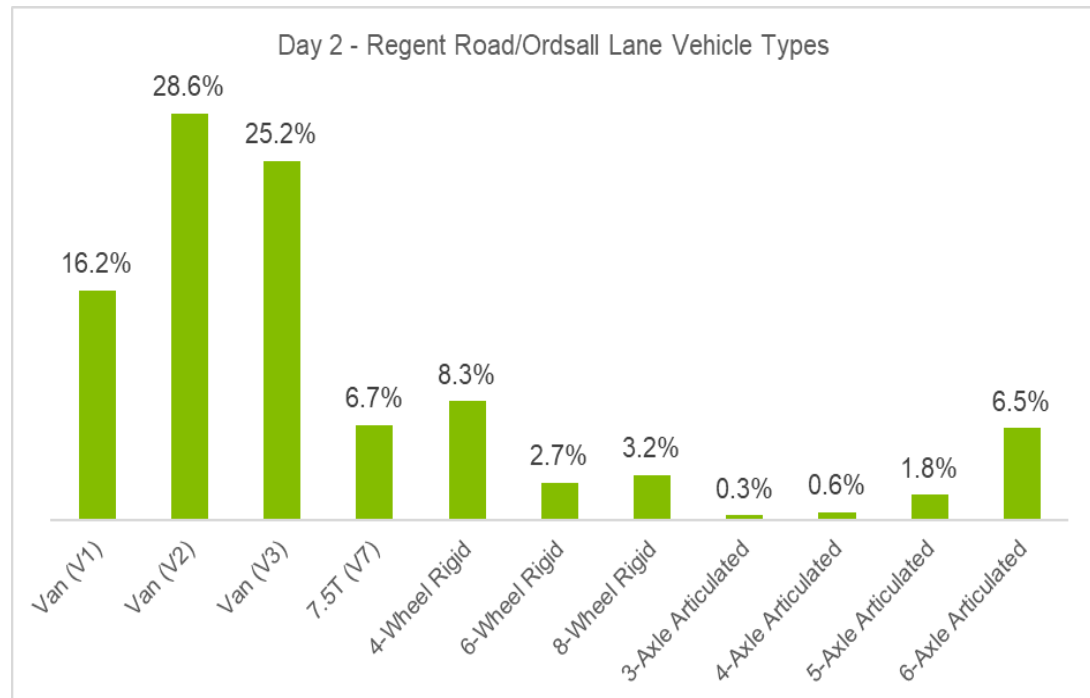
**Figure 3-2 Regent Road/Ordsall Lane Vehicle Type Splits**

3.2.1 **Figure 3-2** below shows the split of vehicle types observed at the Regent Road site.

3.2.2 While vans dominate, the proportions of HGVs are notable. There is greater use of rigid lorries than articulated lorries, with four wheel examples being the most frequently observed. This is expected as Regent Road acts as a main radial route heading to the centre of Manchester. The proportion of 6-axle articulated lorries reflects the proximity of this site to the M602 motorway – with Regent Road effectively linking this to the A57 (M) inner ring road.

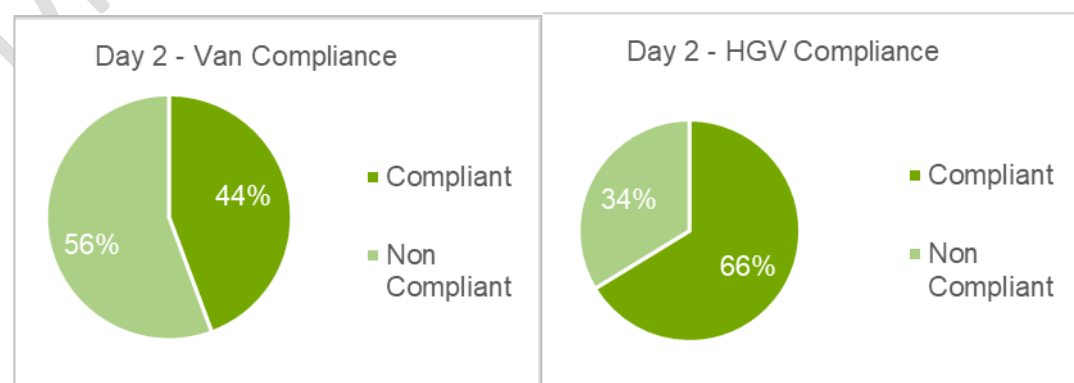
**Figure 3-3 Regent Road/Ordsall Lane vehicle compliance splits**

3.2.3 **Figure 3-3** below shows the split of vans and HGVs separately at this location based on their compliance with clean air regulations.

- 3.2.4 While the majority of vans are non-compliant (56%), this is not the case for HGVs, where 66% of observations were of compliant vehicles.
- 3.2.5 Further, **Figure 3-4** and **Figure 3-5** below shows the total observations by year of registration at this site, where red bars represent registrations which are non-complaint, and blue bars represent registrations which are compliant.

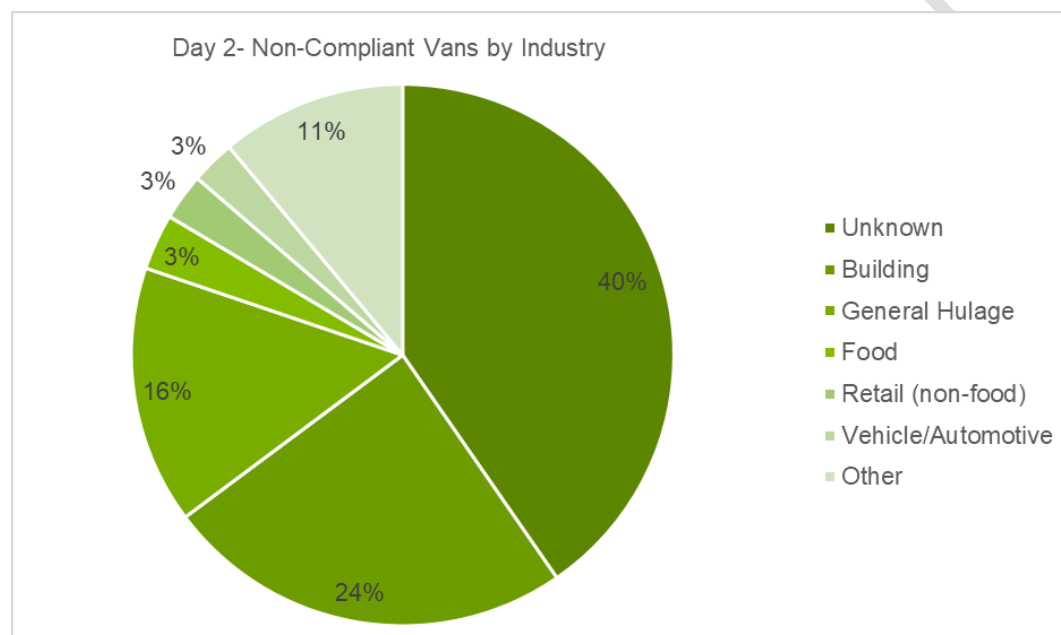
**Figure 3-6 Regent Road/Ordsall Lane non-complaint vehicles by industry**

- 3.2.8 The highest proportion of non-compliant vans are categorised as unknown (40%), again due to the prevalence of unmarked vans that could not be assigned an industry category. The building industry presented the second highest proportion (24%), which could be accounted for given the presence and intensity of works not just on Regent Road itself, but in the immediate area surrounding it. The next highest proportion came from general haulage (16%), which is little surprise given that Regent Road is a well-used freight route, close to the strategic road network. Other industries which contributed notably to the proportions of non-compliant vehicles were food (3%), non-food retail (3%), and the vehicle and automotive industry (3%).

- 3.2.9 The 11% of non-compliant vehicles listed as 'other' above are made up as follows:
- 6% as 'other' - vehicles that could not be categorised into one of the industries used in this survey;

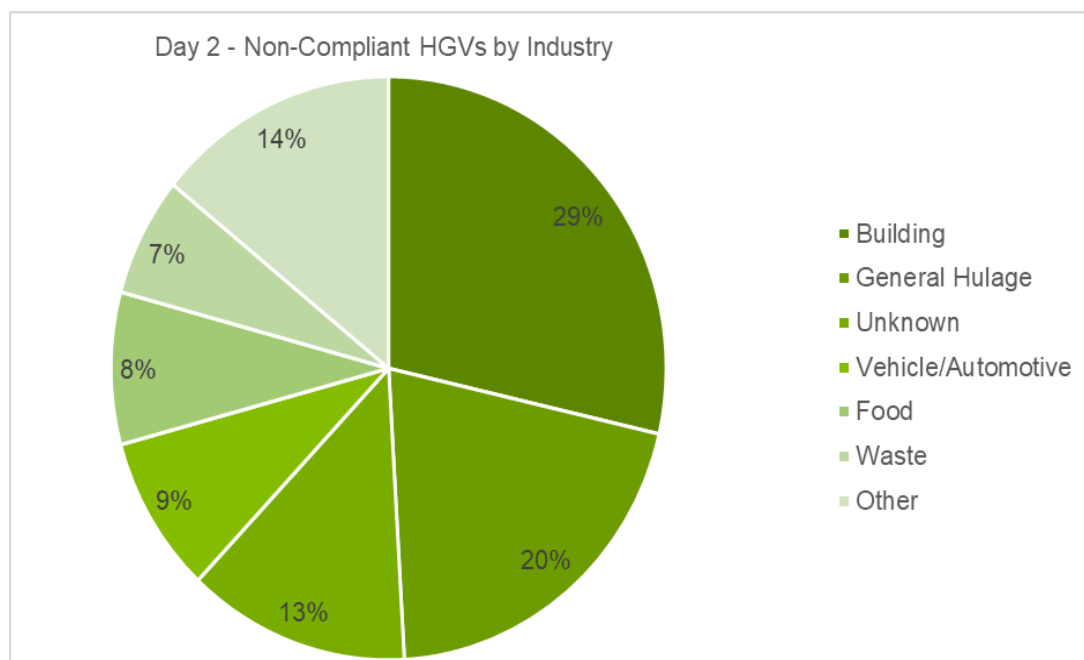
**Figure 3-7 Regent Road/Ordsall Lane non-compliant vehicles by industry**

3.2.10 Similarly to vans, the highest proportion of HGVs that are non-compliant are from the building industry (29%), followed by general haulage (20%). Unmarked lorries that could not be categorised into a particular industry make up 13% of non-compliant observations. The vehicle and automotive (9%), food (8%), and waste (7%) industries also contribute notable proportions of non-compliant vehicles.

- The 14% of non-compliant vehicles listed as 'other' above are made up as follows:
  - 4% as 'other' - vehicles that could not be categorised into one of the industries used in this survey;
  - 2% as vehicles linked to the drinks industry;
  - 2% as vehicles linked to the non-food retail industry;
  - 2% as vehicles linked to the container industry;
  - 2% as vehicles linked to the parcel and post industry;
  - 1% as vehicles linked to the chemical industry; and
  - Less than 1% each linked to the manufacturing, agricultural, steel, scrap metal, and media and telecommunications industries.

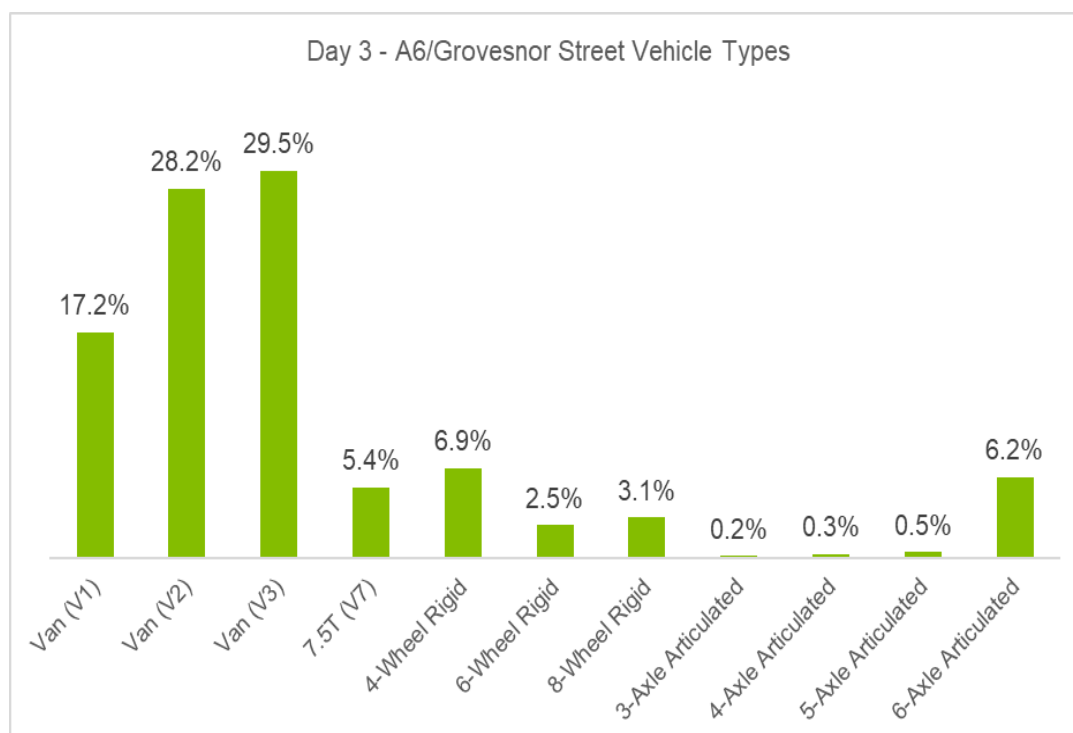
**Figure 4-2 A6/Grosvenor Street Vehicle Type Split**

- 4.1.2 This area appeared to be functioning as it usually would be on the day of the survey – there were no incidents or road works that were observed that would have caused issues affecting the results of the survey.
- 4.1.3 At the point the survey was carried out, the road is a traditional two lane urban dual carriageway, with a right turn filter lane for the movement from the A6 outbound to Grosvenor Street. The site is adjacent to the junction with the A57 (M). It should be noted that traffic travelling westbound on the A57 (M) cannot access the A34 at the next junction – so it must leave the motorway at the A6, then turn right on to Grosvenor Street in order to access it.
- 4.2 Analysis
- 4.2.1 **Figure 4-2** below shows the split of vehicle types observed at the A6/Grosvenor Street site.

4.2.2 The vehicle type split has similar characteristics to that of the Regent Road site, reflecting the A6's proximity to the A57 (M) inner ring road.

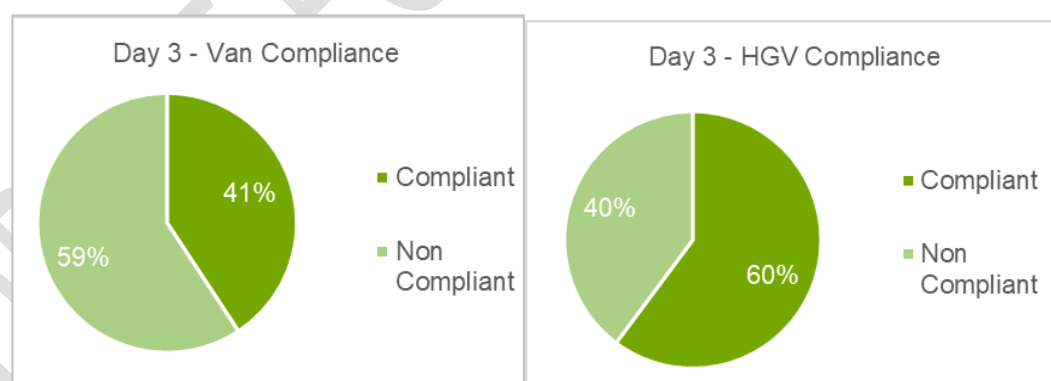
**Figure 4-3 A6/Grosvenor Street vehicle compliance splits**

4.2.3 **Figure 4-3** below shows the split of vans and HGVs separately at this location based on their compliance with clean air regulations:

4.2.4 While the majority of vans are non-compliant (59%), this is not the case for HGVs, where 60% of observations were of compliant vehicles.

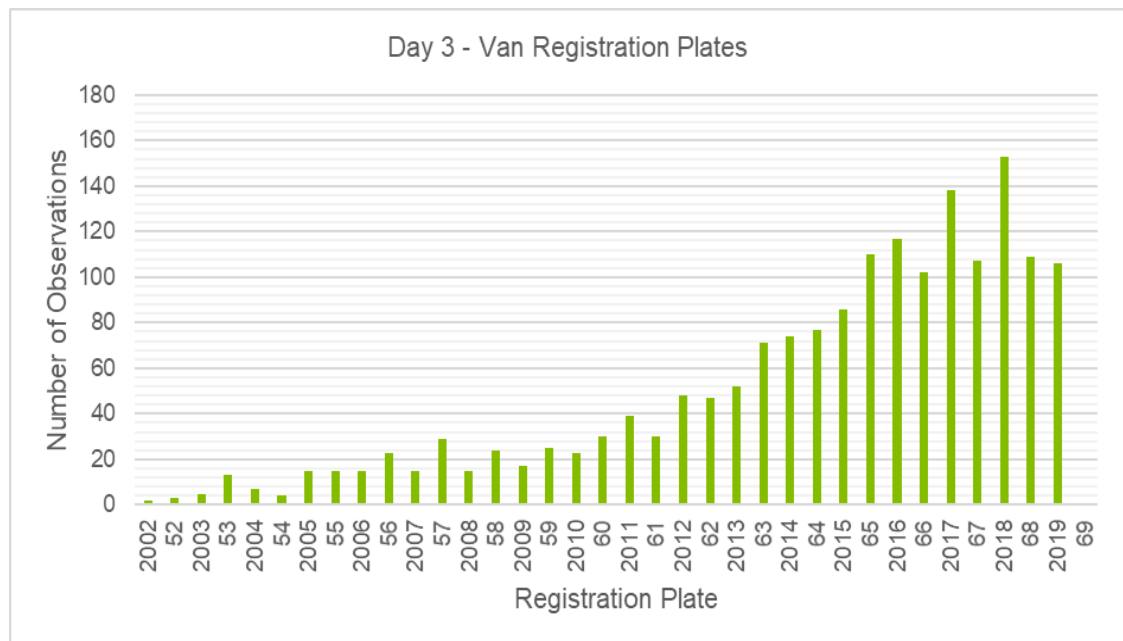
**Figure 4-4 A6/Grosvenor Street van registration years**

4.2.5 Further, **Figure 4-4** and **Figure 4-5** below shows the total observations by year of registration at this site, where red bars represent registrations which are non-complaint, and blue bars represent registrations which are compliant.

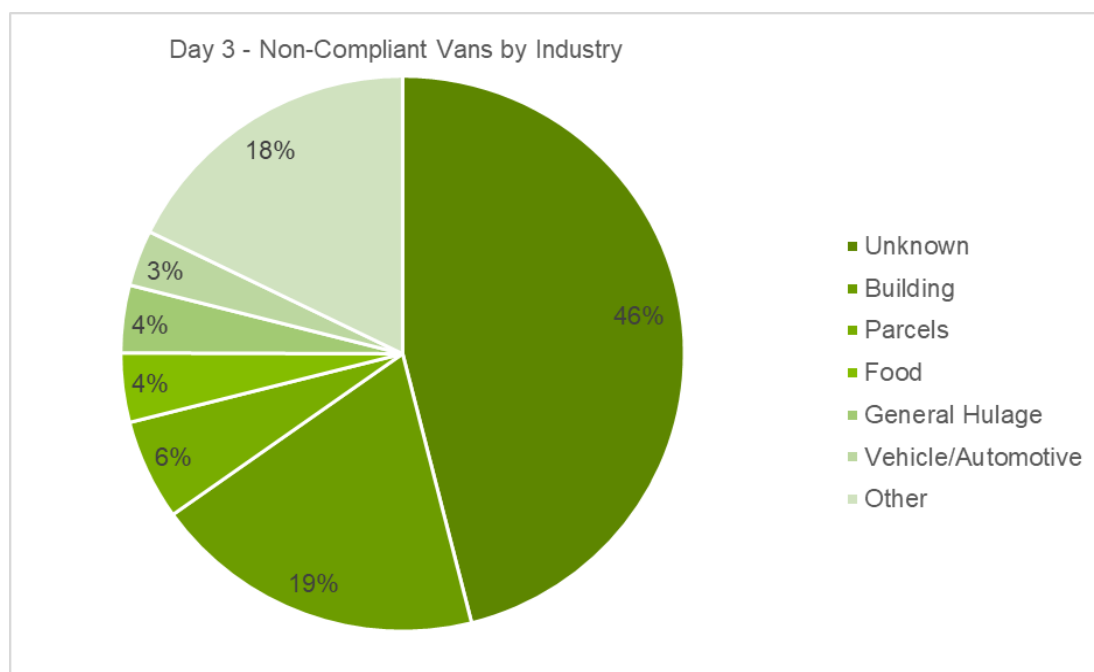
**Figure 4-6 A6/Grosvenor Street non-compliant vans by industry**

4.2.8 The high volumes of unmarked vans result in this category producing the highest proportion of non-compliant observations (46%). The building industry produces the next highest proportion (19%), followed by parcels and post (6%), food (4%), general haulage (4%) and the vehicle and automotive industry (3%).

4.2.9 The 18% of non-compliant vehicles listed as 'other' above are made up as follows:

- 10% as 'other' - vehicles that could not be categorised into one of the industries used in this survey;
- 2% as vehicles linked to the media and telecommunications industry;
- 2% as vehicles linked to the non-food retail industry;
- 2% as vehicles linked to the utilities industry; and
- Less than 1% each linked to the drink, waste, manufacturing, chemical and steel industries.

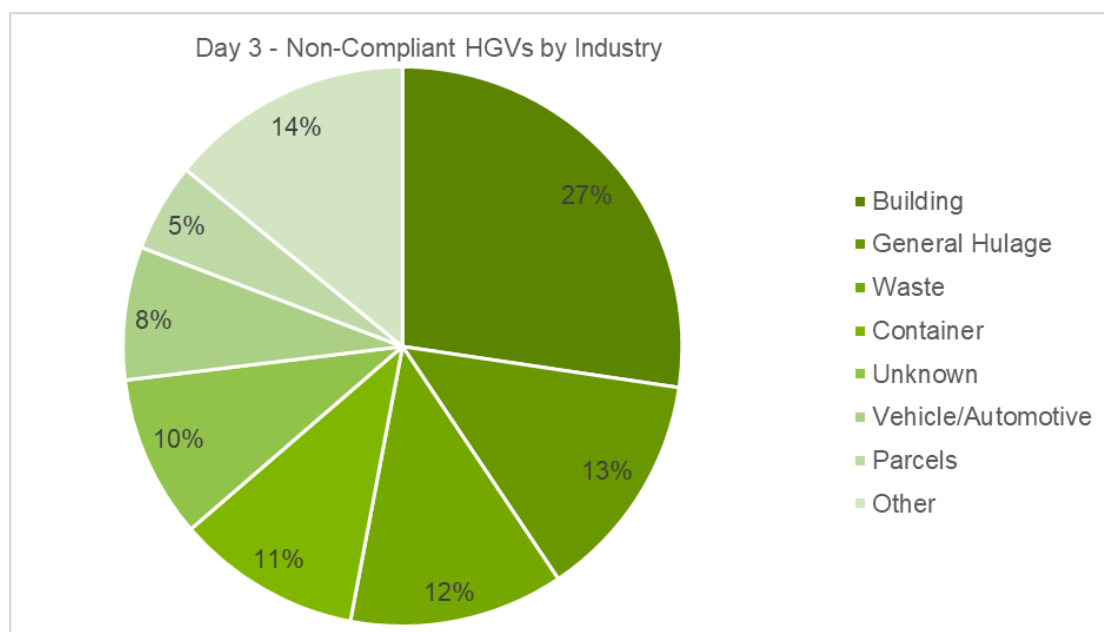
**Figure 4-7 A6/Grosvenor Street non-compliant HGVs by industry**

4.2.10 Building industry vehicles account for the highest proportion of HGV non-compliances (27%). General haulage accounts for the second highest proportion (13%), reflective of the significance of this route as a radial route from Manchester and its closeness to the A57 (M). The waste industry accounts for the third largest proportion of non-compliant vehicles (12%), again likely due to the extra expense incurred in having to replace highly specialised vehicles. There is also a notable proportion of non-compliant vehicles attributable to the container industry (11%) – these are likely to be on routes to and from the various container depots located on Trafford Park (travelling to and from the survey site using the A5081, A56 and A57 (M)). Vehicles for which the industry type is unknown account for 10% of non-compliant HGVs, while the vehicle and automotive industry (8%) and the parcel and post industry (5%) also make notable contributions.

4.2.11 The 14% of non-compliant vehicles listed as 'other' above are made up as follows:

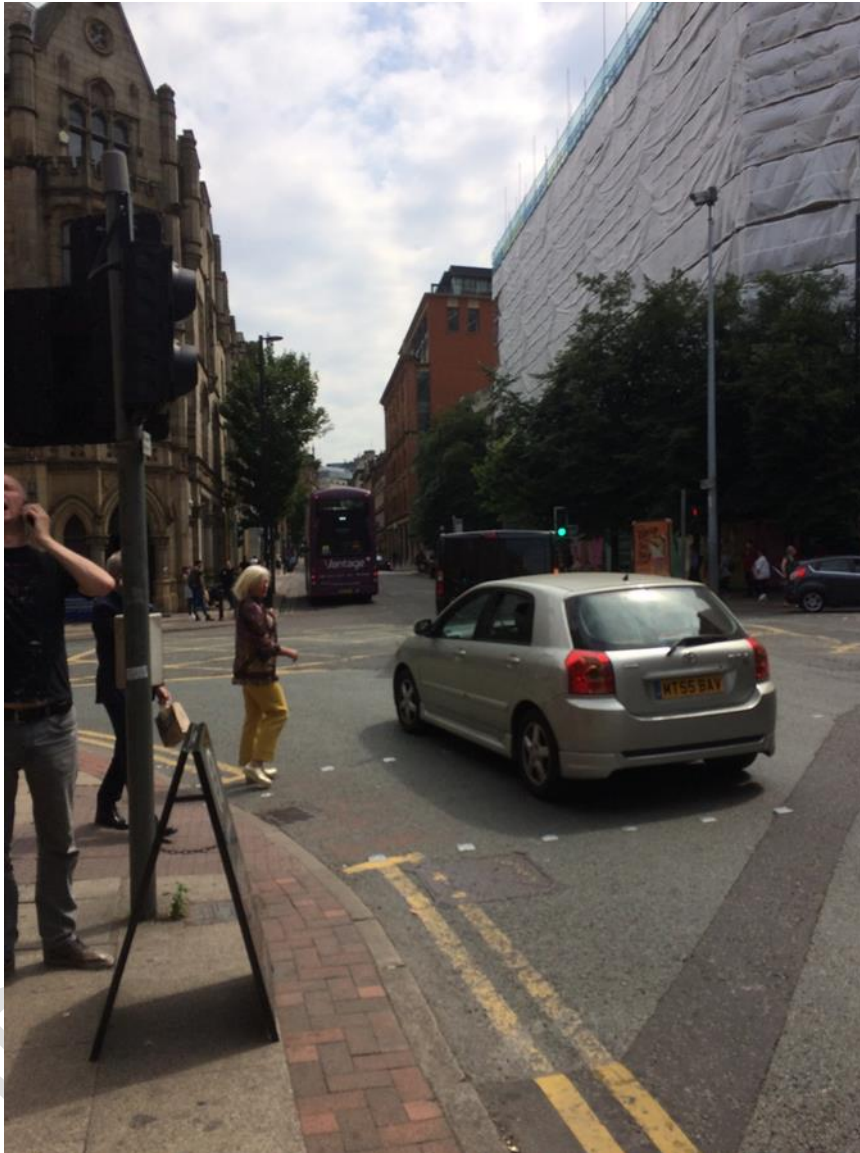
#### A.2.1 Backed up traffic from John Dalton Street

- Congestion: There were regular instances in the morning with inbound traffic on the other side of the junction backed up preventing forward movement through the junction. This could have been due to traffic on John Dalton Street being held for tram movements etc. This is shown in A.2.1.

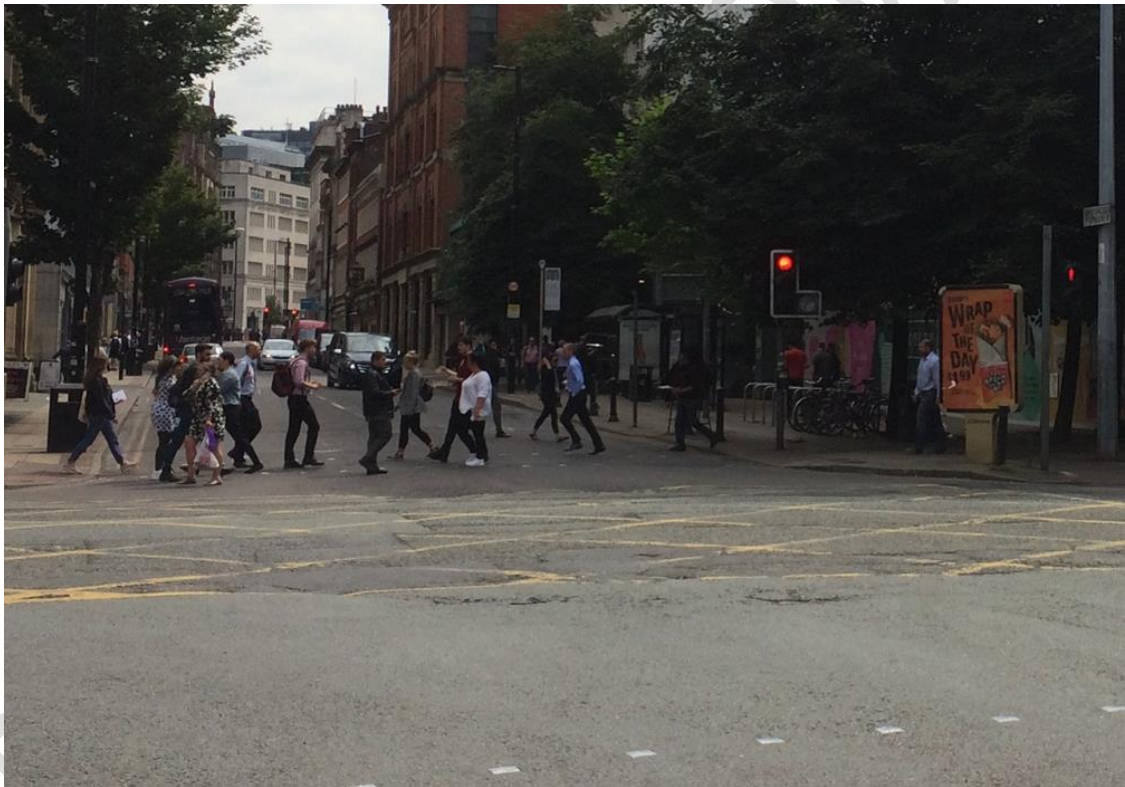
#### **A.2. 2 Poor quality road surface at Bridge Street/Deansgate junction**

- **Traffic Lights and timing:** The lights seemed to have regular timings which didn't reflect directional traffic flow. There were numerous occasions where three to four double decker buses were sitting in the queue for the lights and the time setting would not allow the queue to clear even if the receiving arm had the capacity to accommodate the vehicles.
- **Road Surface quality:** The road surface at the Deansgate junction is starting to crack. It is already uneven and has rutting lines running along Deansgate. This means traffic, especially buses, using Bridge Street have to slow down for the junction to give the passenger a smoother ride. This reduces the capacity of the junction. This is shown in **A.2. 2** below.

- **Pedestrian issues:** There is a high flow of pedestrians on Deansgate and at times this could cause some safety near-misses. The poor road surface meant pedestrians were having to deviate from the crossings to avoid potholes.
- **Bus issues:** It is understood that this is an important bus corridor into the city for multiple routes and Stagecoach & First have multiple routes plus National Express Coaches to Liverpool. A number of buses appeared to be pre-2013 and therefore non-compliant. A large number of these also appeared to be carrying very few passengers. There were frequently buses queued at the traffic signals, and others at a bus stop further down Bridge Street, all idling as they were queuing or waiting.

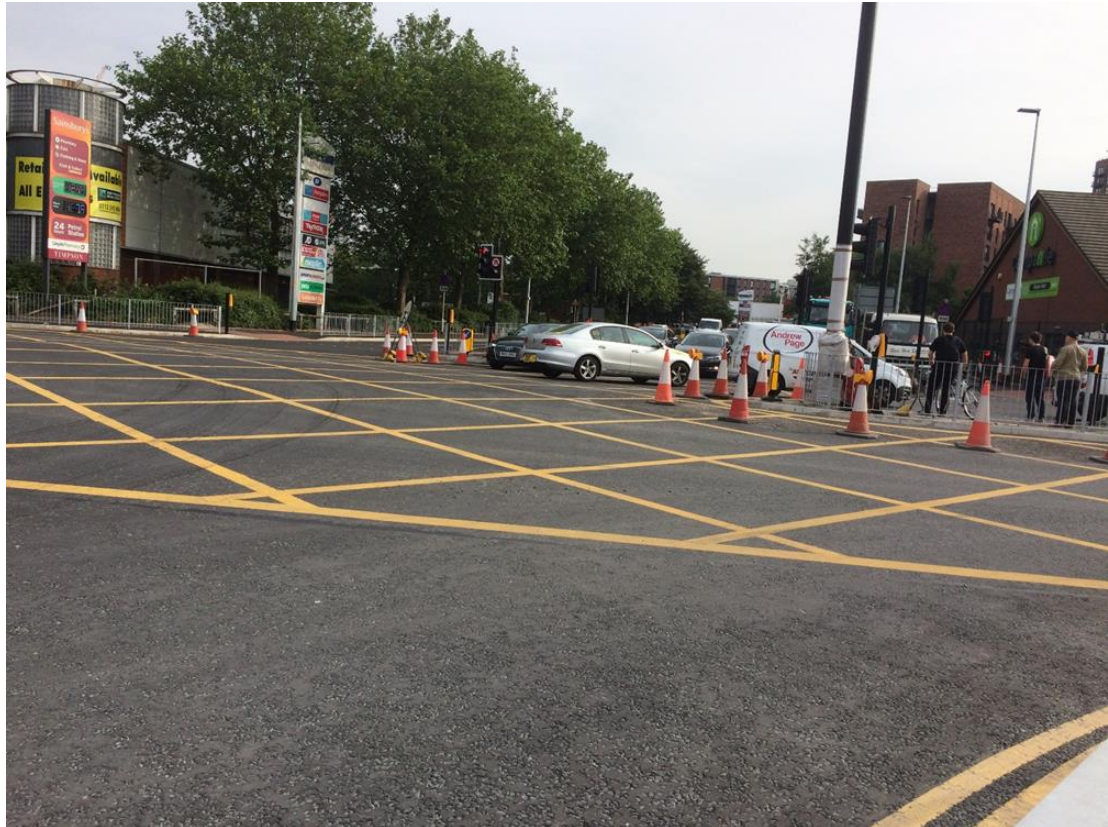
### A.2. 3 Trapped traffic on Ordsall Lane

- Safety concerns or near misses observed: There was lots of near misses involving cars that had driven through the lights when the exit route was not free, so they were effectively blocking traffic flow. This was despite yellow boxes being painted on the road. **A.2. 3** below shows an example of this – here, inbound traffic is blocking movements out of Ordsall Lane.

- Yellow box: The junction was regularly being blocked by turning vehicles which prevented some through movements on the side roads. See safety concerns above.

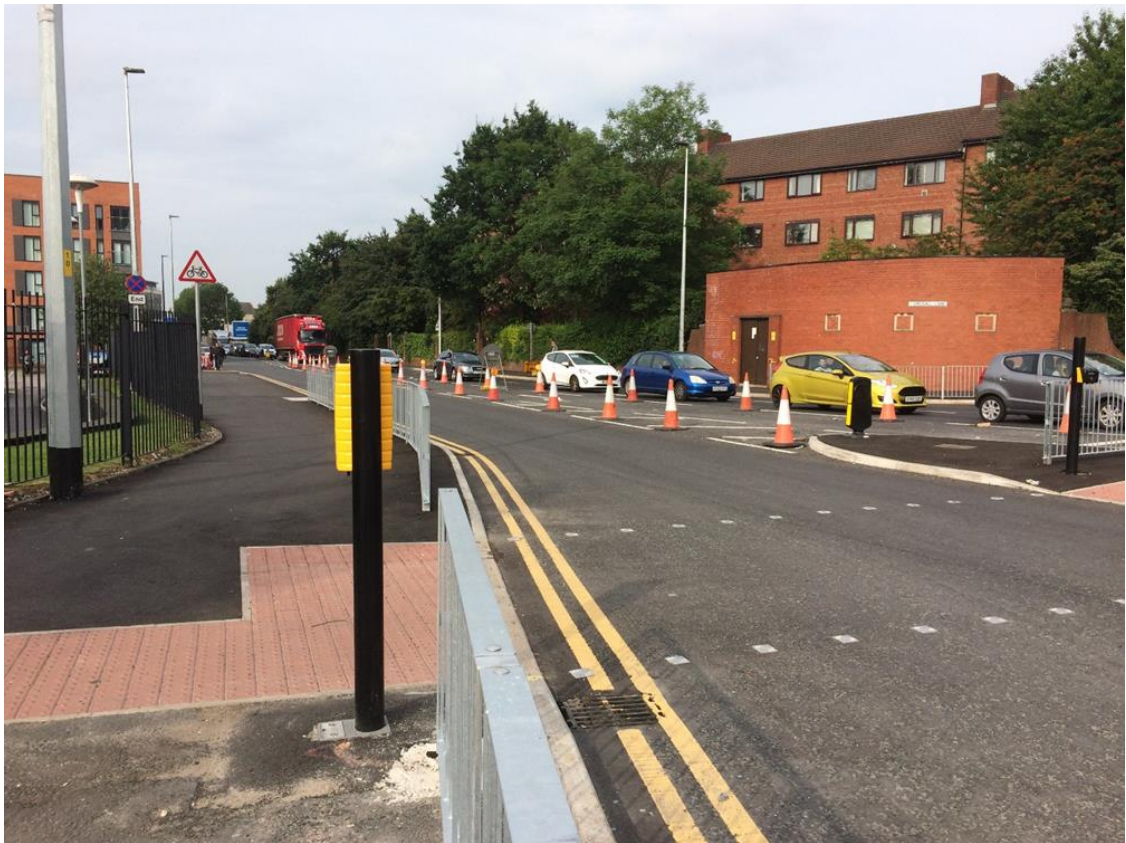
#### A.2. 4 Traffic queuing on Ordsall Lane

- Traffic Flow: Heavier freight route, serving some of the local major construction projects including new tower blocks and highway improvements. Regent Road was by far the dominant traffic flow. There was a relatively modest flow of traffic on the minor road despite having a retail park nearby.
- Congestion: The whole area was congested as it was reduced to one lane in each direction, significantly increasing journey times and likely to result in drivers (of all vehicles) taking alternative routes. As Regent Road was reduced to one lane in either direction it was causing traffic to build on the side roads, as demonstrated in A.2. 4
