Mid-Bay Bridge Tendon Restoration

Case Study

The Northwest Florida Panhandle Mid-Bay toll bridge underwent emergency closure for repairs due to tendon corrosion. DYWIDAG successfully restored and repaired five multistrand tendons on this 3.6-mile bridge connecting Niceville and Destin.

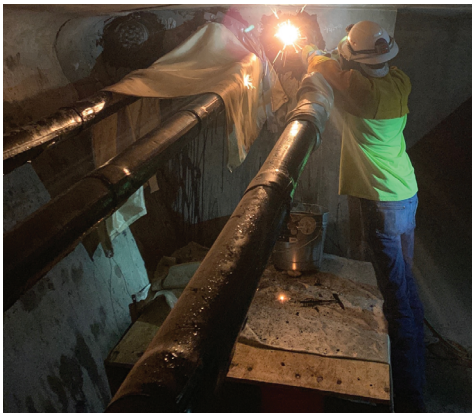
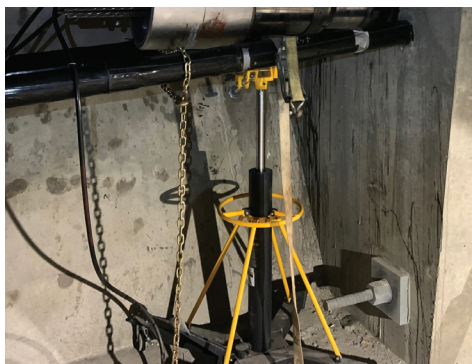
With precision and expertise, we proceeded to install new external post-tensioned tendons within the box girders. The project was completed safely, on time, and on budget.

Our comprehensive scope of work included the design of the de-tensioning methodology, the design of the new PT system, the removal of the existing system, and the installation of the new PT system. This required precise measurements for jack fitment and the development of a highly specialized four-foot-long, curved stressing nose. We began by de-tensioning and carefully removing the damaged tendons, leaving no room for safety compromise. These old components were responsibly disposed of, making way for the next phase of our transformative project.
