8 Technical Improvements

8.1 B33-Solution: Connect Seatframe to Scooter Frame

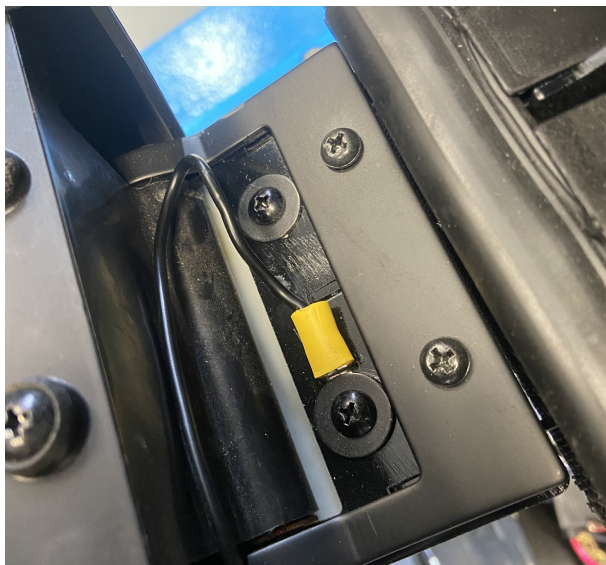
1. Connect wire on the seat, as shown below. Please route the cable as shown. For a better customer experience use a terminal lug with a black isolation colour, so it will be less visible.

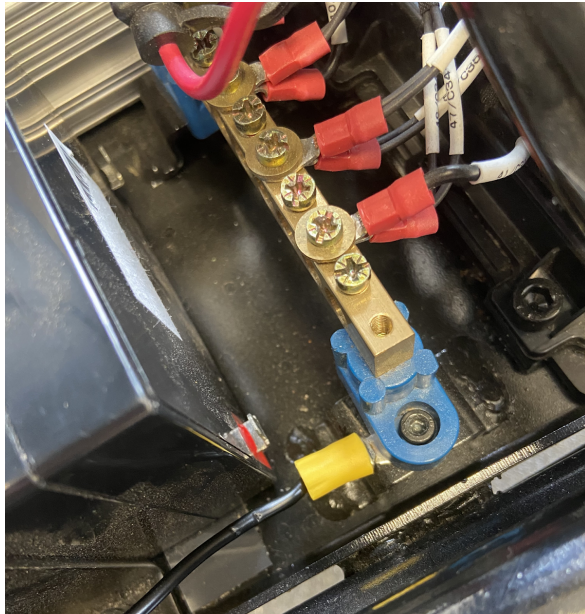
3. On the other end of the wire, connect the terminal with the frame by attaching the cable to the screw that holds the bus bar.
