**ETS-LINDGREN
ACOUSTIC RESEARCH LABORATORY
OFFICIAL LABORATORY REPORT
AS-TL3554**

Subject: **Sound Transmission Loss Test**

Marine Plywood Reference Panel - 3/4" Thickness

Richlite USA

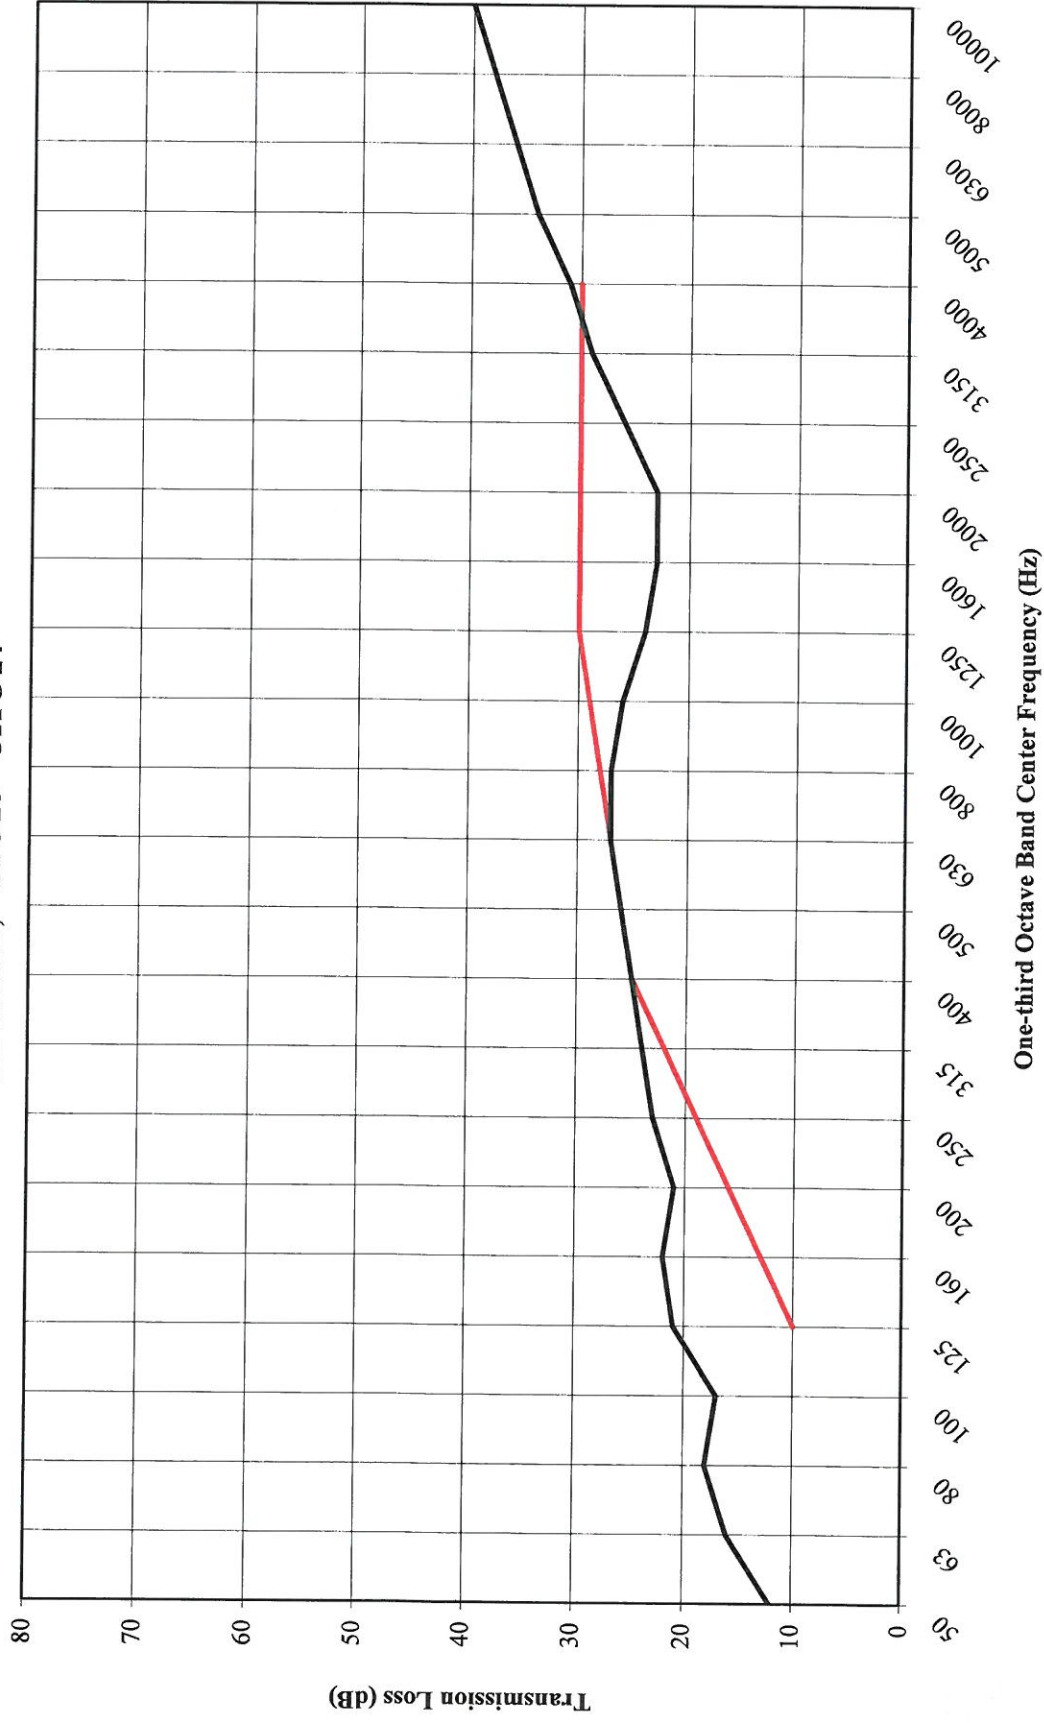
Richlite USA Marine Plywood Panel - 3/4" Thickness
AS-TL3554; STC 26 OITC 24

Sound Transmission Loss of the test specimen at the preferred one-third octave band center frequencies is tabulated below and then presented graphically. Octave-band Transmission Loss values are calculated as described in Section 12.3 of ASTM E90.

1/3 Octave Band Center Freq (Hz)	Transmission Loss (dB)	Uncertainty (+/- dB)	Notes	Octave Band TL (dB)	STC Deficiencies	R _w Deviations >8dB
50	12		[b][c][f]			
63	16		[c][f]	15		
80	18	4.6				
100	17	2.1				
125	21	1.9		19		
160	22	2.0				
200	21	0.8				
250	23	0.4		22		
315	24	0.5				
400	25	0.4				
500	26	0.3		26		
630	27	0.3				
800	27	0.3			1	
1000	26	0.2		25	3	
1250	24	0.2			6	
1600	23	0.2			7	
2000	23	0.2		24	7	
2500	26	0.2			4	
3150	29	0.2			1	
4000	31	0.2		31		
5000	34	0.2				
6300	36	0.3				
8000	38	0.3		38		
10000	40	0.5				
STC	26	R _w	26			
OITC	24
