Lower Deschutes River Gravel Study

Overview

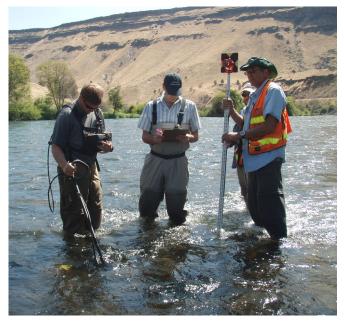
In Phase 1 of the gravel study, tagged tracer rocks were surveyed, providing information on river flows and use by spawning salmon.

- From 2007-2014, over 200 rocks (all suitably-sized for Chinook spawning) were tagged with microchips and monitored for movement.
- We utilized Acoustic Doppler Current Profilers to map the river channel floor in seven locations, totaling 34 cross-sections.
- Six natural gravel bars in the Lower Deschutes were extensively mapped and monitored for trout spawning.
- In 2008, we constructed three experimental gravel bars in areas that would naturally have similar deposits. These sites were mapped and closely monitored for gravel movement and fish use.
