# Large Wood in the Lower Deschutes River

## Our commitment to the Deschutes Basin

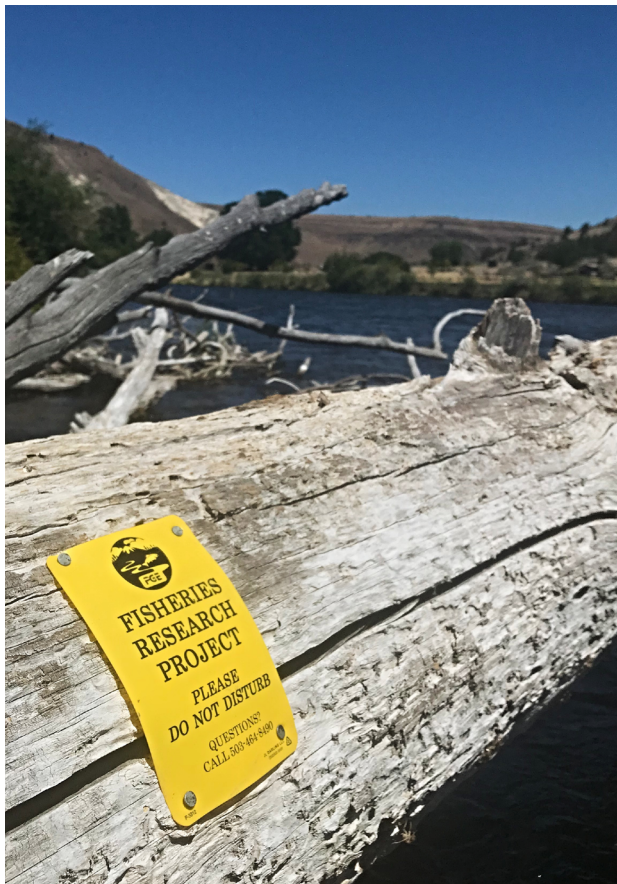
*(Left) Logs placed in the Lower Deschutes River are marked and monitored for movement by PGE staff.*

From 2007-2019, we have moved 352 pieces of large wood to the Lower Deschutes. Each log is individually marked prior to placement, and the length, diameter, tree species and presence or absence of limbs and roots are all recorded. Large wood pieces are left unanchored in the river channel, allowing for their movement downstream.

Each year after high spring flows, biologists float downriver, monitoring the position of marked logs and recording any movement. We have tracked large wood as far as 25 miles downstream of its original placement!

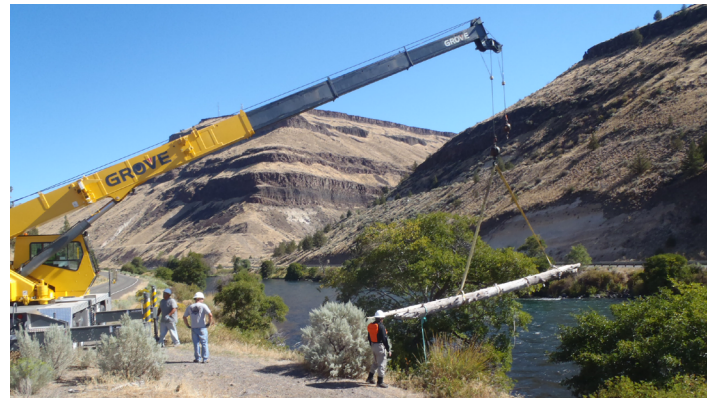
*PGE crews use cranes to place logs in locations and configurations that mimic naturally-transported wood.*

Today, we transport large wood from Lake Billy Chinook to the Lower Deschutes, placing it in natural configurations.

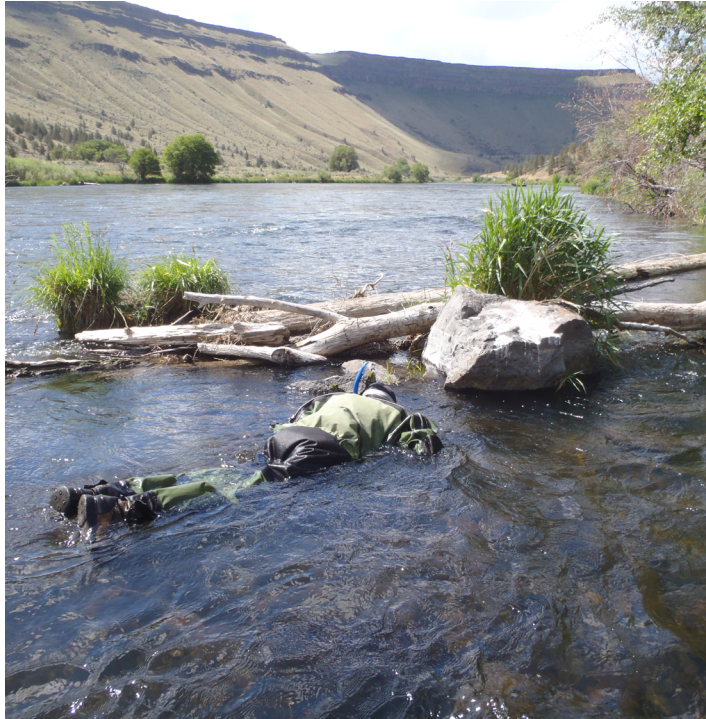
*Each spring, our biologists conduct snorkel surveys, searching under and around tagged logs to monitor for use by fish and wildlife.*

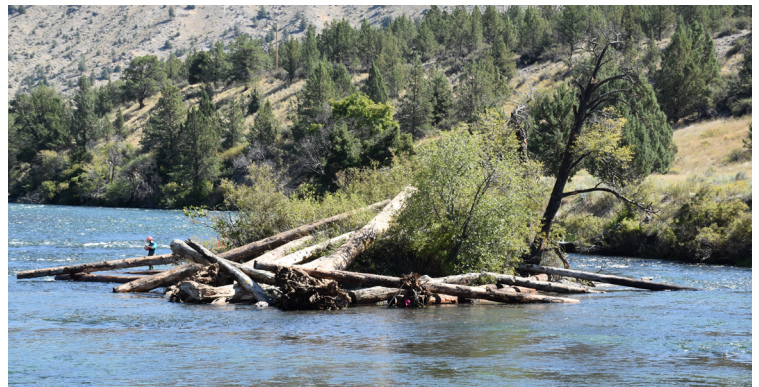
*In 2019, we used a helicopter to place logs and boulders in strategic locations below our dams.*
