Project:
Joint repair

Location:
Seven Hills, MB Solutions site

MB Solutions Seven Hills Site

Joint repair for busy driveway

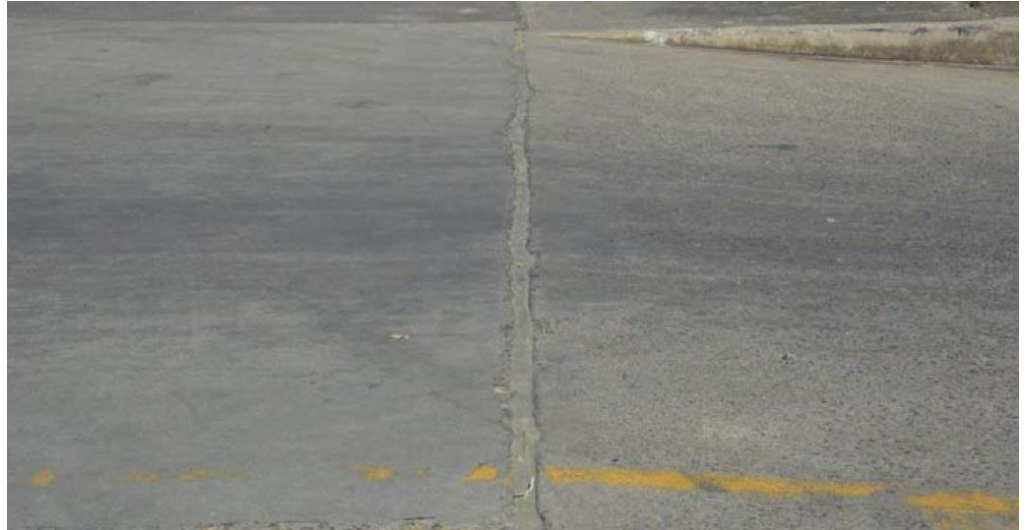
The repaired joint outside MB Solutions Seven Hills warehouse driveway

A joint between two slabs (one sloping) had opened up over time and the joint had become contaminated with dirt and debris. The exposed edges of the joint were showing signs of damage. The immediate needs were to stop further deterioration and seal the joint.

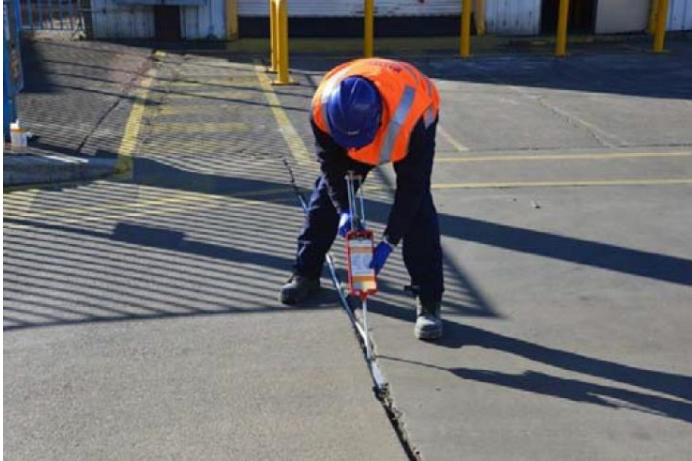
Joint sealant is applied to the cleaned joint after backer rod application

The MasterSeal CR 435 joint sealant has some unique characteristics that made it perfect for this application. It has high Shore A hardness making it abrasion resistant. It has fast cure allowing return to service in minutes, rather than hours or days. It is self priming so minimal preparation was required. All that was needed was to clean the joint and install a backer rod to give the right joint thickness. This allows the joint sealant to move with the expansion and contraction of the slabs.

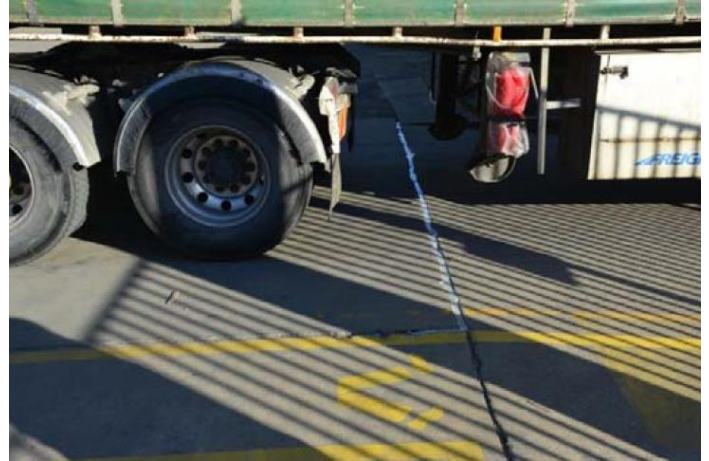
Traffic moved over the joint within 15 minutes of application

- Shore A hardness of 80MPa – giving long term durability and abrasion resistance.
- Gel time of approximately 4 minutes – fast hardening allowing for return to service within 15 minutes, almost no disruption to normal operations.
- Twin cartridge – part used cartridges can be kept for the next job. Only the static mixer was discarded- no wastage.
- Concrete grey colour of the cured sealant – blends in with the concrete.
- UV stable – suitable for internal and external use. Sealant will not crack or disintegrate under exposure.
